# BRANDYWINE RIVER DAMS 4 AND 6 FISH PASSAGE ALTERNATIVES ANALYSIS

Prepared for:

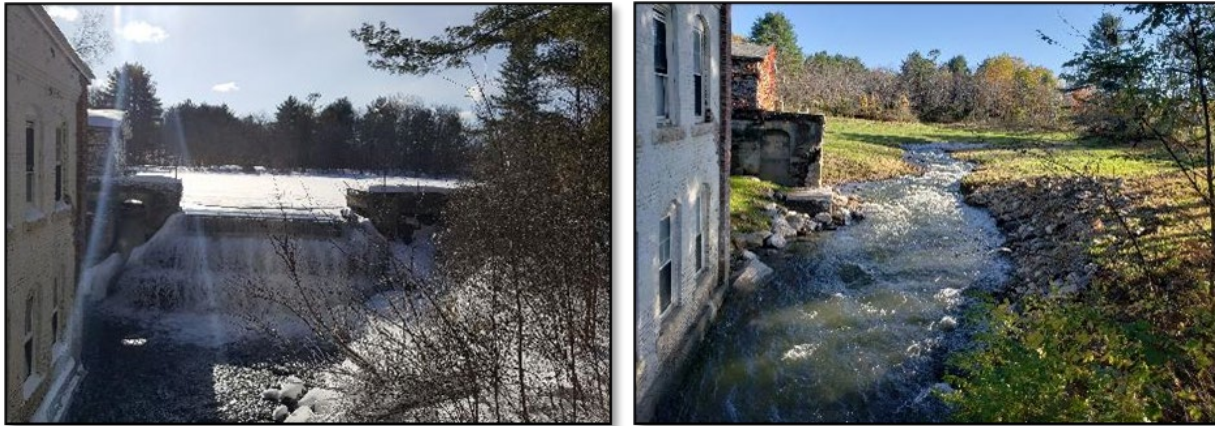
**Figure 4. Example Partial Dam Removal by Kleinschmidt - Lombard Dam; Vassalboro, Maine**

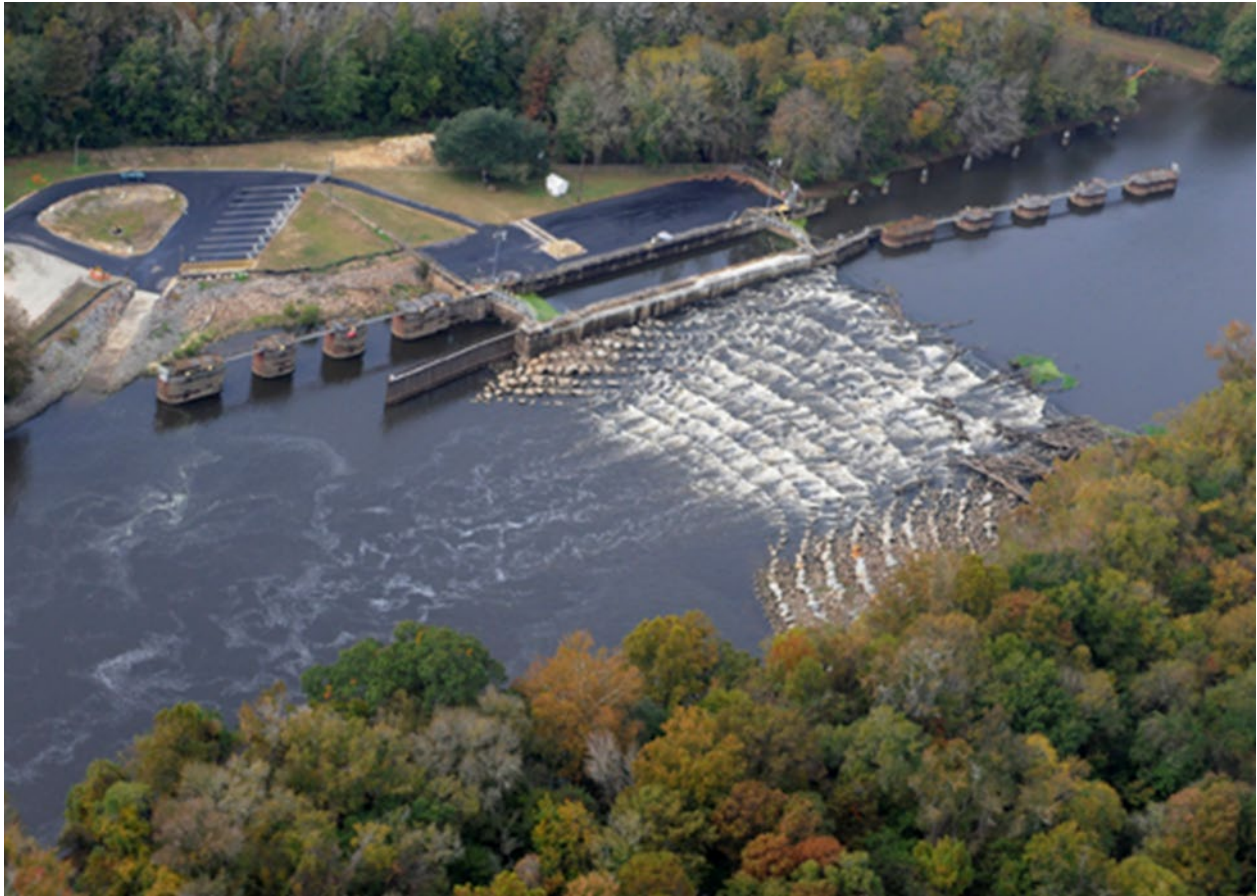
**Figure 5. Example Rock Ramp Fishway – Rock Arch Rapids Fishway at the Cape Fear River Lock and Dam No.1; Cape Fear River, North Carolina**

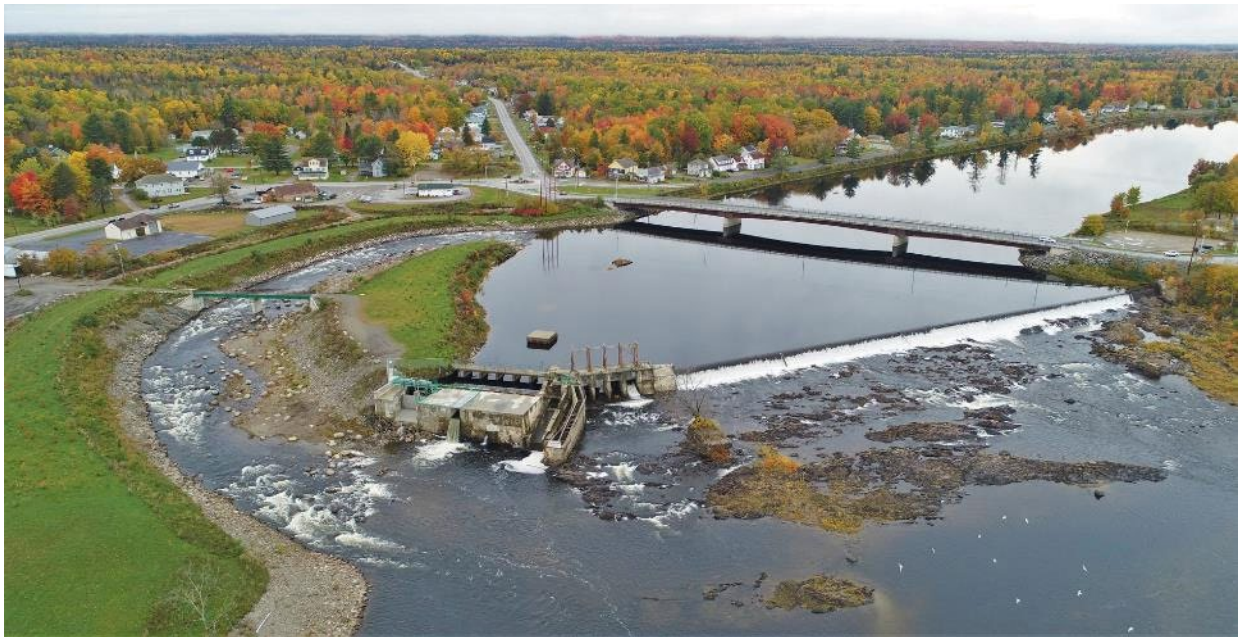
**Figure 6. Example Natural Bypass NLF on the Penobscot River in - Howland, Maine**

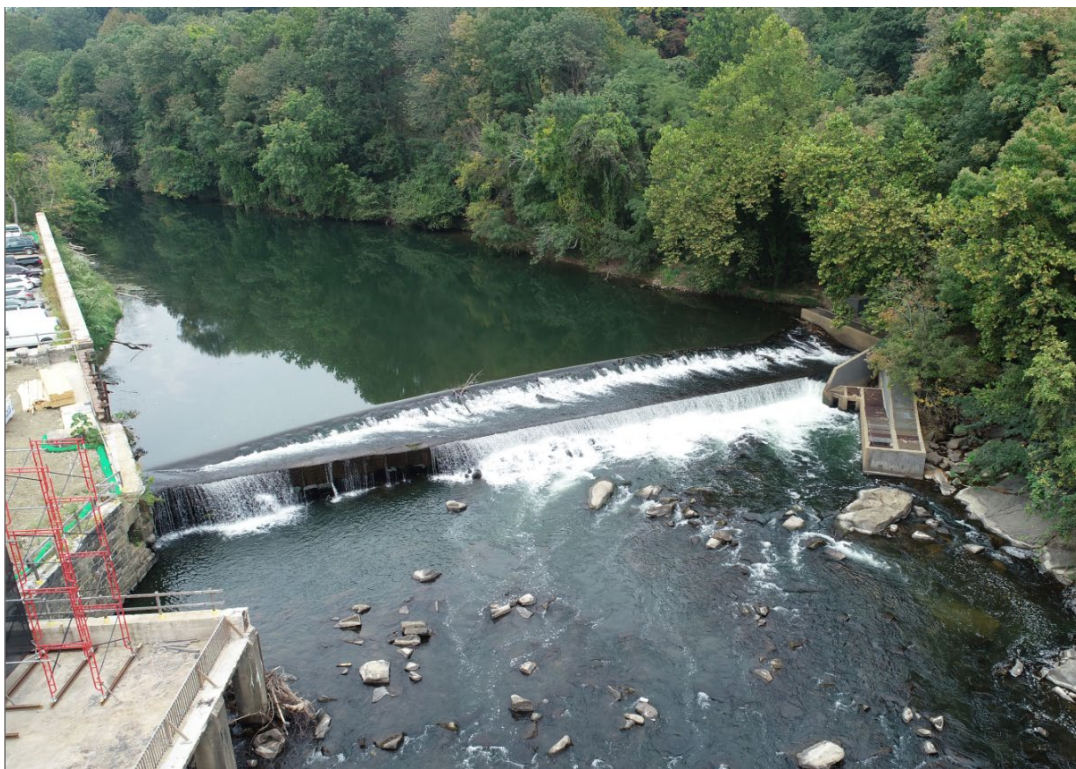
**Photo 1. Aerial View of Dam 4 from Drone Showing Void on Left Side, Dated 9/25/2020**

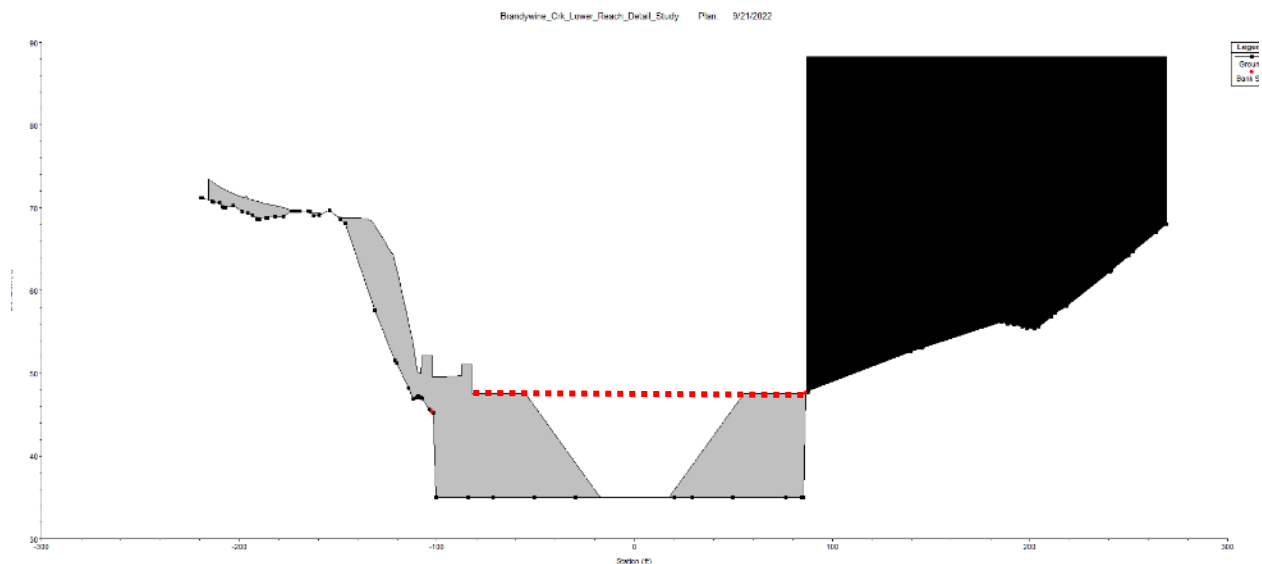
**Figure 9. Partial-width Removal Geometry Visualization for Dam 4 in HEC-RAS Modeling Software (red line is existing dam crest, grey is dam/banks to remain)**

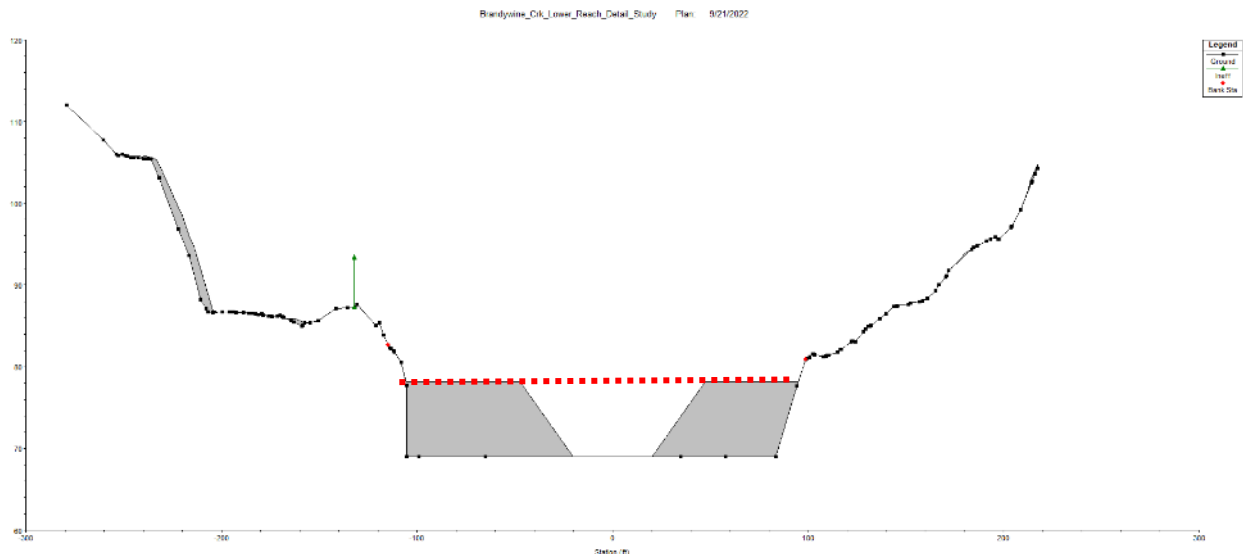
**Figure 12. Partial-width Removal Geometry Visualization for Dam 6 in HEC-RAS Modeling Software (red line is dam crest, grey is dam/banks to remain)**

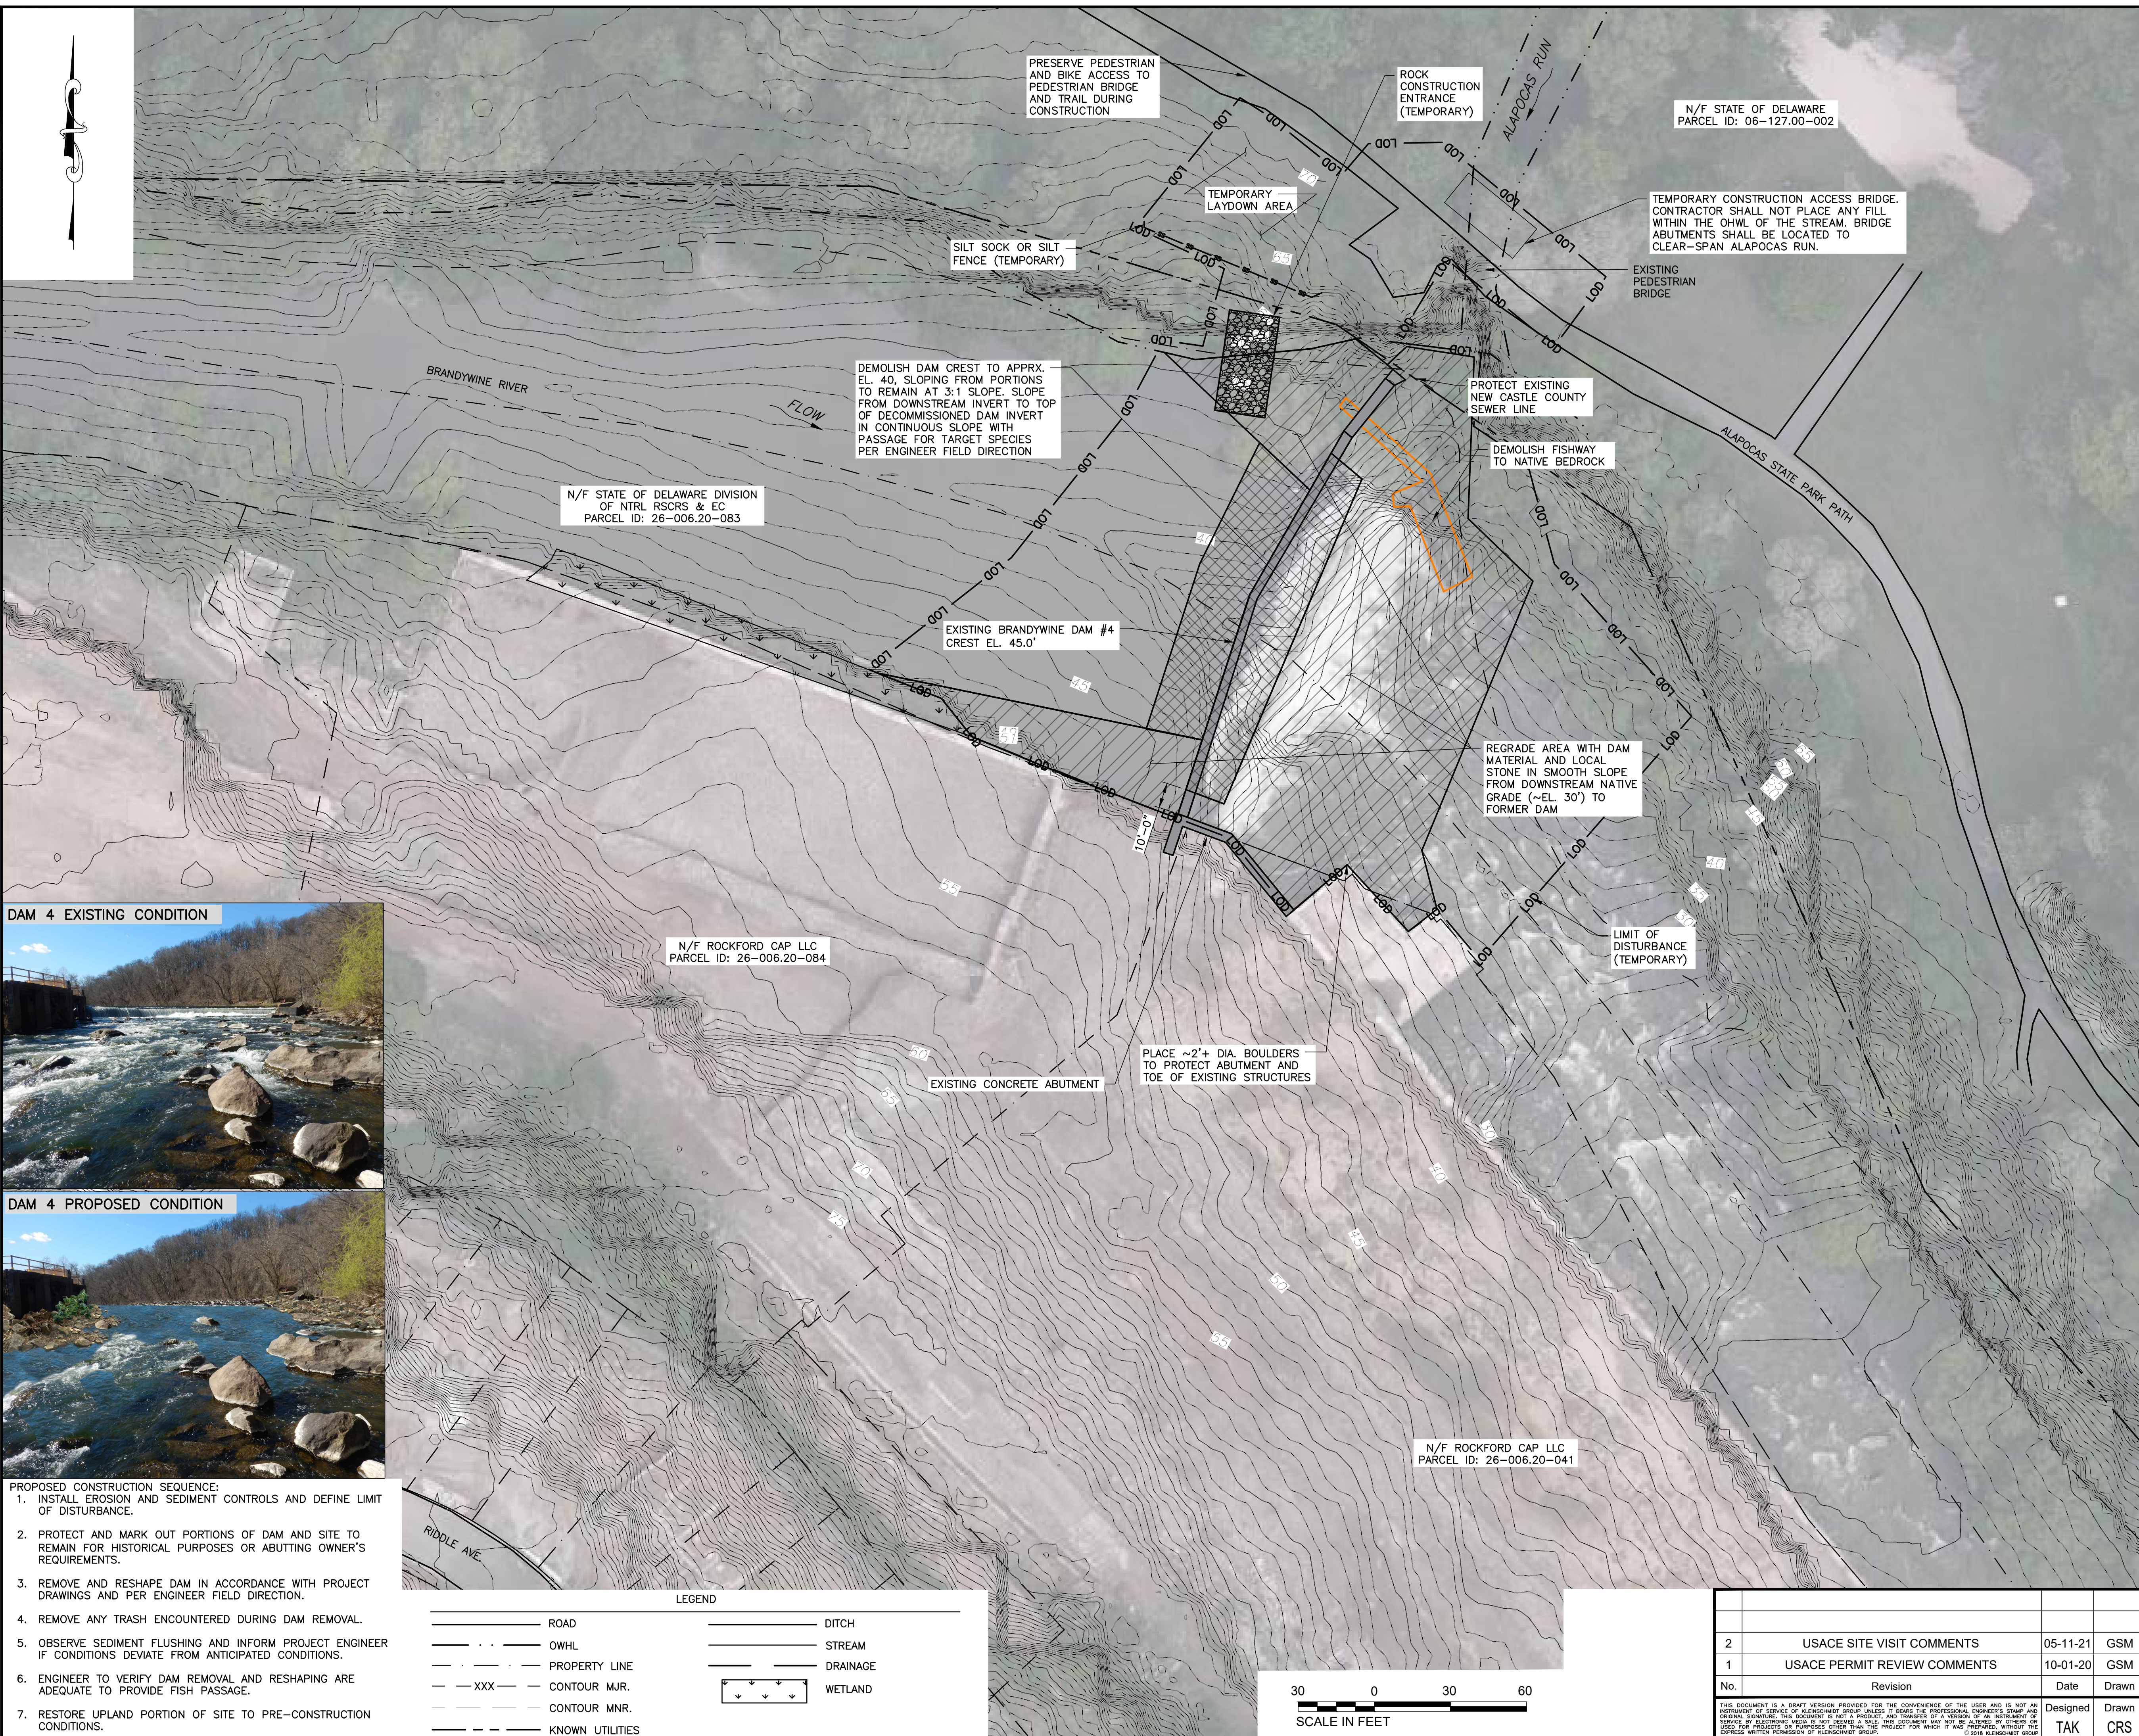
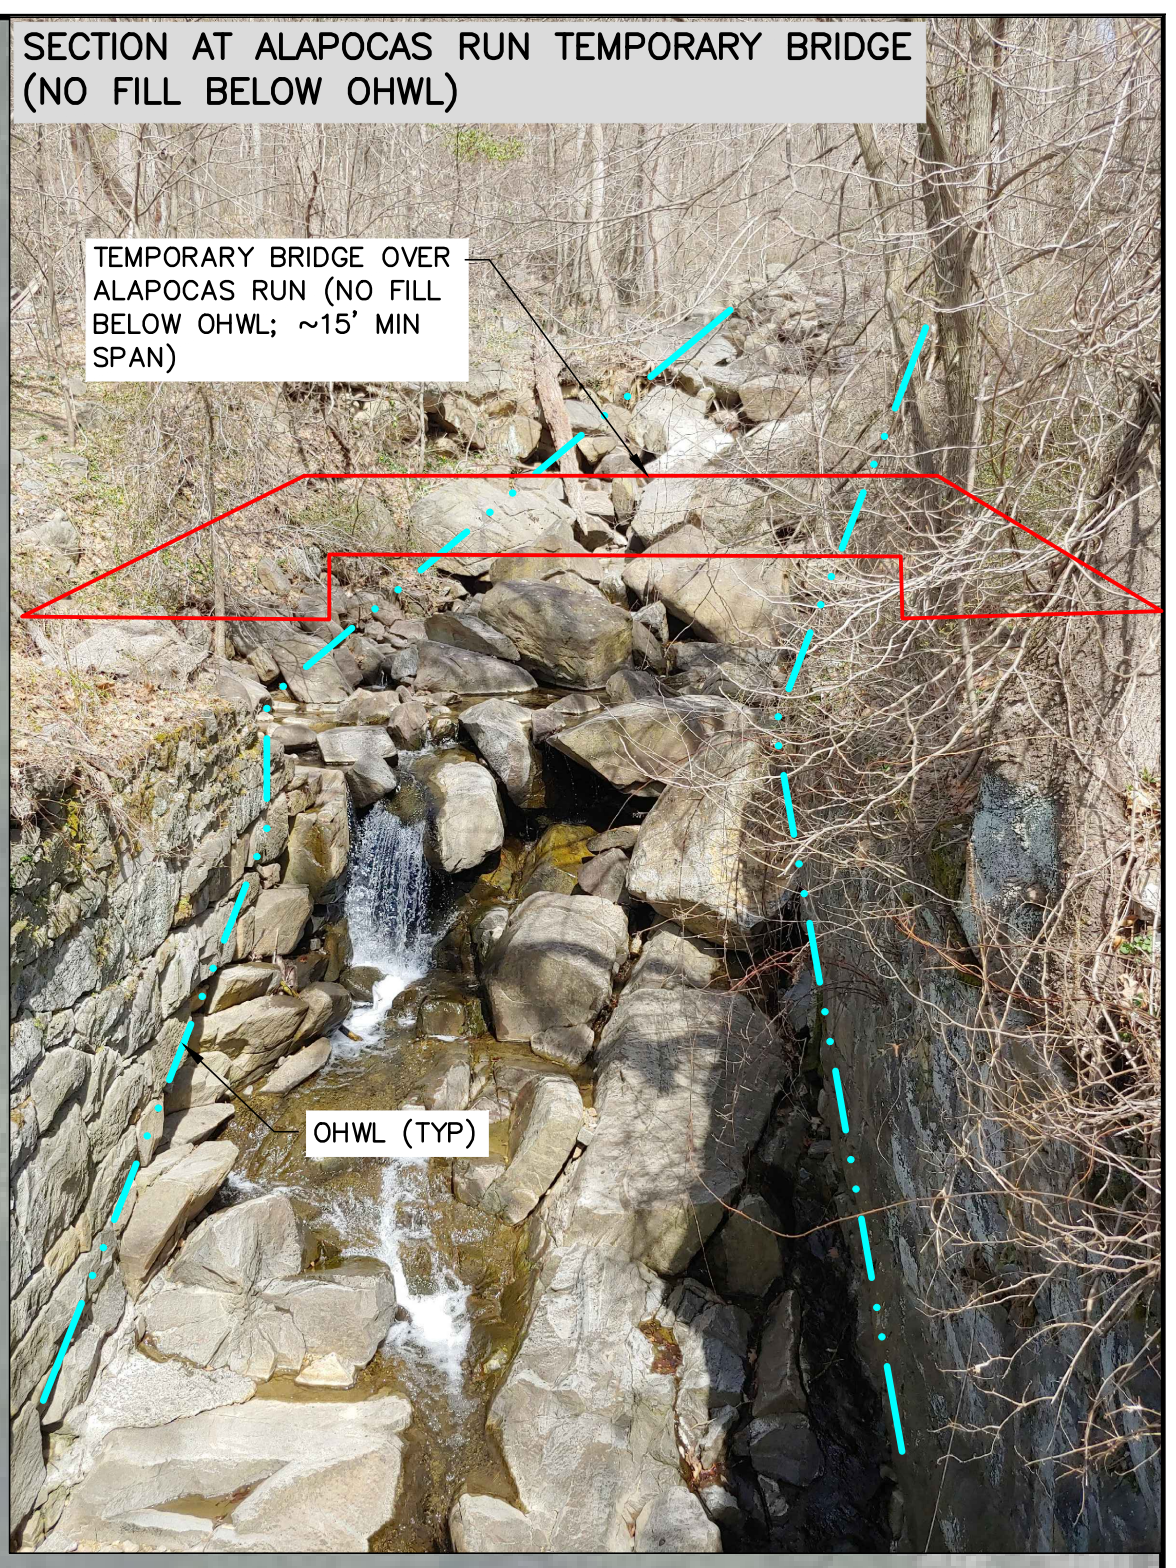
DAM 4 EXISTING CONDITION

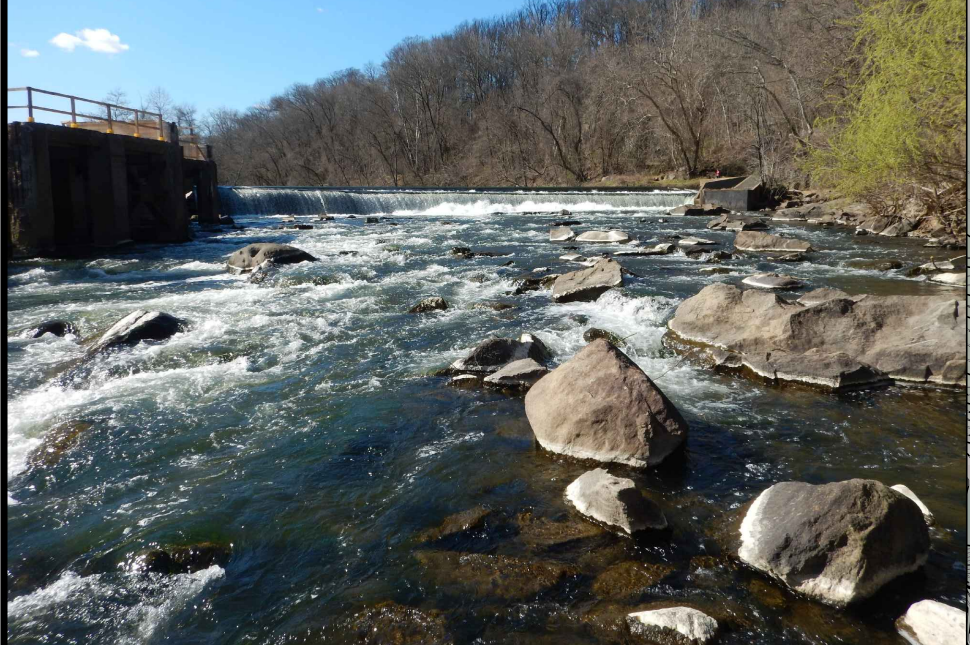
DAM 4 PROPOSED CONDITION

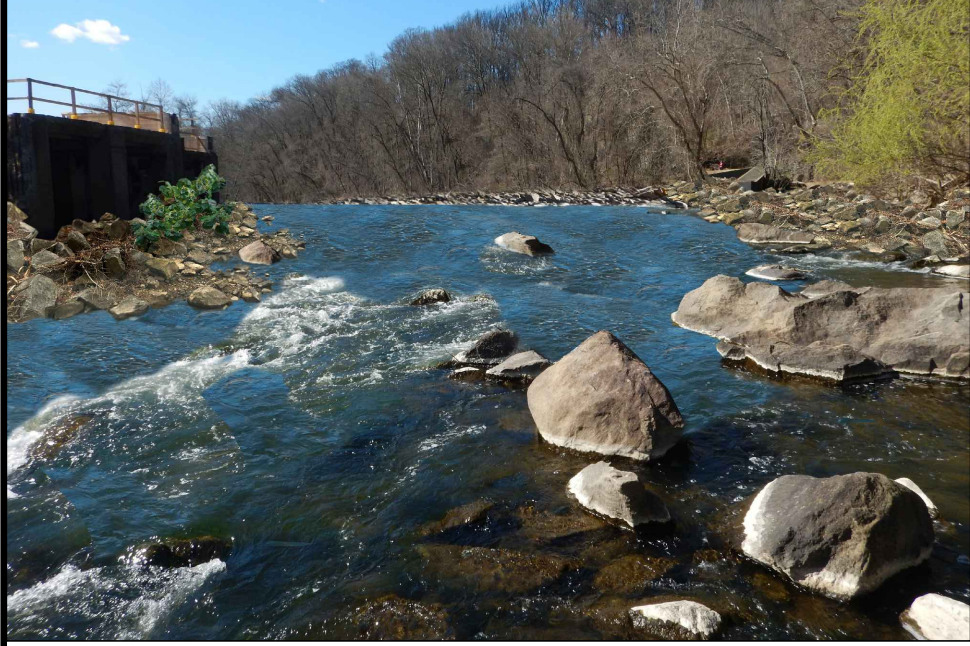
- PROPOSED CONSTRUCTION SEQUENCE:
1. INSTALL EROSION AND SEDIMENT CONTROLS AND DEFINE LIMIT OF DISTURBANCE.
  2. PROTECT AND MARK OUT PORTIONS OF DAM AND SITE TO REMAIN FOR HISTORICAL PURPOSES OR ABUTTING OWNER'S REQUIREMENTS.
  3. REMOVE AND RESHAPE DAM IN ACCORDANCE WITH PROJECT DRAWINGS AND PER ENGINEER FIELD DIRECTION.
  4. REMOVE ANY TRASH ENCOUNTERED DURING DAM REMOVAL.
  5. OBSERVE SEDIMENT FLUSHING AND INFORM PROJECT ENGINEER IF CONDITIONS DEVIATE FROM ANTICIPATED CONDITIONS.
  6. ENGINEER TO VERIFY DAM REMOVAL AND RESHAPING ARE ADEQUATE TO PROVIDE FISH PASSAGE.
  7. RESTORE UPLAND PORTION OF SITE TO PRE-CONSTRUCTION CONDITIONS.

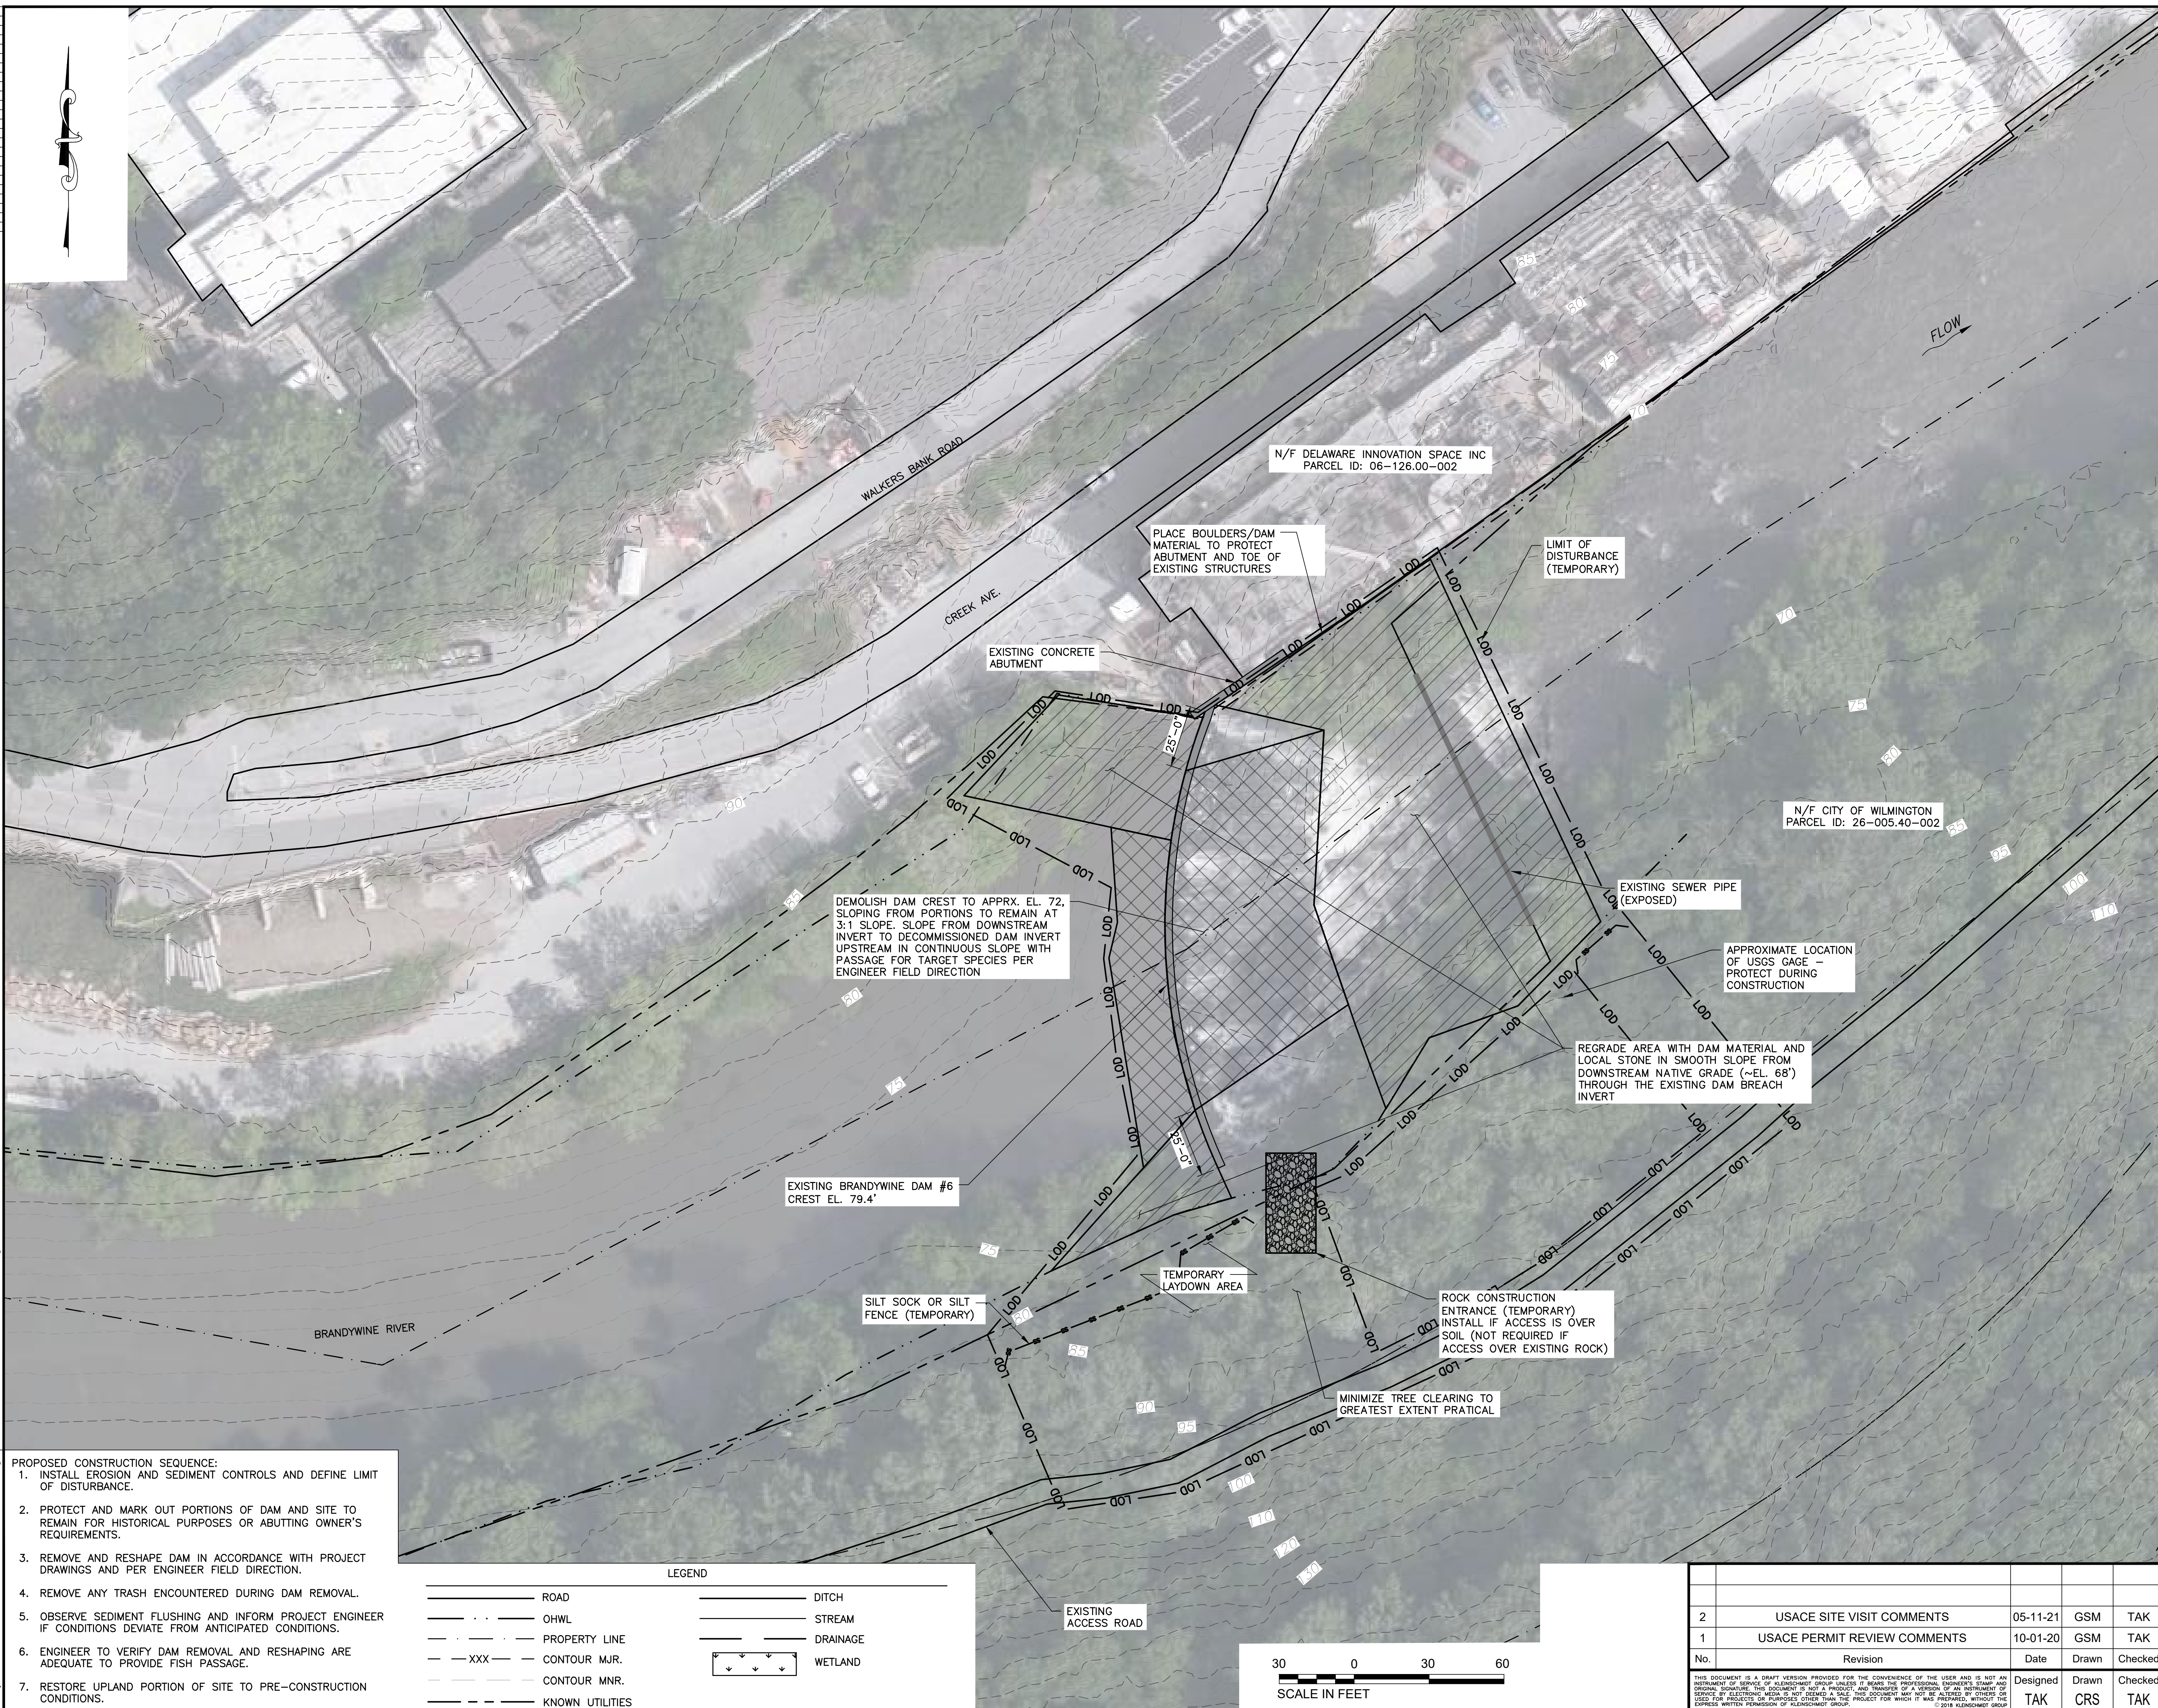
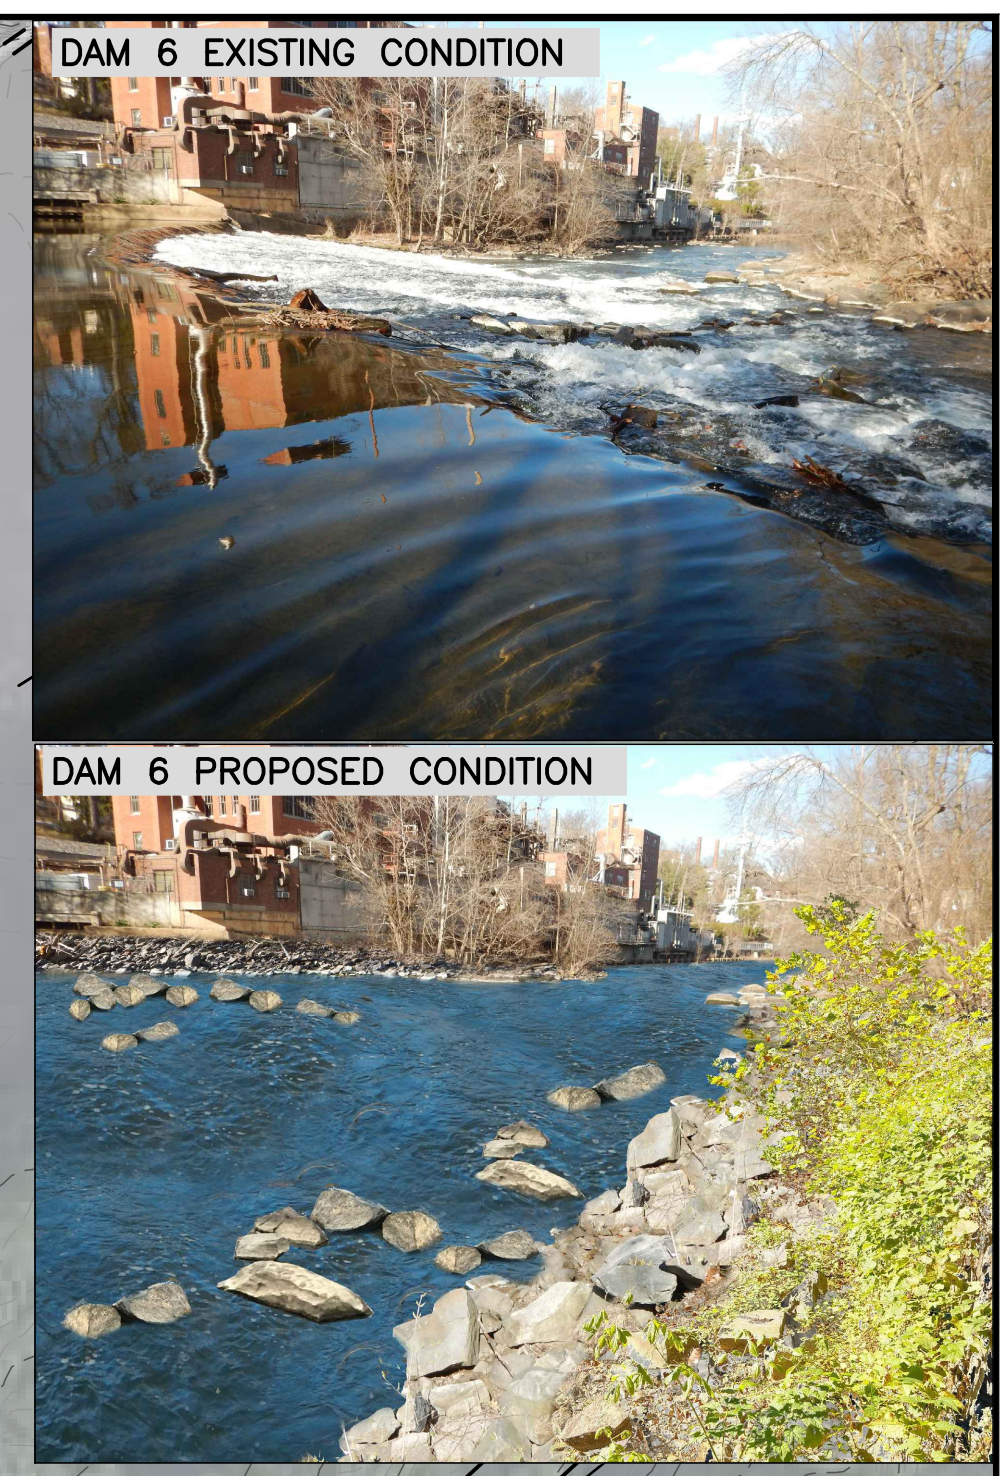
- PROPOSED CONSTRUCTION SEQUENCE:**
1. INSTALL EROSION AND SEDIMENT CONTROLS AND DEFINE LIMIT OF DISTURBANCE.
  2. PROTECT AND MARK OUT PORTIONS OF DAM AND SITE TO REMAIN FOR HISTORICAL PURPOSES OR ABUTTING OWNER'S REQUIREMENTS.
  3. REMOVE AND RESHAPE DAM IN ACCORDANCE WITH PROJECT DRAWINGS AND PER ENGINEER FIELD DIRECTION.
  4. REMOVE ANY TRASH ENCOUNTERED DURING DAM REMOVAL.
  5. OBSERVE SEDIMENT FLUSHING AND INFORM PROJECT ENGINEER IF CONDITIONS DEVIATE FROM ANTICIPATED CONDITIONS.
  6. ENGINEER TO VERIFY DAM REMOVAL AND RESHAPING ARE ADEQUATE TO PROVIDE FISH PASSAGE.
  7. RESTORE UPLAND PORTION OF SITE TO PRE-CONSTRUCTION CONDITIONS.
