ARCHAEOLOGICAL MONITORING REPORT

REMOVAL OF BRANDYWINE DAM 6

City of Wilmington

(DHCA Project Review No. 2020.06.22.06)

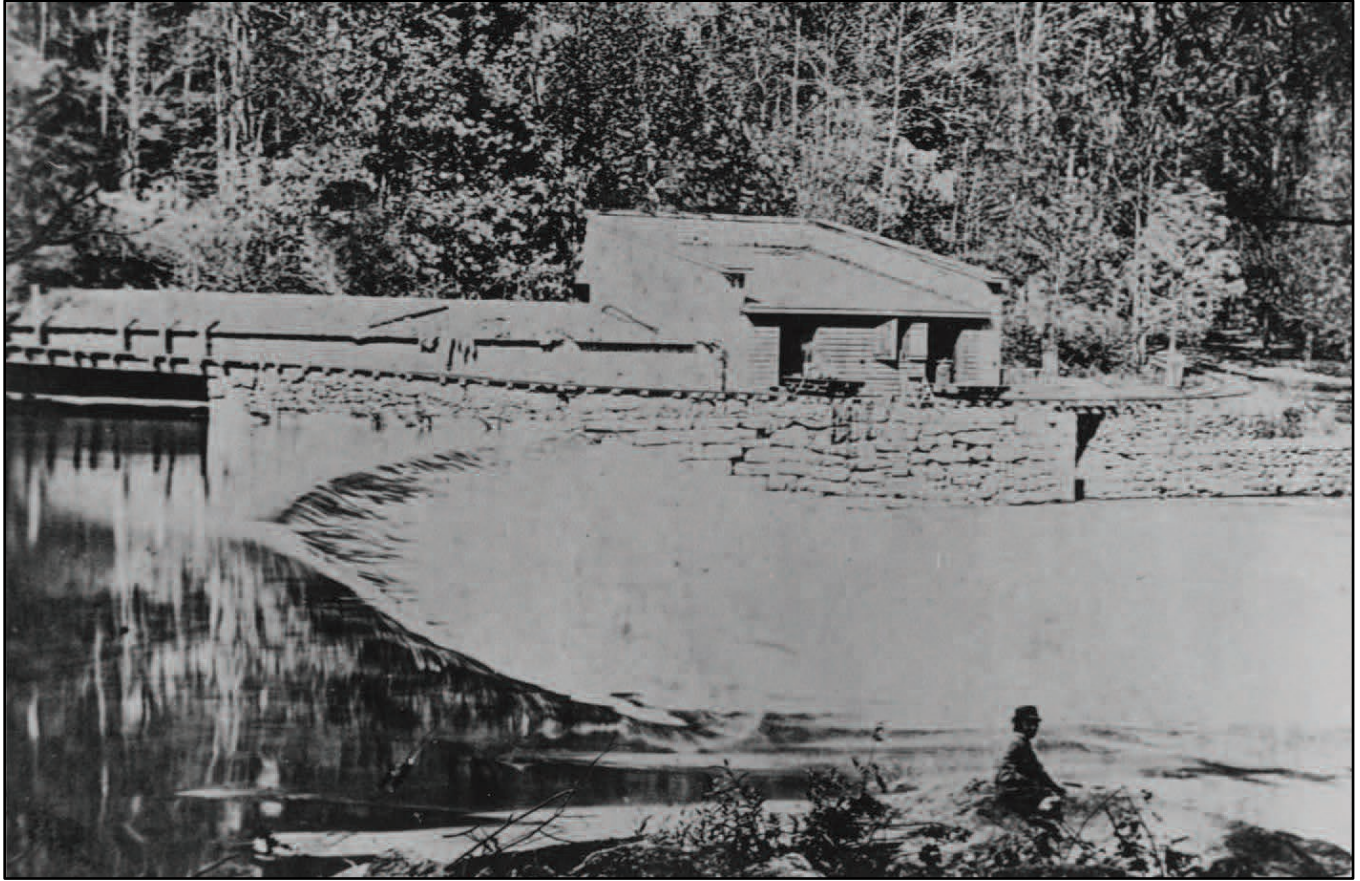
Figure 3.8: Glaze mill, Lower Yard (with view of Dam 6) in 1870.
(Anonymous 1870).

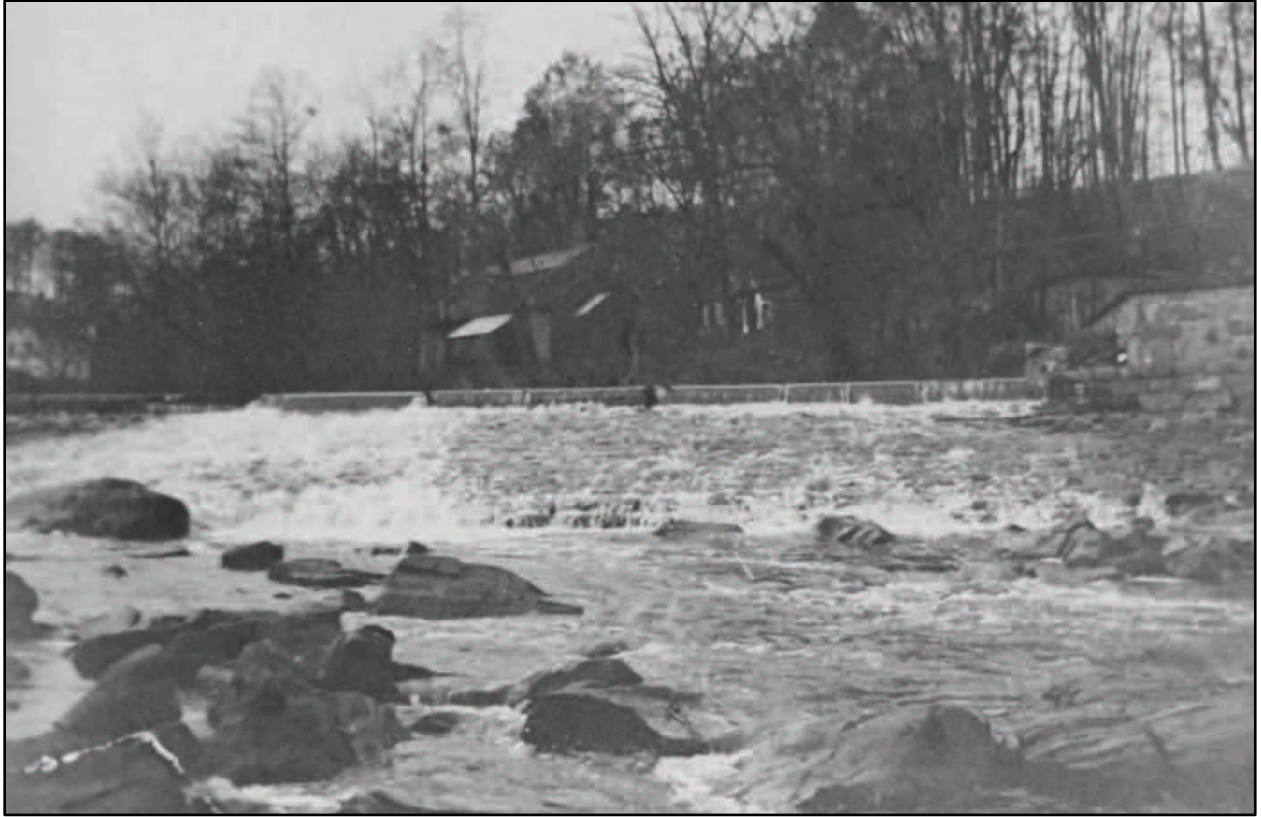
Figure 3.9: Dam, Lower Hagley Yard in 1870.
(Maybin 1870).

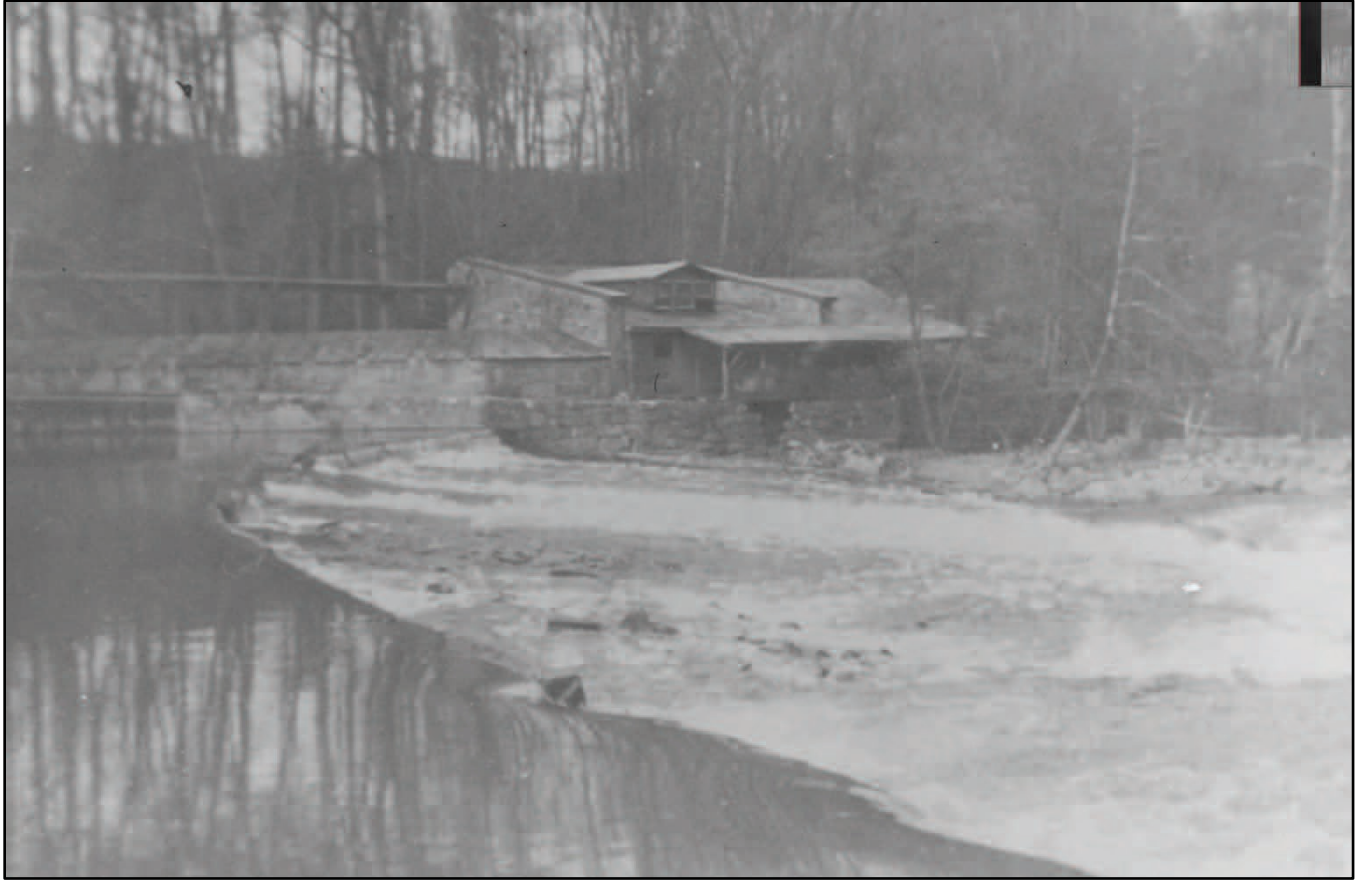
Figure 3.11: Dust mill, rolling mills, Lower Hagley Yard (with view of Dam 6) in 1896.
(Anonymous 1896).

The 1881 county map shows the Lower Hagley Yard is part of the E. I. DuPont & Co. Powder Mills, with present-day Creek Road now passing through the complex (Figure 3.10; Hopkins 1881). A photograph of the Lower Hagley Yard Dam (Dam 6) taken in 1896 shows that a gabled dormer addition had been built onto the building adjacent to the dam on the northern bank since it was photographed in 1870 and the stone armoring was in a greater state of disrepair (see Figure 3.8; Figure 3.11; Anonymous 1870; 1896). A map of the Lower Powder Yard from 1902 depicts the project location in relation to the Lower Hagley Yard Dam, the DuPont complex adjacent and to the north, and Rising Sun Lane adjacent and to the west (Figure 3.12; E. I. du Pont de Nemours & Company 1903). The Wilmington and Northern Railroad – Kentmere Branch passed to the south of the project location. In 1903, the DuPont Company constructed an Experimental Station to facilitate their new commercial endeavor of researching and developing chemicals. Due to a diminished demand for black powder, the powder mills ceased operation entirely in 1921, and it is unlikely that the Lower Hagley Yard mill dam has been used since (CHAD 2021b).

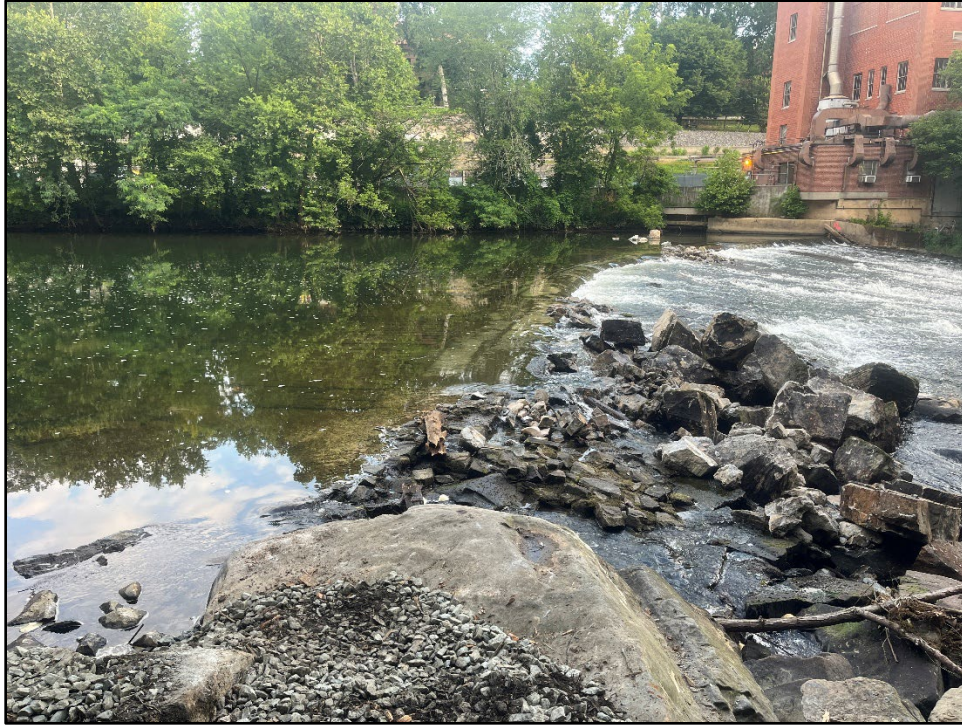
Plate 4.1: Overview of Brandywine Dam 6 from its southern abutment after the initial breach.

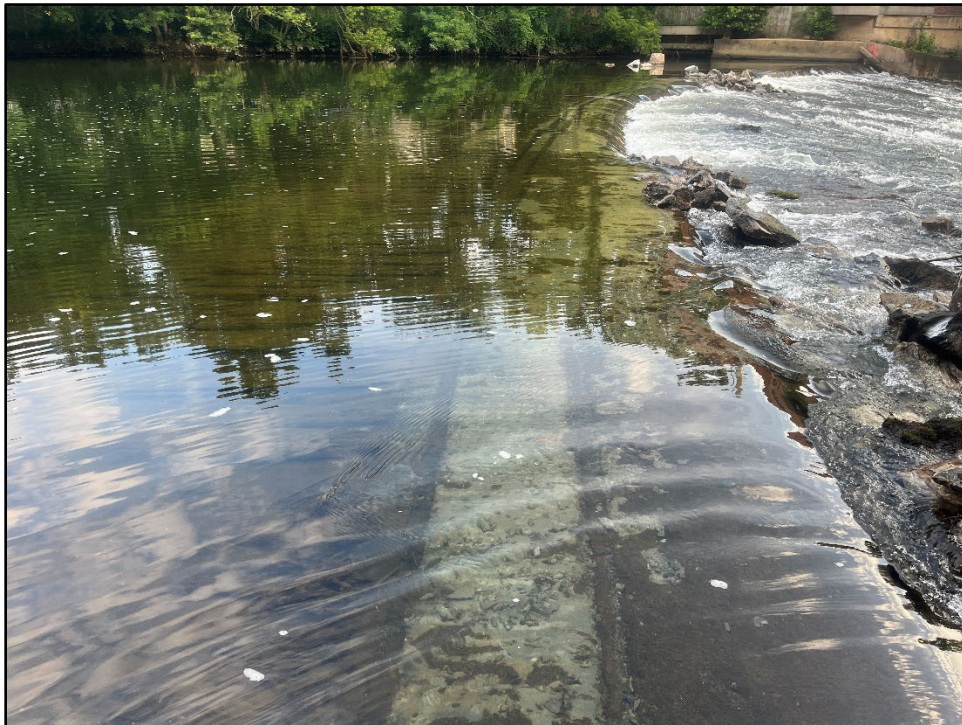
Plate 4.2: Closeup view of the top of Brandywine Dam 6 following the initial breach.

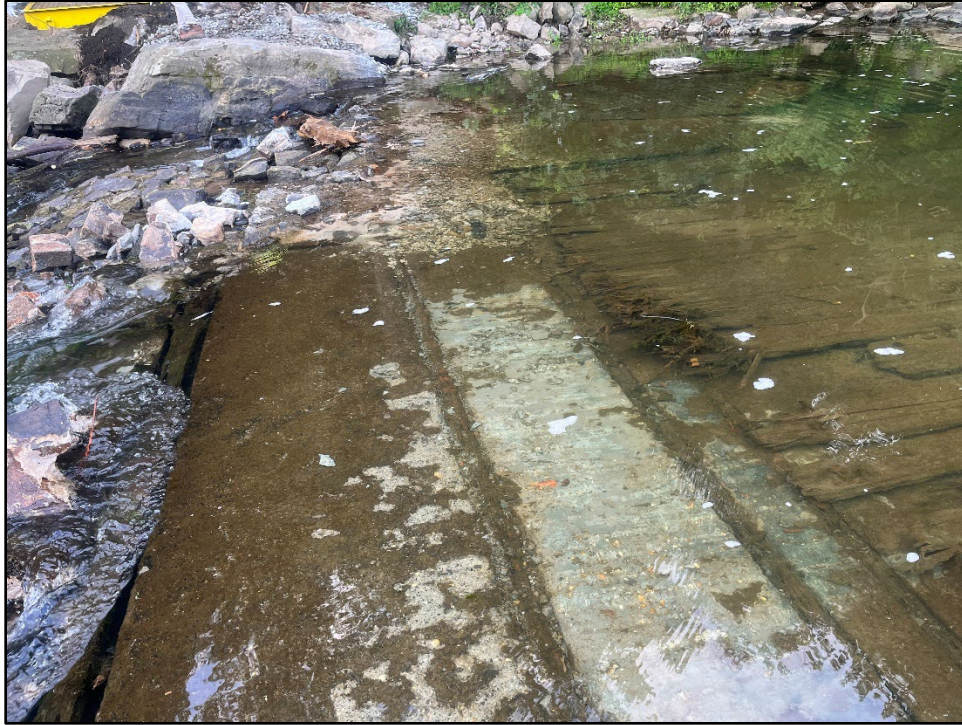
Plate 4.3: View of the southern abutment of Brandywine Dam 6 showing concrete strips with milled timbers and wooden planks on the upstream side of the dam. Photo view: Southeast; Photographer: Jonathan E. Dernbach; Date: July 23, 2025.

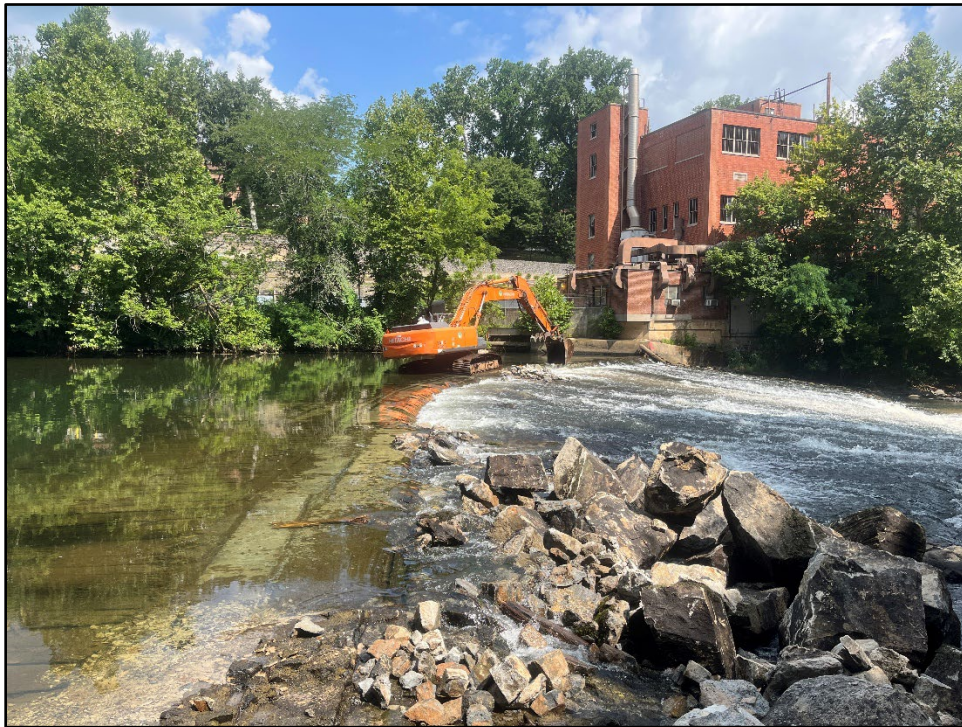
Plate 4.4: View of the removal work in progress at Brandywine Dam 6. Photo view: Northwest; Photographer: Jonathan E. Dernbach; Date: July 23, 2025.

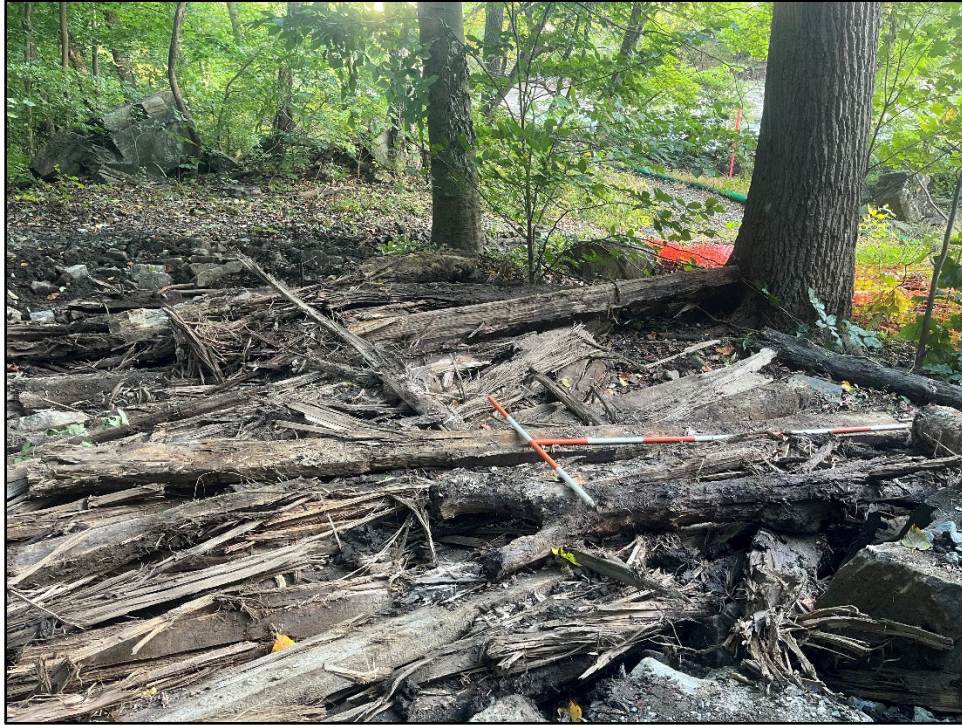
Plate 4.5: View of an intact milled board removed from the upper dam structure.
Photo view: N/A; Photographer: Jonathan E. Dernbach; Date: October 15, 2025.

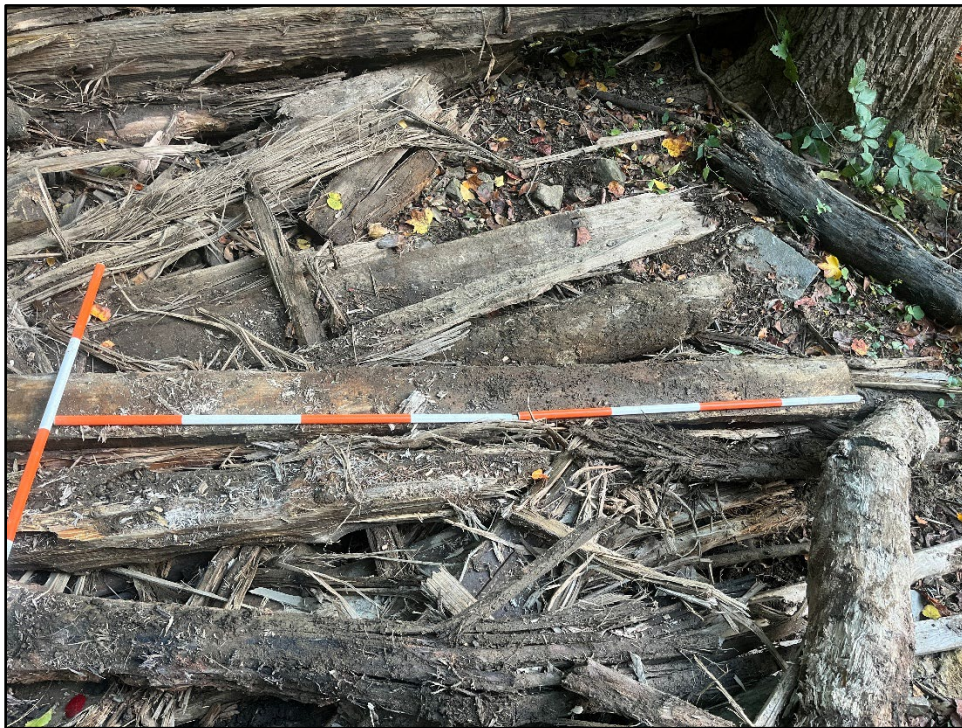
Plate 4.6: View of the end of an intact milled board removed from the dam structure.
Photo view: N/A; Photographer: Jonathan E. Dernbach; Date: October 15, 2025.

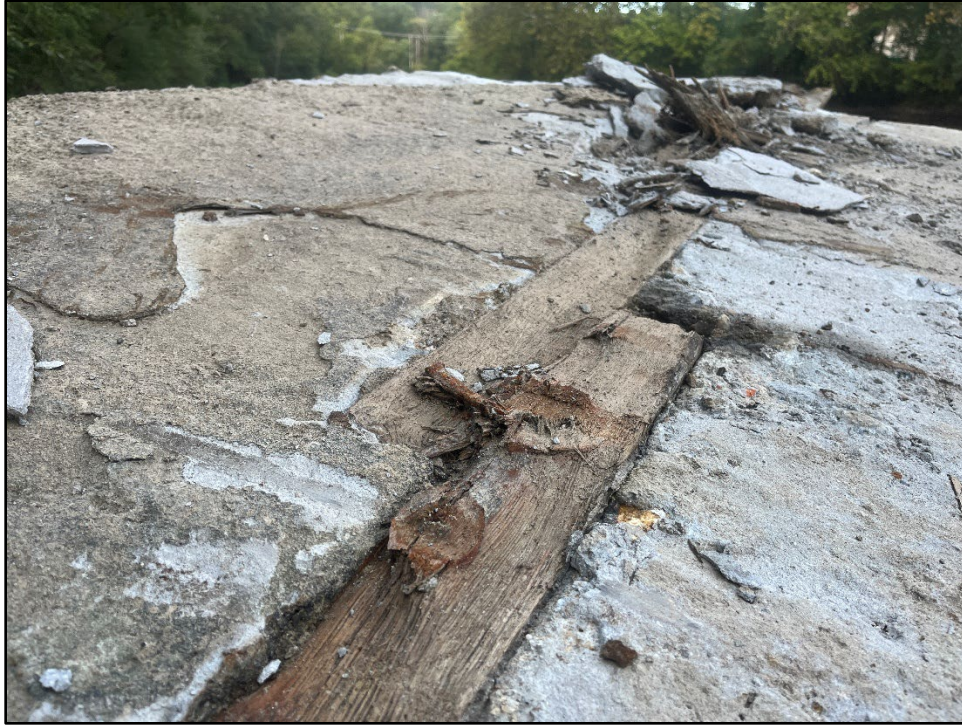
Plate 4.7: View of overlapped, milled boards on the upper surface of the concrete top .
Photo view: N/A; Photographer: Jonathan E. Dernbach; Date: August 2, 2025.

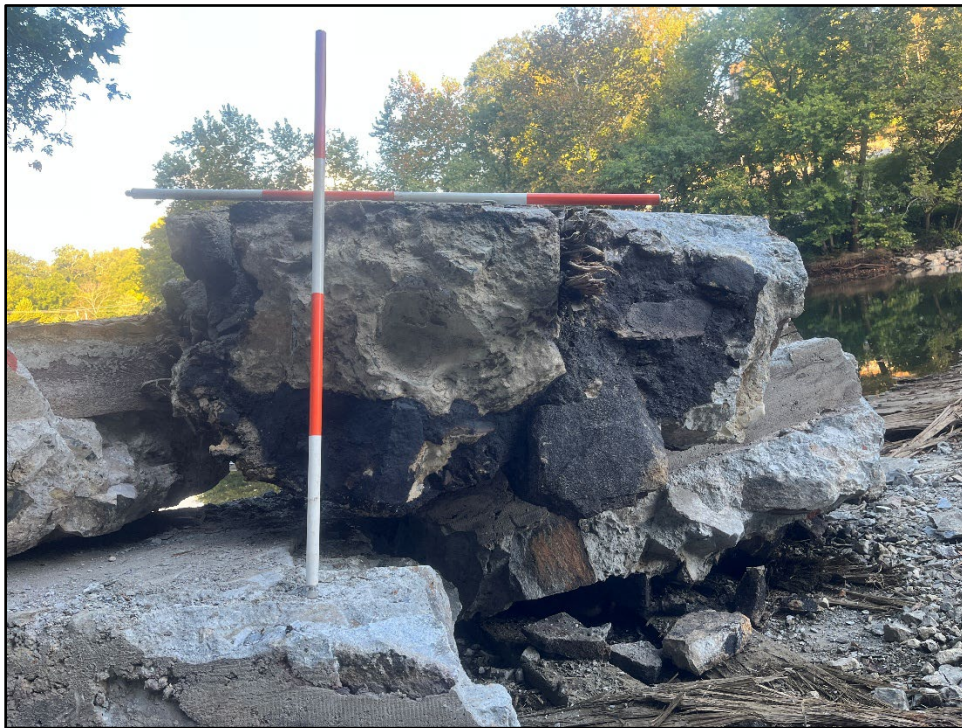
Plate 4.8: View of the cross section of a portion of the concrete top removed from the dam.
Photo view: N/A; Photographer: Jonathan E. Dernbach; Date: August 2, 2025.

Figures 4.2 and 4.3; see Plate 4.17). A series of long, milled wooden planks were present on the upper surface of the sloped portion of the dam that served as a covering for the upstream ramp (see Figure 4.2 and 4.3; see Plates 4.2, 4.17–4.19). Intact, representative samples measured approximately 0.65 feet by 0.3 feet (8×3.5 inches) in cross section and up to 15 feet in length. They were fastened to the dam with ferrous metal nails that were driven into the upright, wooden timbers below (see Figures 4.2 and 4.3; see Plates 4.20–4.21). As with the milled boards, these planks were installed at the same time as the concrete cap. Removed portions of the upper concrete cap indicated that it varied between approximately 1 and 2 feet thick across the dam, and was likely poured directly over a rough, underlying structure of large rocks and boulders, which were partially embedded into the lower surface of the concrete (see Figure 4.3; see Plates 4.8 and 4.9).

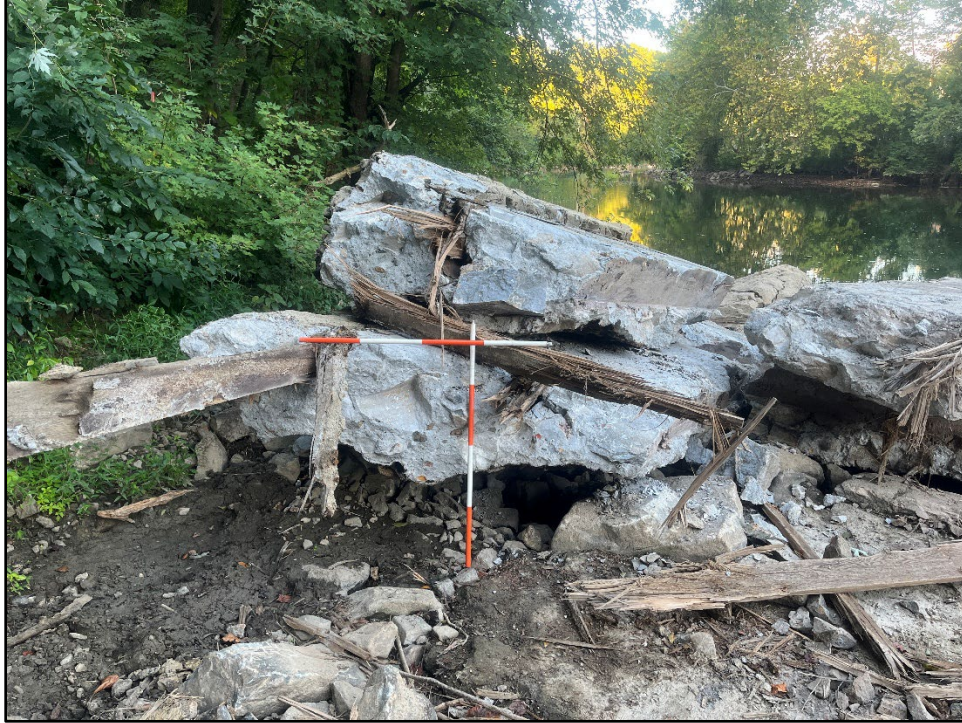
Plate 4.9: View of the cross section of a portion of the concrete top removed from the dam showing milled boards.

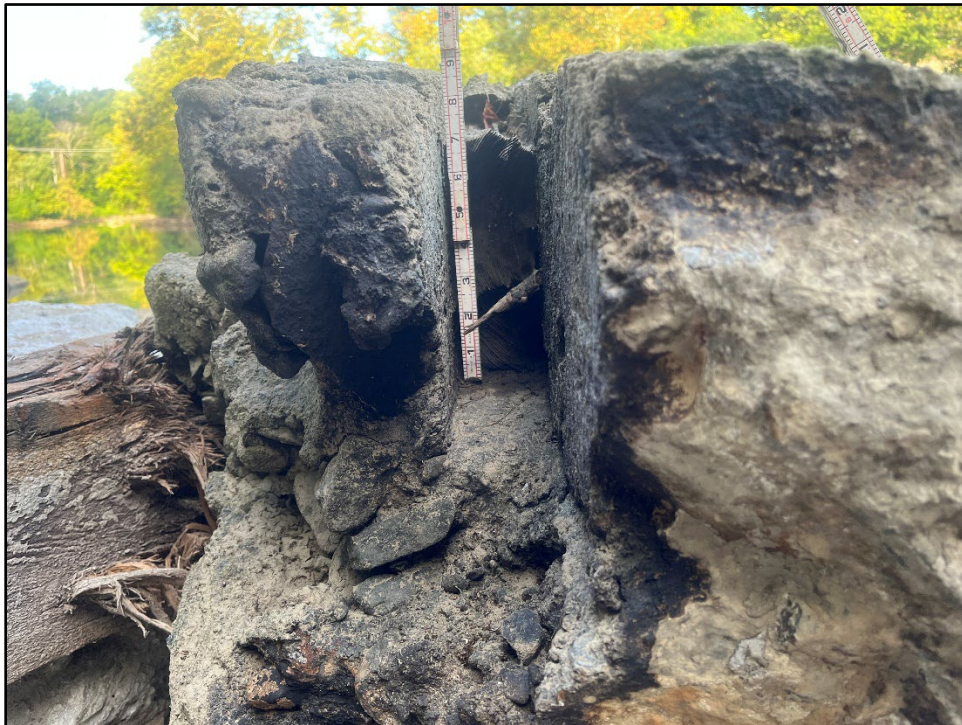
Plate 4.10: View of a milled board embedded upright in a removed portion of the concrete top of the dam.

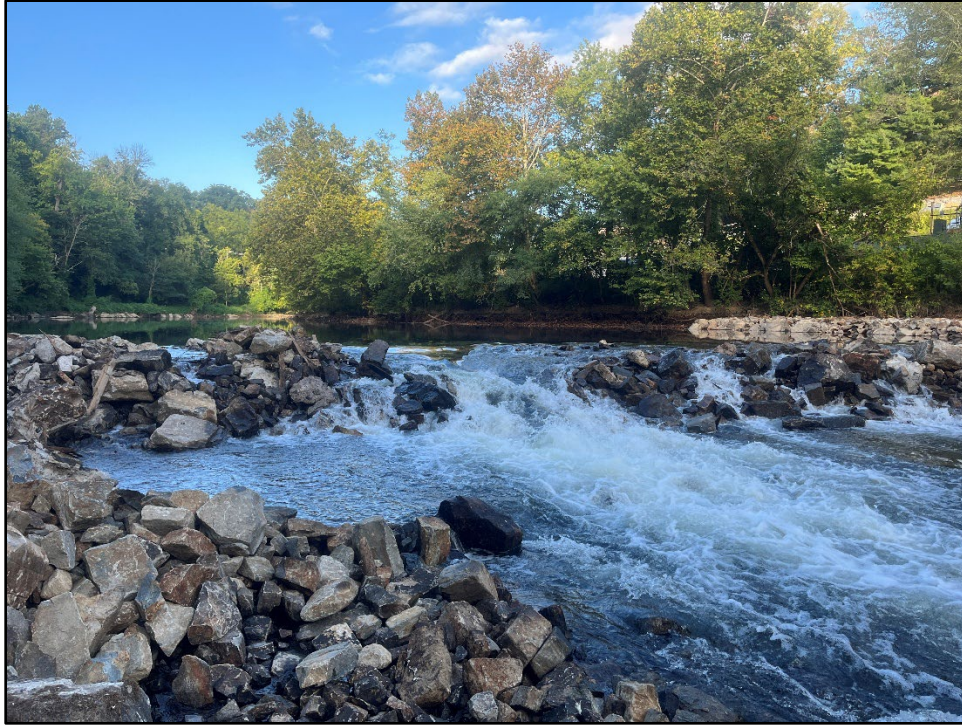
Plate 4.11: View of the loose boulders stacked in front of the downstream portion of the dam and the visibility conditions at approximately 50 percent breach progress.
Photo view: West; Photographer: Jonathan E. Dernbach; Date: September 4, 2025.

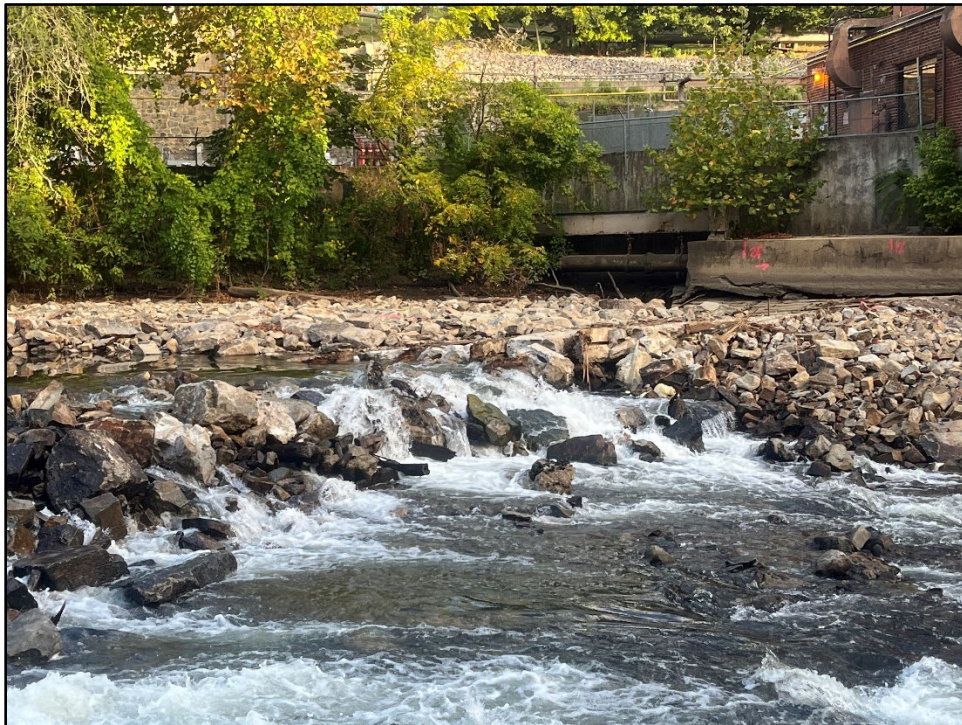
Plate 4.12: View of the cross section and front of the dam at approximately 50 percent breach.
Photo view: Northwest; Photographer: Jonathan E. Dernbach; Date: August 2, 2025.

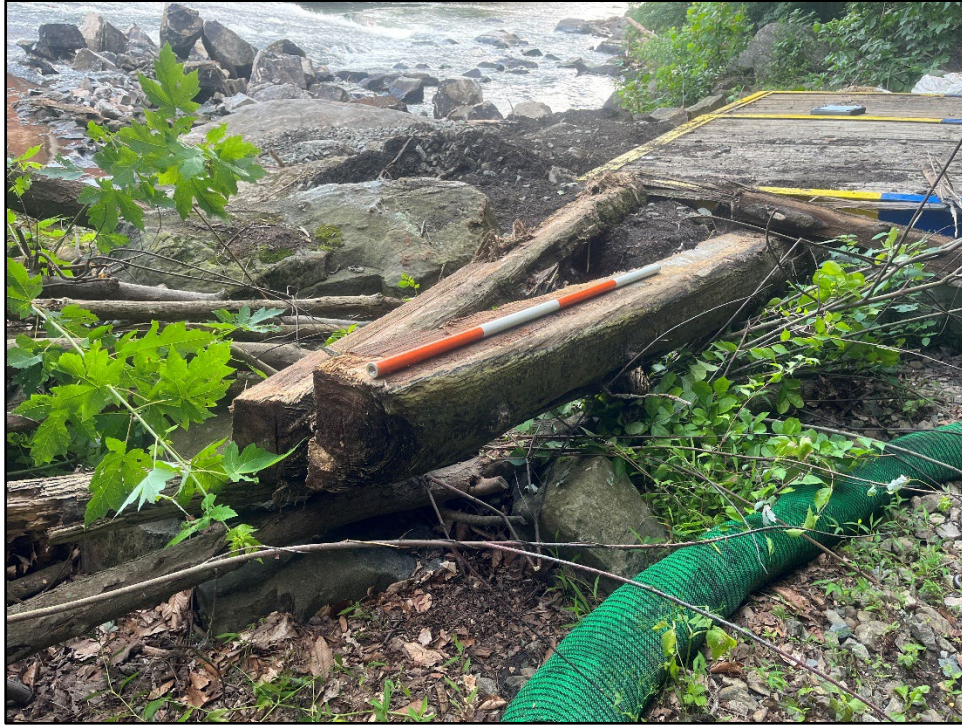
Plate 4.13: View of large, square timbers removed from the downstream portion of the dam during the initial breach.

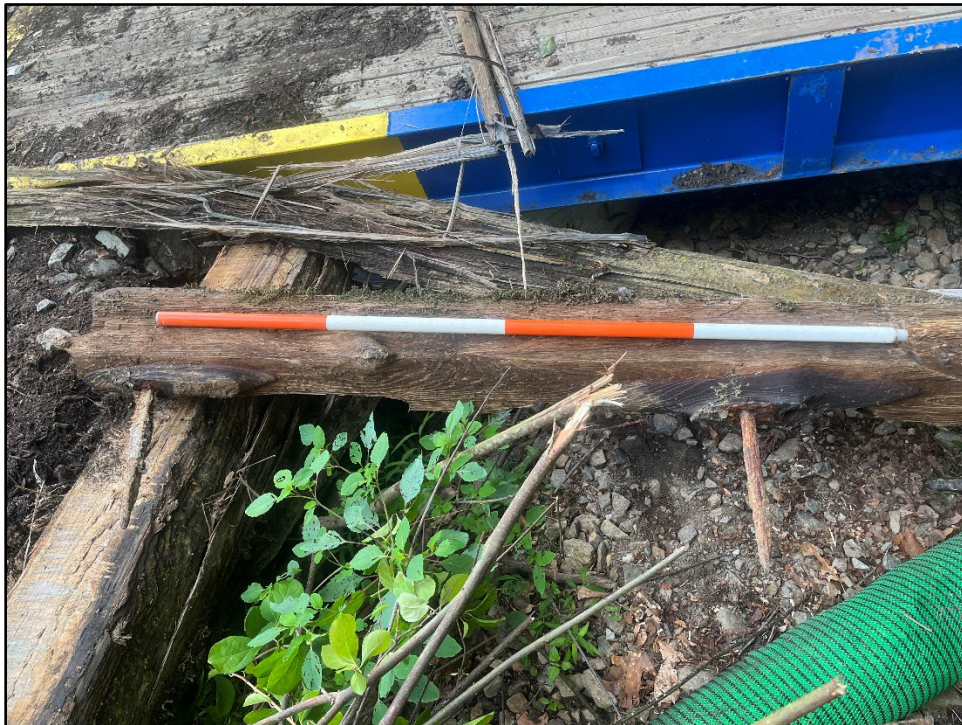
Plate 4.14: View of large, square timbers with ferrous metal spikes removed from the downstream portion of the dam during the initial breach.

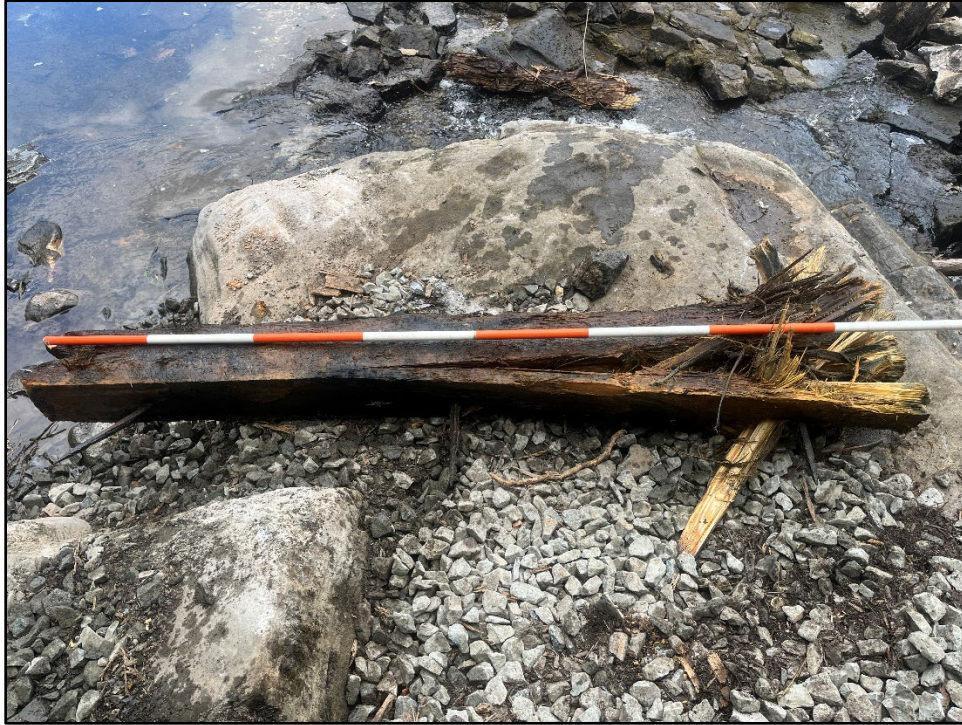
Plate 4.15: View of a large, square timber with ferrous metal spikes removed from the downstream portion of the dam during the initial breach.
Photo view: N/A; Photographer: Jonathan E. Dernbach; Date: July 23, 2025.

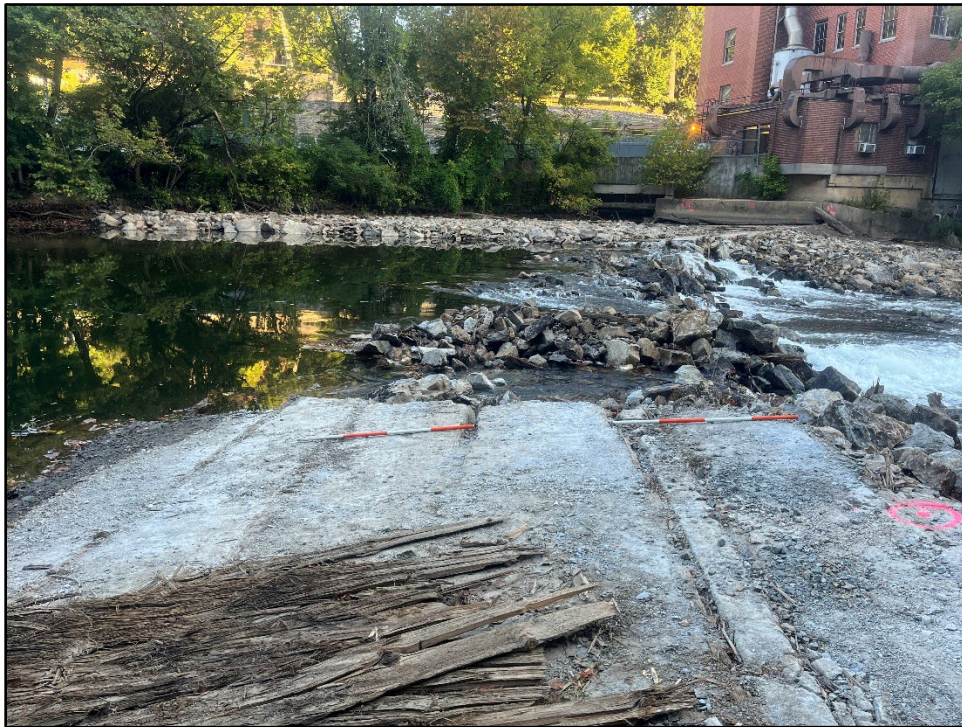
Plate 4.16: View of the upper concrete face of the dam at 50 percent breach showing the concrete strips and upright, milled boards.
Photo view: Northwest; Photographer: Jonathan E. Dernbach; Date: August 2, 2025.

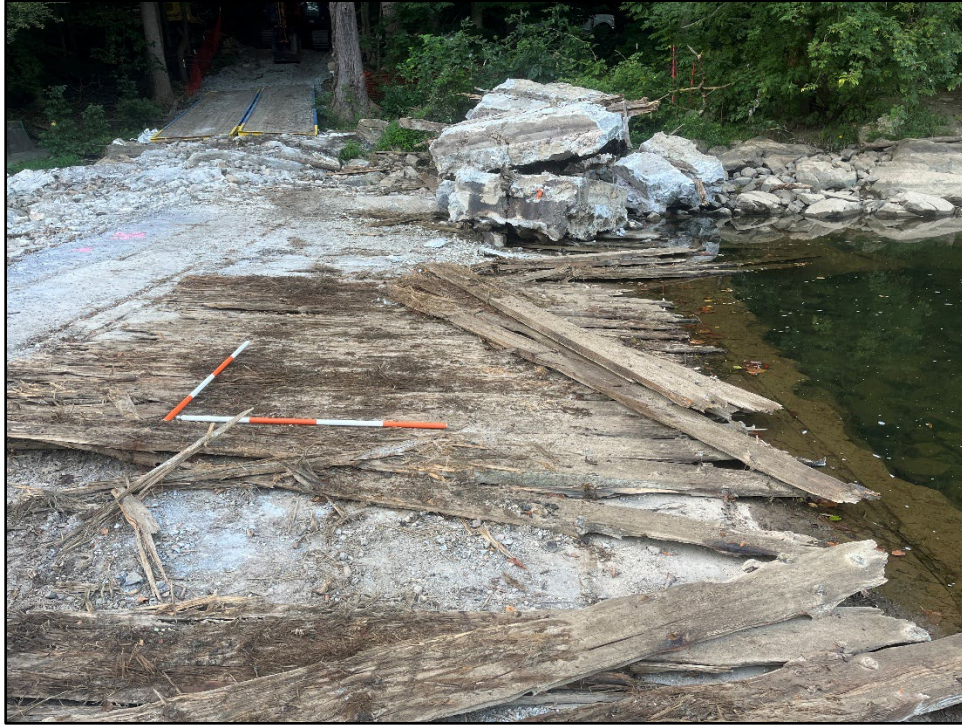
Plate 4.17: View of top of the dam at its southern abument showing wooden planking covering the upstream, sloped portion of the dam.
Photo view: South; Photographer: Jonathan E. Dernbach; Date: August 2, 2025.

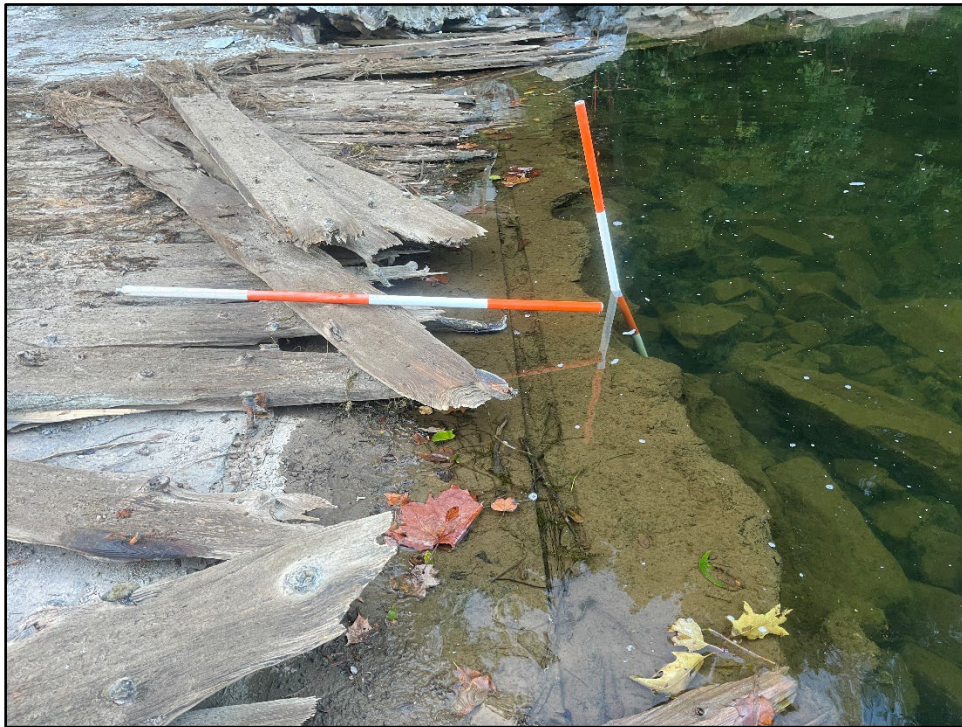
Plate 4.18: View of the upstream end of the dam showing rough concrete and submerged, loose boulders.
Photo view: South; Photographer: Jonathan E. Dernbach; Date: August 2, 2025.

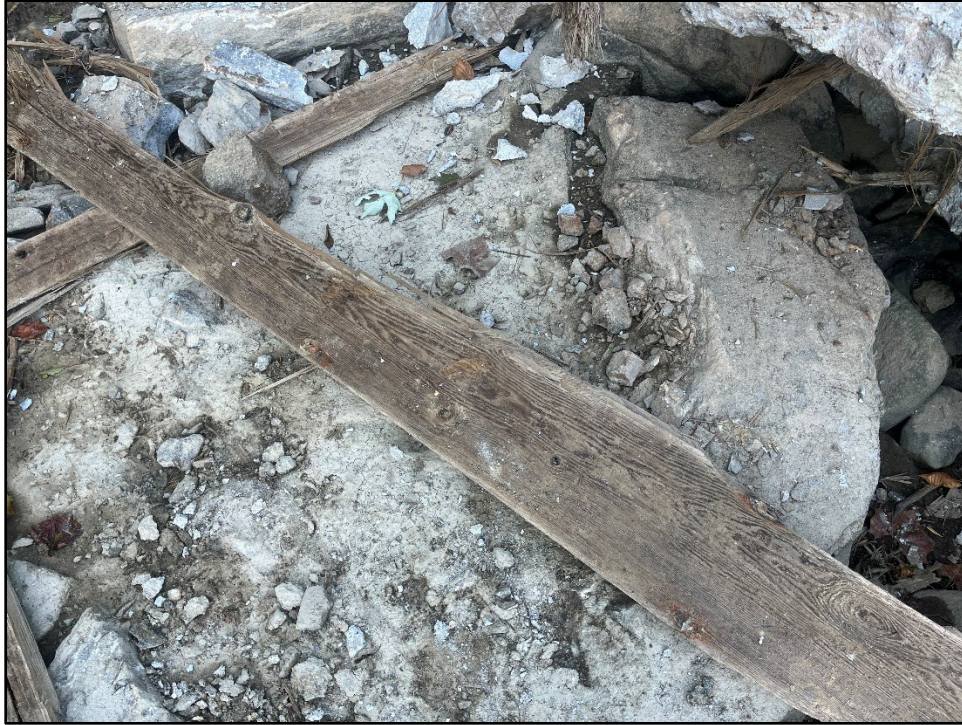
Plate 4.19: View of the upper surface of a wooden plank removed from the downstream, sloped portion of the dam.

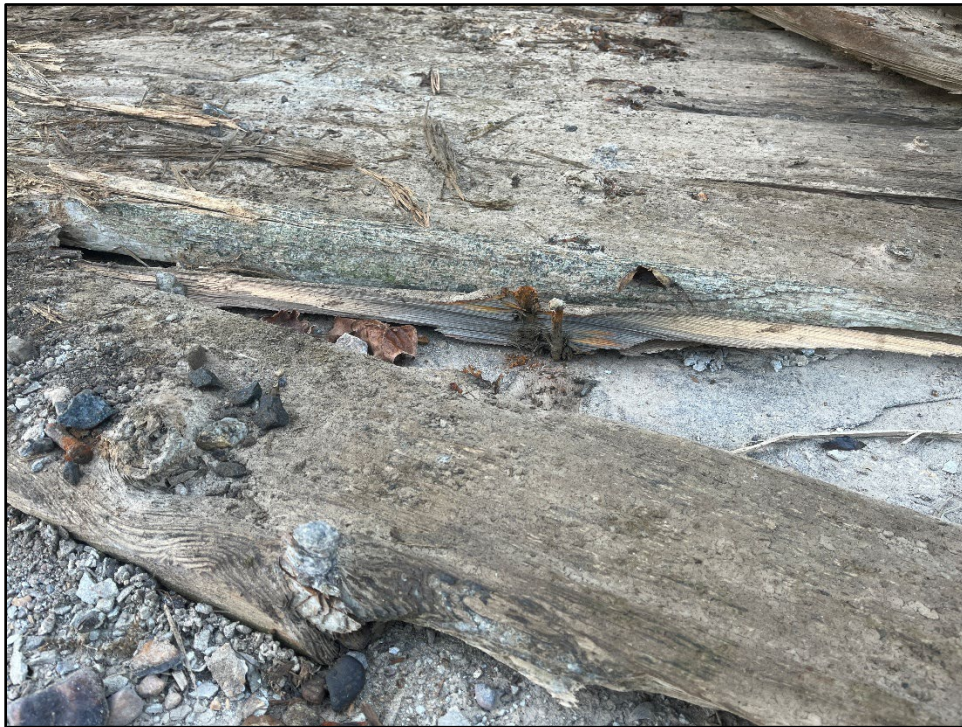
Plate 4.20: View of planks and fasteners on the upstream portion of the dam.

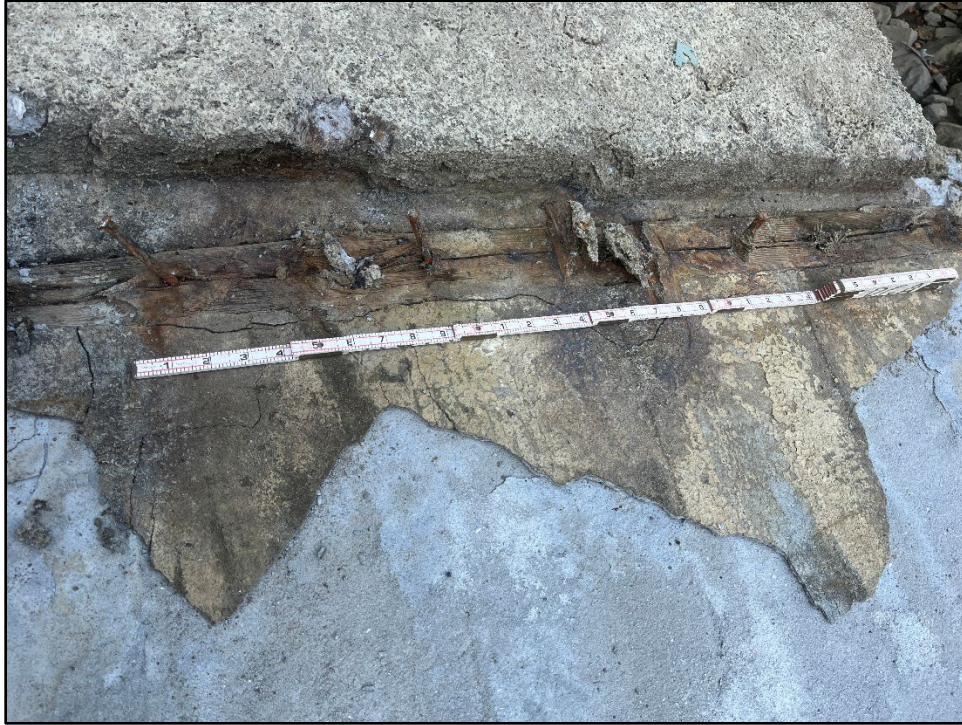
Plate 4.21: View of the upper surface of a portion of the concrete dam topvshowing fasteners used to attach the wooden planking to the upright, milled boards on the upstream side of the dam.
Photo view: N/A; Photographer: Jonathan E. Dernbach; Date: August 2, 2025.

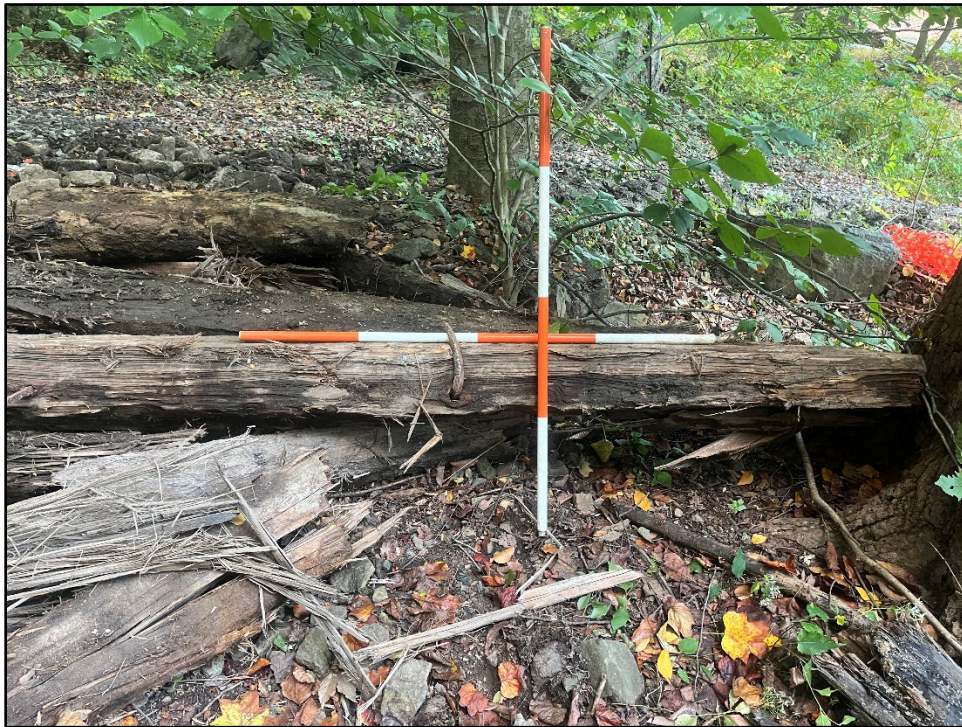
Plate 4.22: View of a large, square timber with a 2-foot ferrous metal spike removed from the lower portion of the dam structure near 100 percent breach.
Photo view: N/A; Photographer: Jonathan E. Dernbach; Date: October 15, 2025.

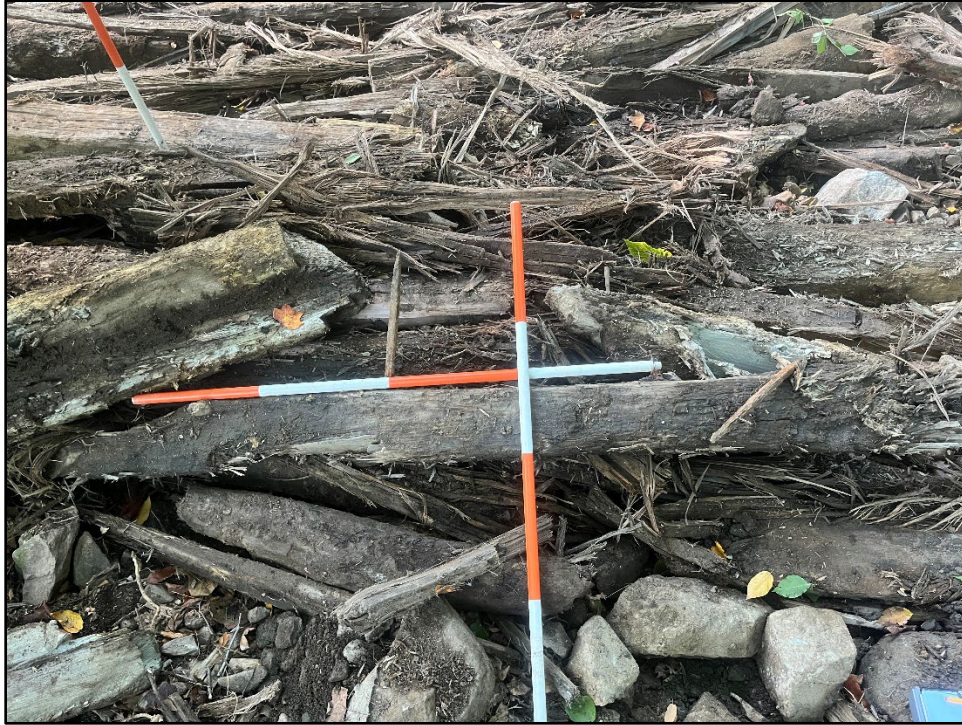
Plate 4.23: View of a large, square timber with 2-foot ferrous metal spikes removed from the lower portion of the dam structure near 100 percent breach.
Photo view: N/A; Photographer: Jonathan E. Dernbach; Date: October 15, 2025.

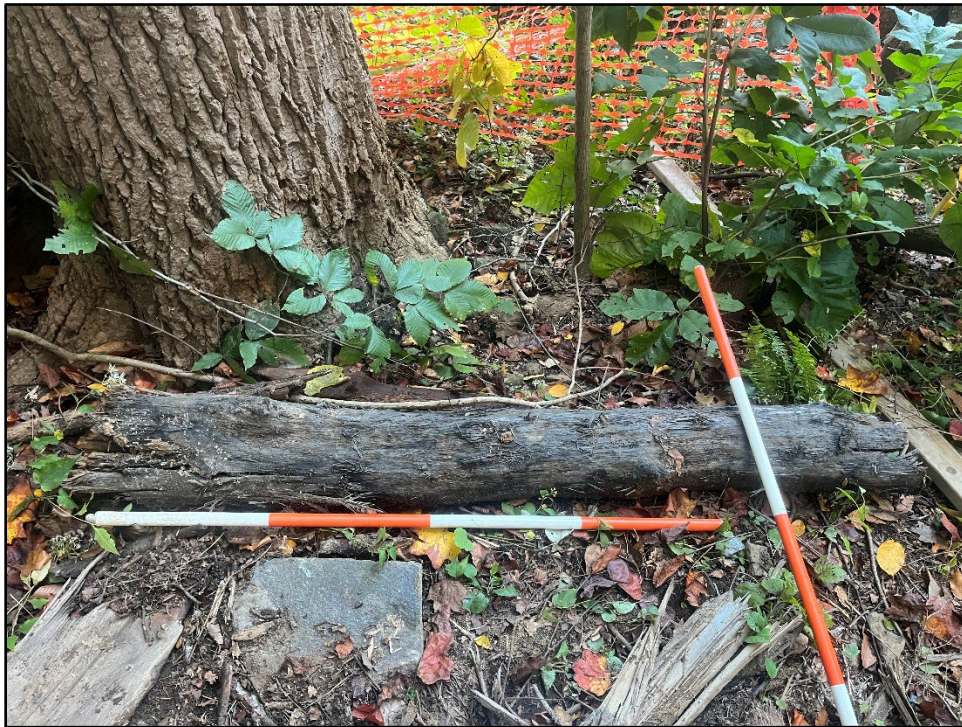
Plate 4.24: View of a log removed from the lower portion of the dam structure near 100 percent breach.
Photo view: N/A; Photographer: Jonathan E. Dernbach; Date: October 15, 2025.

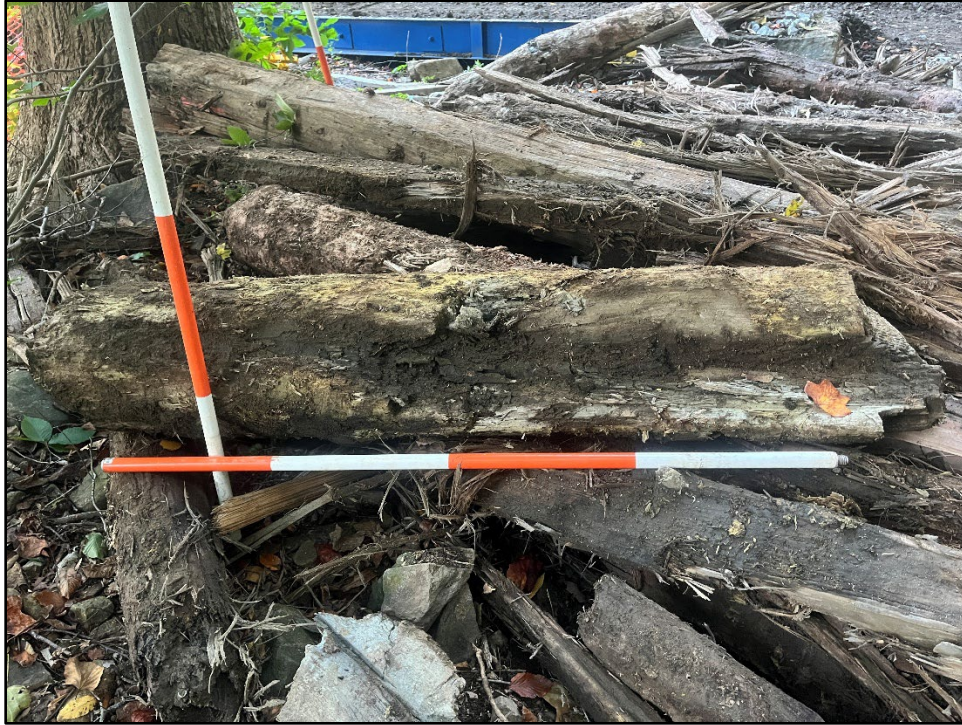
Plate 4.25: View of a circular log removed from the lower portion of the dam structure near 100 percent breach.
