ARCHAEOLOGICAL MONITORING REPORT

REMOVAL OF BRANDYWINE DAM 6

City of Wilmington

(DHCA Project Review No. 2020.06.22.06)

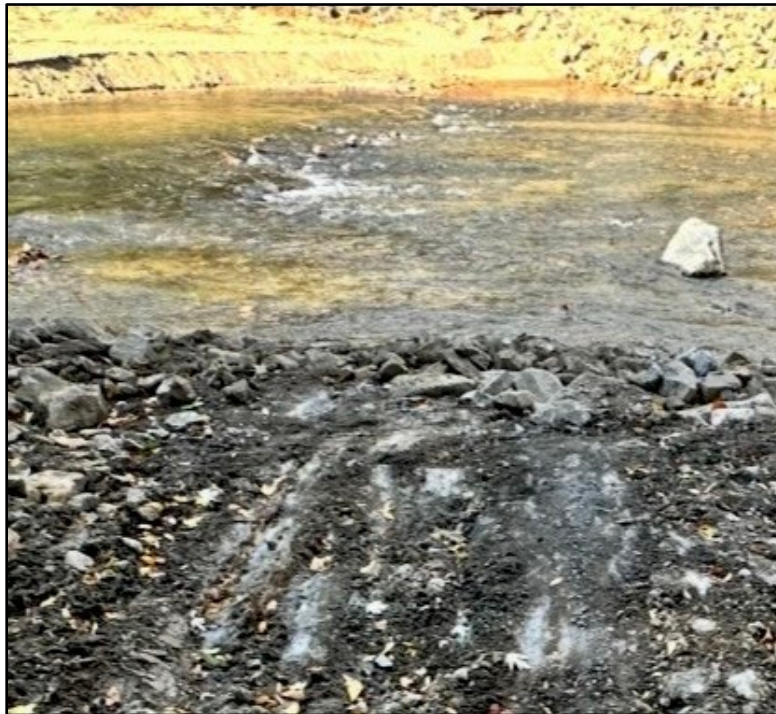
Plate 4.26: View of the remaining portion of the dam at the southern abutment following the completion of excavation/removal.

Following the completion of the project, portions of the Brandywine Dam 6 structure within approximately 25 feet of its northern and southern abutments were left intact and in place. Updated CRS forms for Brandywine Dam 6/Lower Hagley Mill Yard Dam were submitted to the DHCA, and the dam was given an archaeological site number (7NC-B-083) due to its current, partially demolished and buried/submerged condition. All updated forms and files are on file with the DHCA and uploaded to CHRIS.

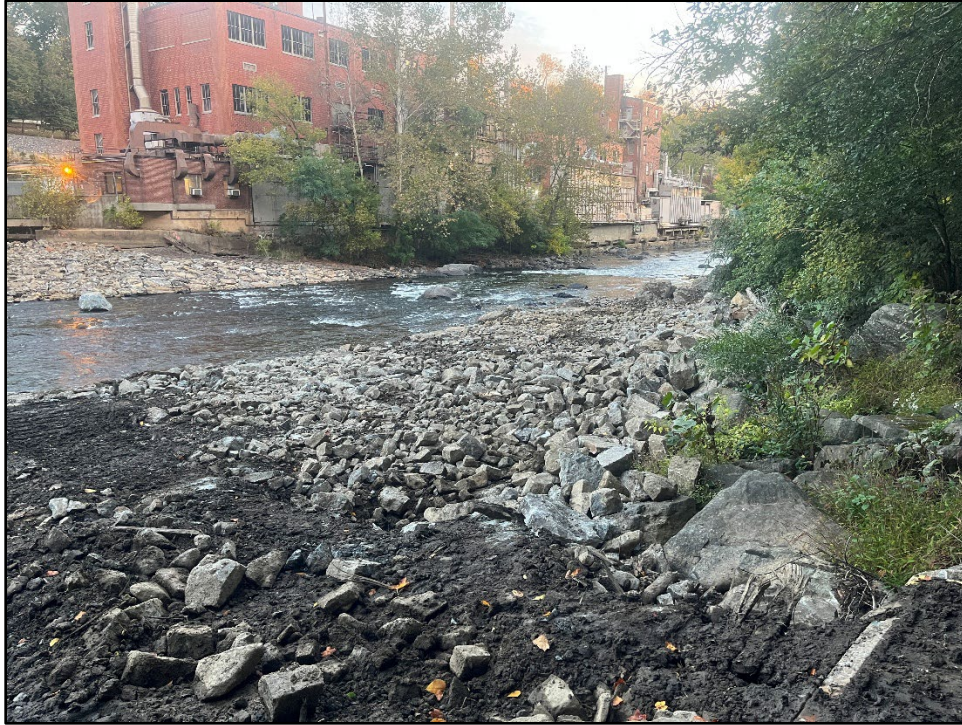
Plate 4.27: View of the stone and concrete debris placed along the southern side of Brandywine Creek during the removal process
Photo view: Northeast; Photographer: Jonathan E. Dernbach; Date: October 15, 2025.

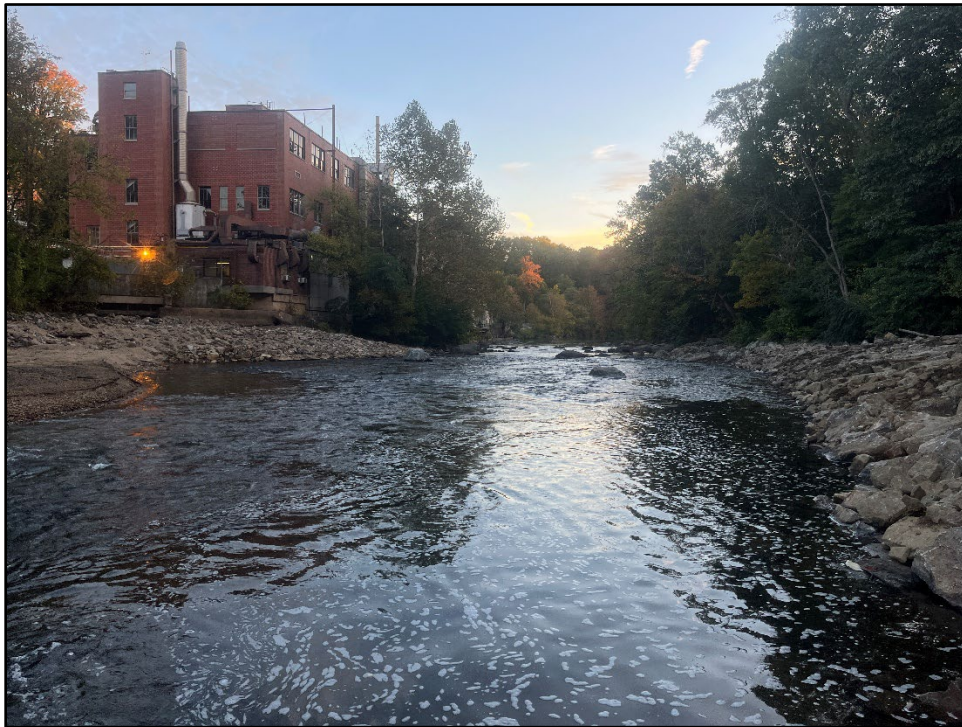
Plate 4.28: View of the location of Brandywine Dam 6 following the completion of excavations/dam removal.
Photo view: Northeast; Photographer: Jonathan E. Dernbach; Date: October 15, 2025.

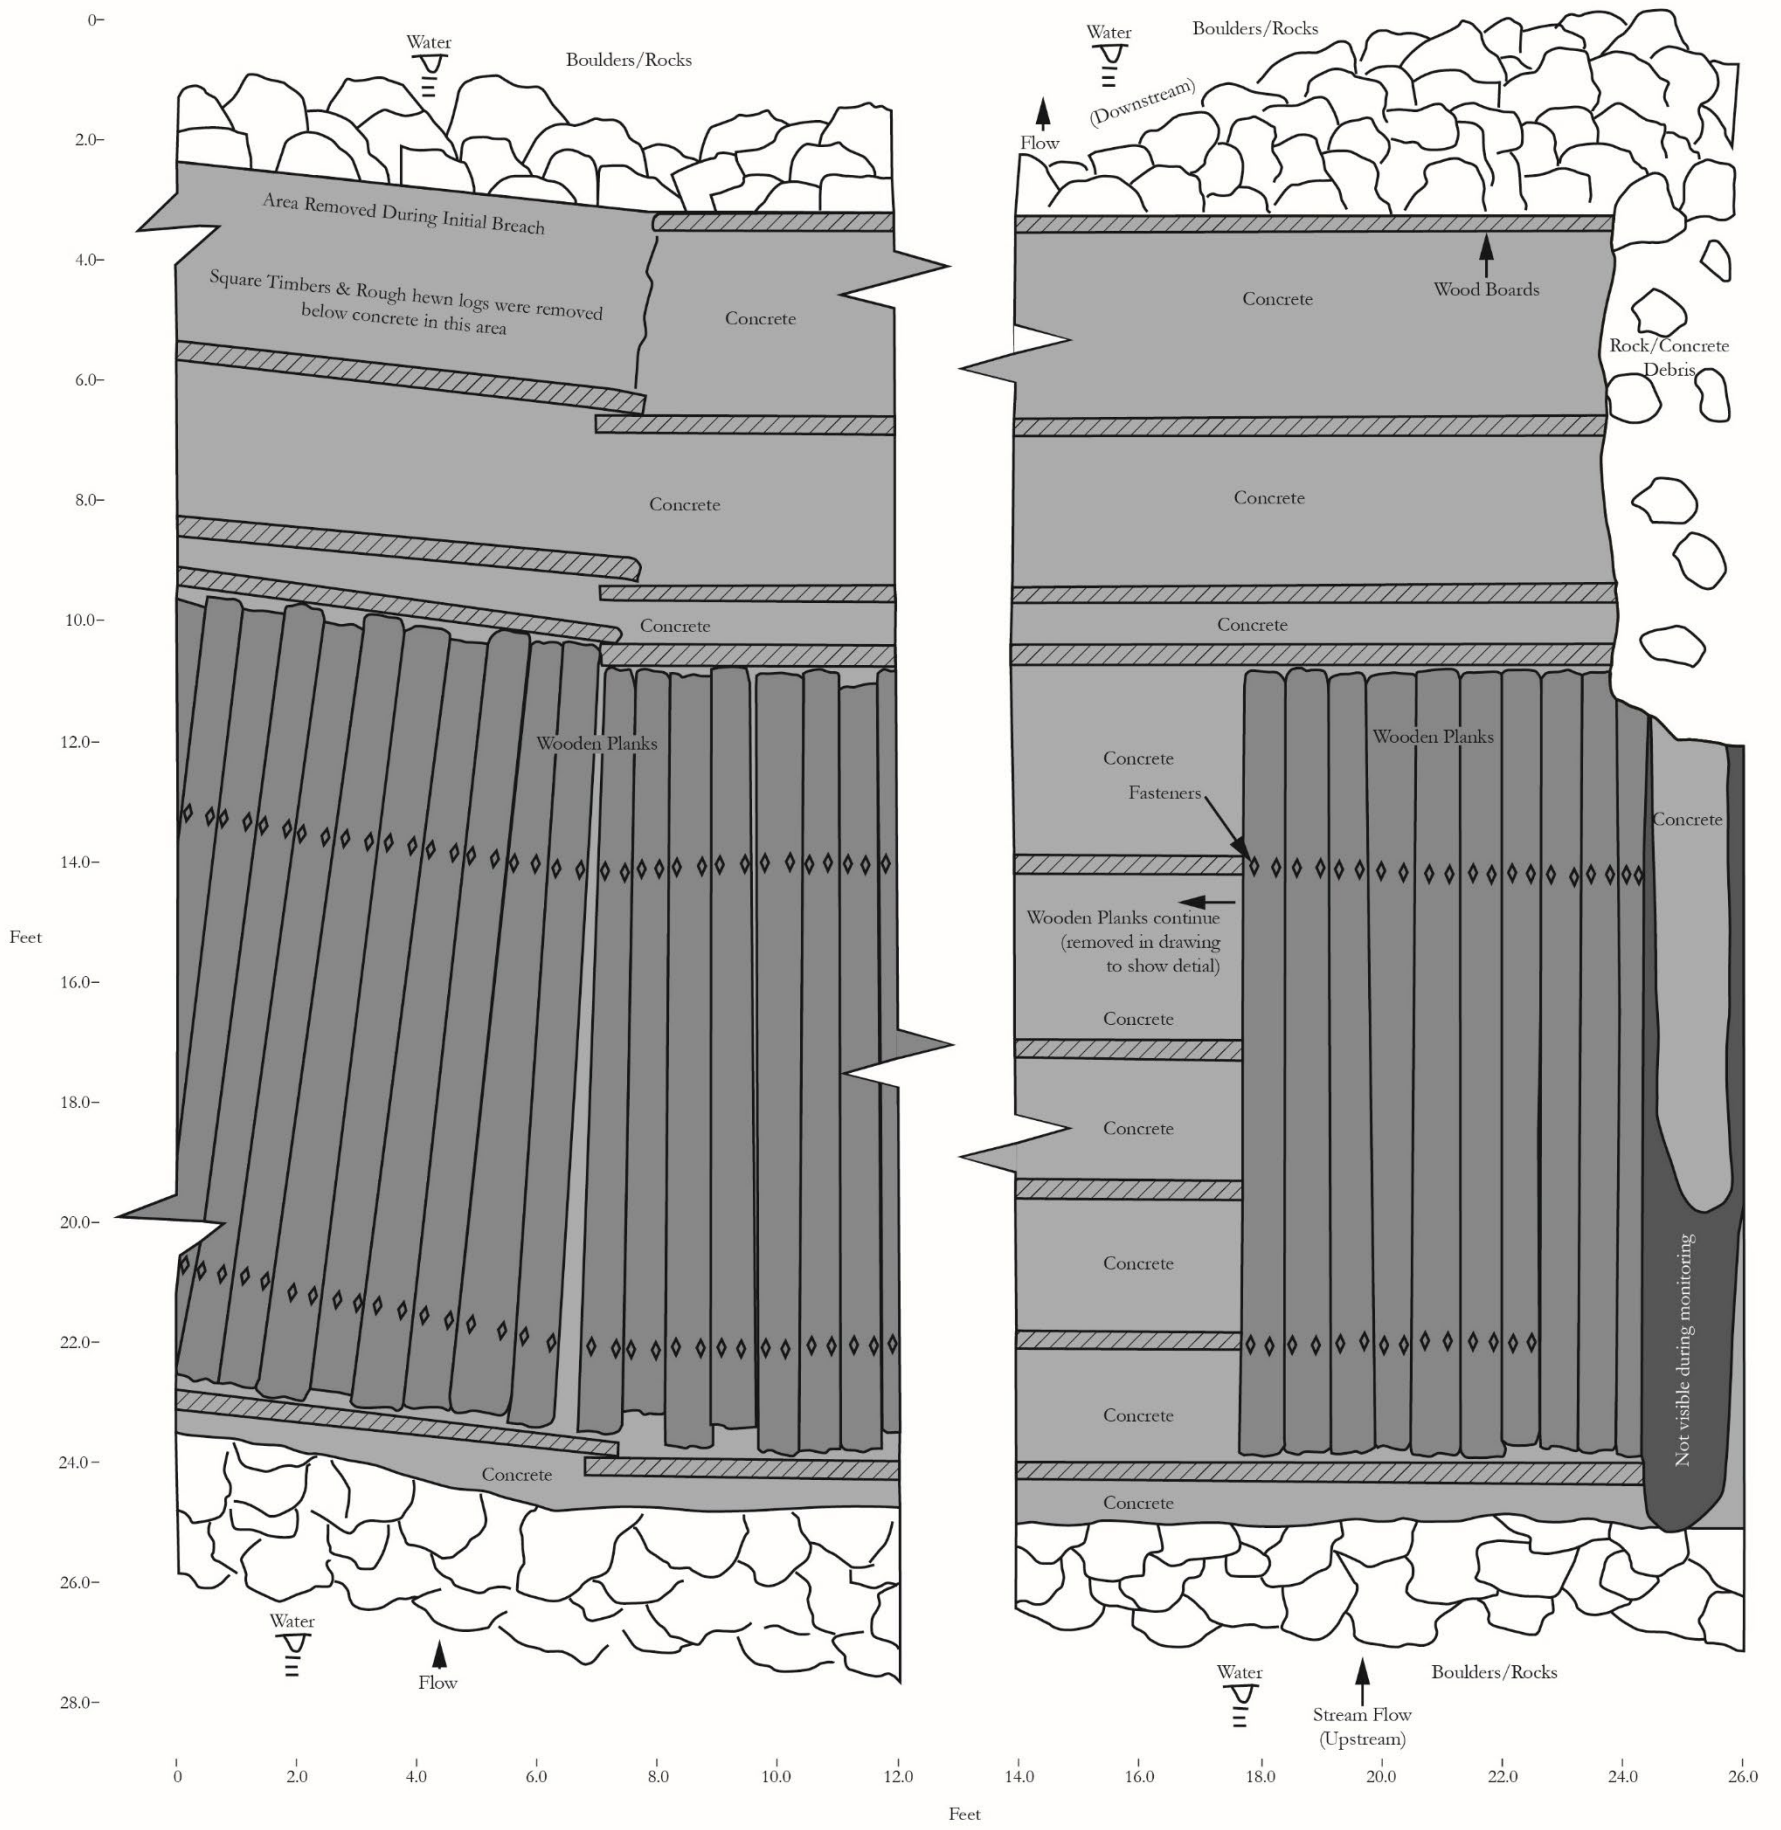
Brandywine Dam 6 Representative Plan Near Southern Abutment

Figure 4.2: Representative plan view of Brandywine Dam 6/Lower Hagley Yard Mill Dam near its southern abutment.

Figures 4.2 and 4.3; see Plate 4.17). A series of long, milled wooden planks were present on the upper surface of the sloped portion of the dam that served as a covering for the upstream ramp (see Figure 4.2 and 4.3; see Plates 4.2, 4.17–4.19). Intact, representative samples measured approximately 0.65 feet by 0.3 feet (8×3.5 inches) in cross section and up to 15 feet in length. They were fastened to the dam with ferrous metal nails that were driven into the upright, wooden timbers below (see Figures 4.2 and 4.3; see Plates 4.20–4.21). As with the milled boards, these planks were installed at the same time as the concrete cap. Removed portions of the upper concrete cap indicated that it varied between approximately 1 and 2 feet thick across the dam, and was likely poured directly over a rough, underlying structure of large rocks and boulders, which were partially embedded into the lower surface of the concrete (see Figure 4.3; see Plates 4.8 and 4.9).

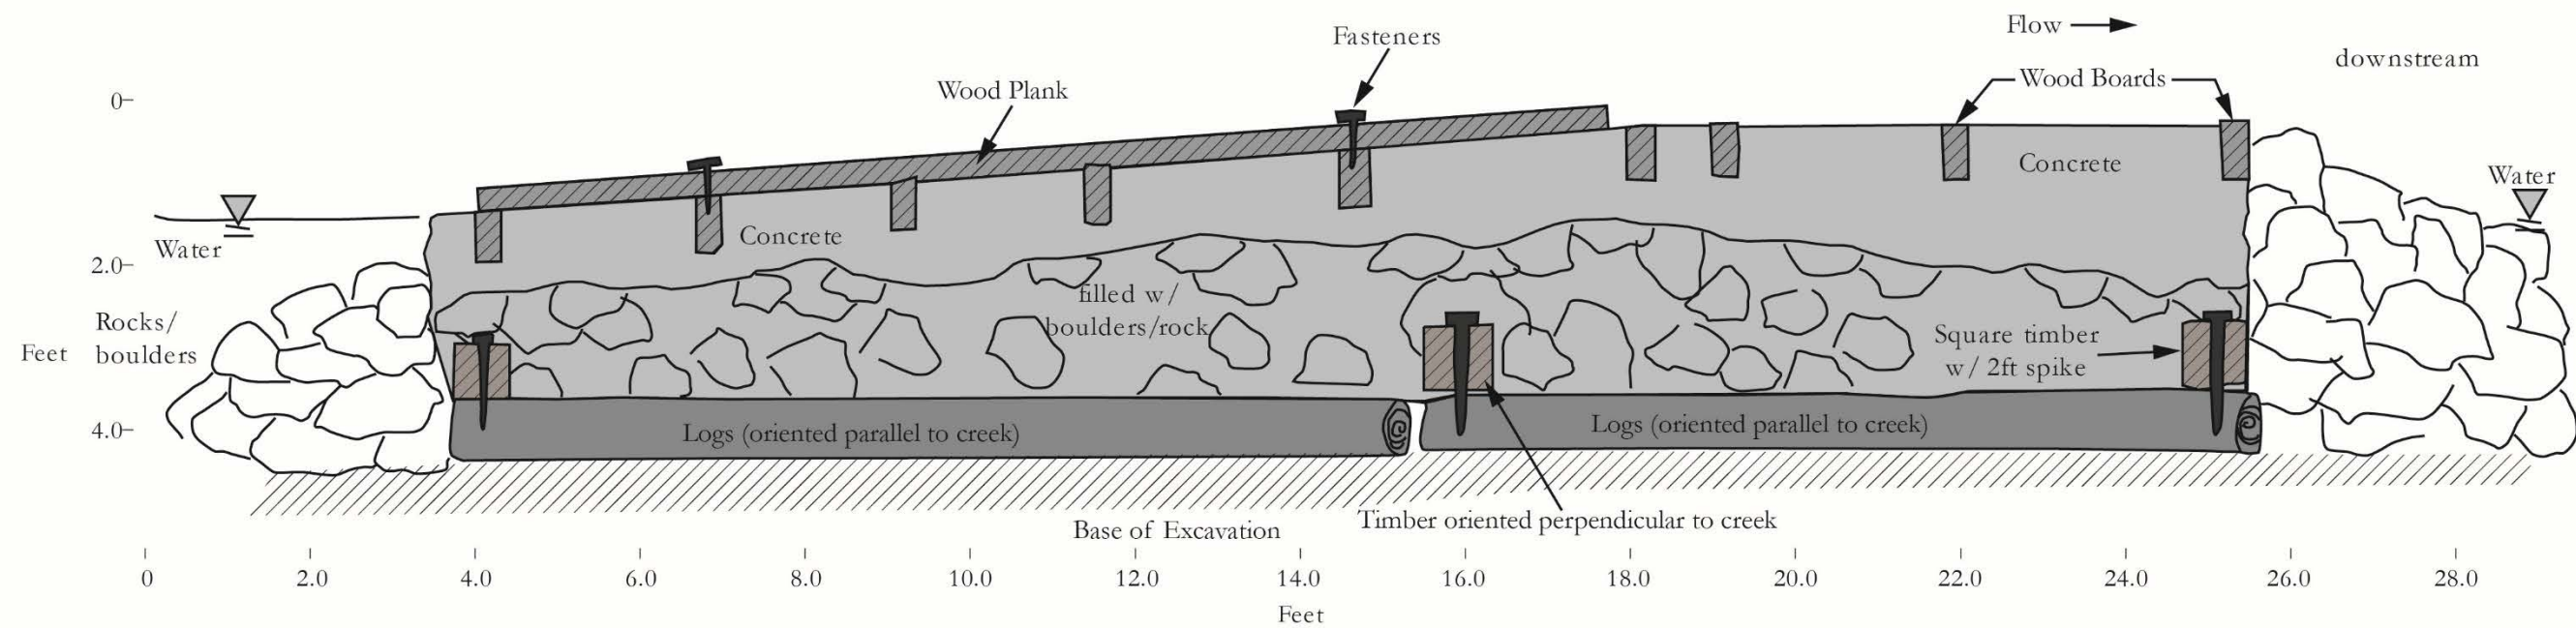
Brandywine Dam 6 Representative Profile Near Southern Abutment

Figure 4.3: Representative north profile of Brandywine Dam 6/Lower Hagley Yard Mill Dam near its southern abutment.

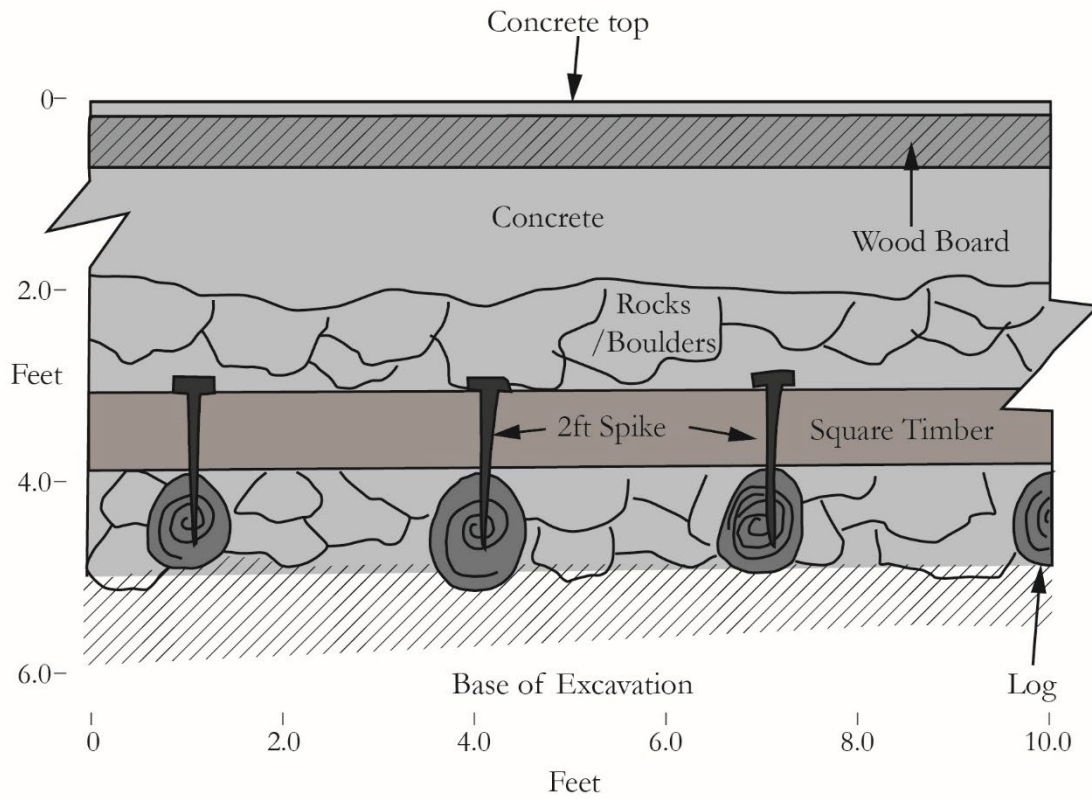
Brandywine Dam 6 Representative Profile Facing Upstream

Figure 4.4: Representative west profile of Brandywine Dam 6/Lower Hagley Yard Mill Dam showing its downstream face.

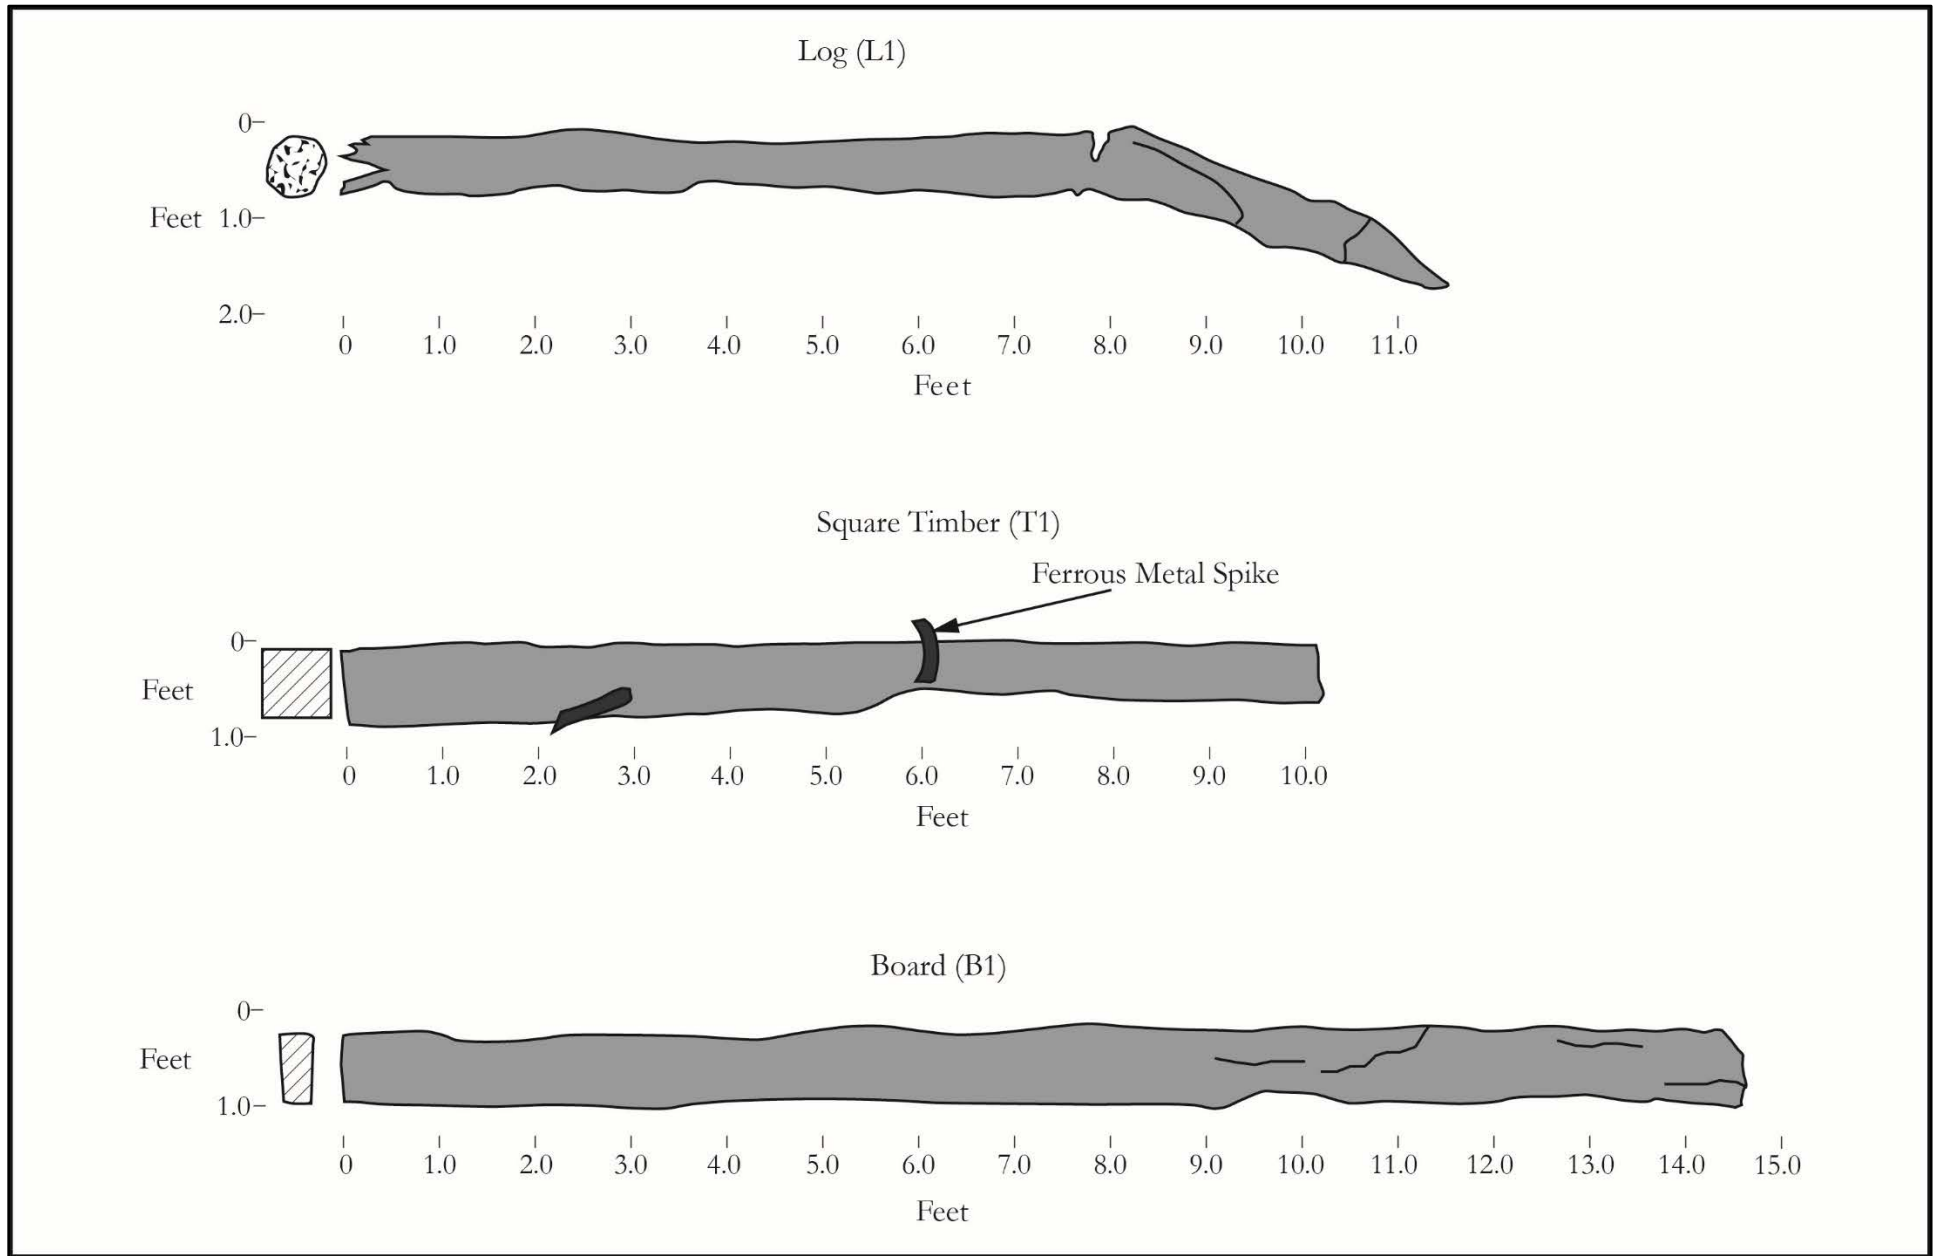
Figure 4.5: Representative structural elements removed from Brandywine Dam 6/Lower Hagley Yard Mill Dam during construction activities.

Altogether, this information suggests that the original portions of the circa-1839 reconstructed dam consisted of a wooden “<”-shaped timber crib structure composed of regularly placed logs and square timbers infilled with large rocks and boulders similar to that shown in Figure 4.7. It appears that significant repairs were previously made that entailed the addition of the concrete top with milled wooden timbers and planks sometime during or after the early twentieth century. Prior to the installation of the concrete spillway cap, some timbers and rock infill may have been removed.

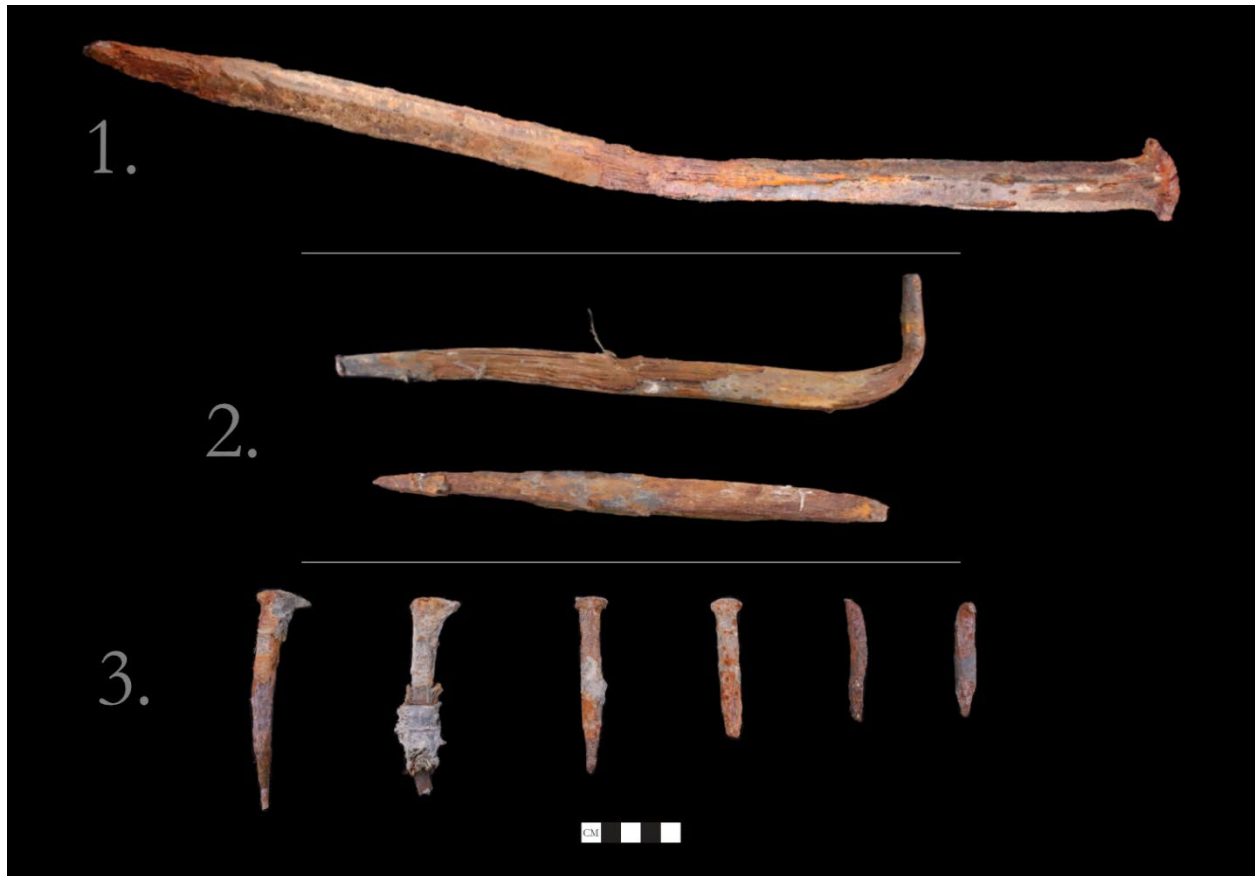
Figure 4.6: Representative artifacts sampled during the removal of Brandywine Dam 6.

1. Ferrous Metal Spike (Cat. #1) recovered from square timbers.
2. Ferrous Metal Spikes (Cat. #1) recovered from square timbers.
3. Square nail (Cat. #3); Square nail (Cat. #3) Square nail (Cat. #3); Cut nail (Cat. #2);
Cut Nail (Cat. #2); Cut Nail (Cat. #2) recovered from milled boards and planks.

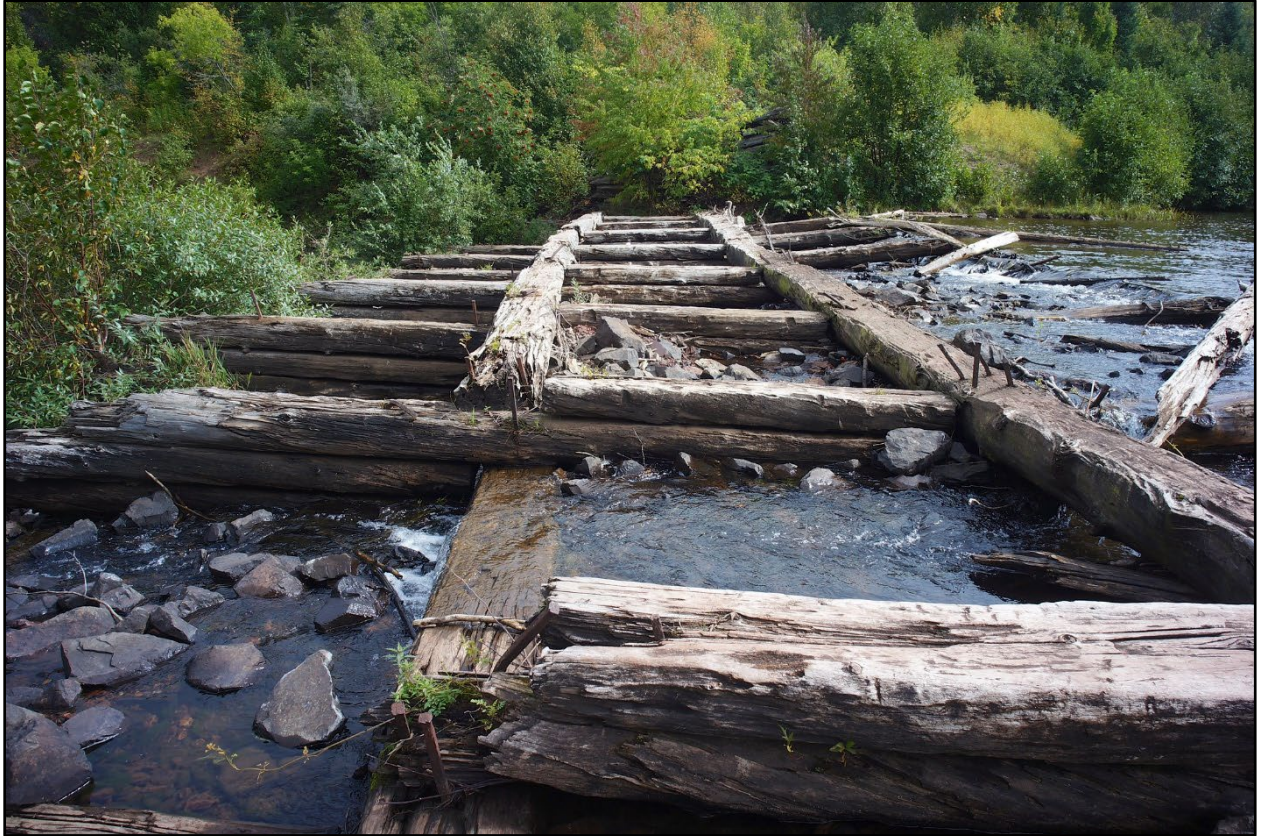
Figure 4.7: A photograph of a typical timber crib dam in Redridge, Michigan that is similar to observations of the underlying structure of Brandywine Dam 6.
Note the large ferrous metal spikes at joints.
(Rexp2 2013).
