FISH PASSAGE AT BRANDYWINE CREEK DAMS 4, 5 AND 6

City of Wilmington, Brandywine and Christiana
Hundreds, New Castle County, Delaware

DHCA Project Review No. 2020.06.22.06

ARCHAEOLOGICAL SURVEYS

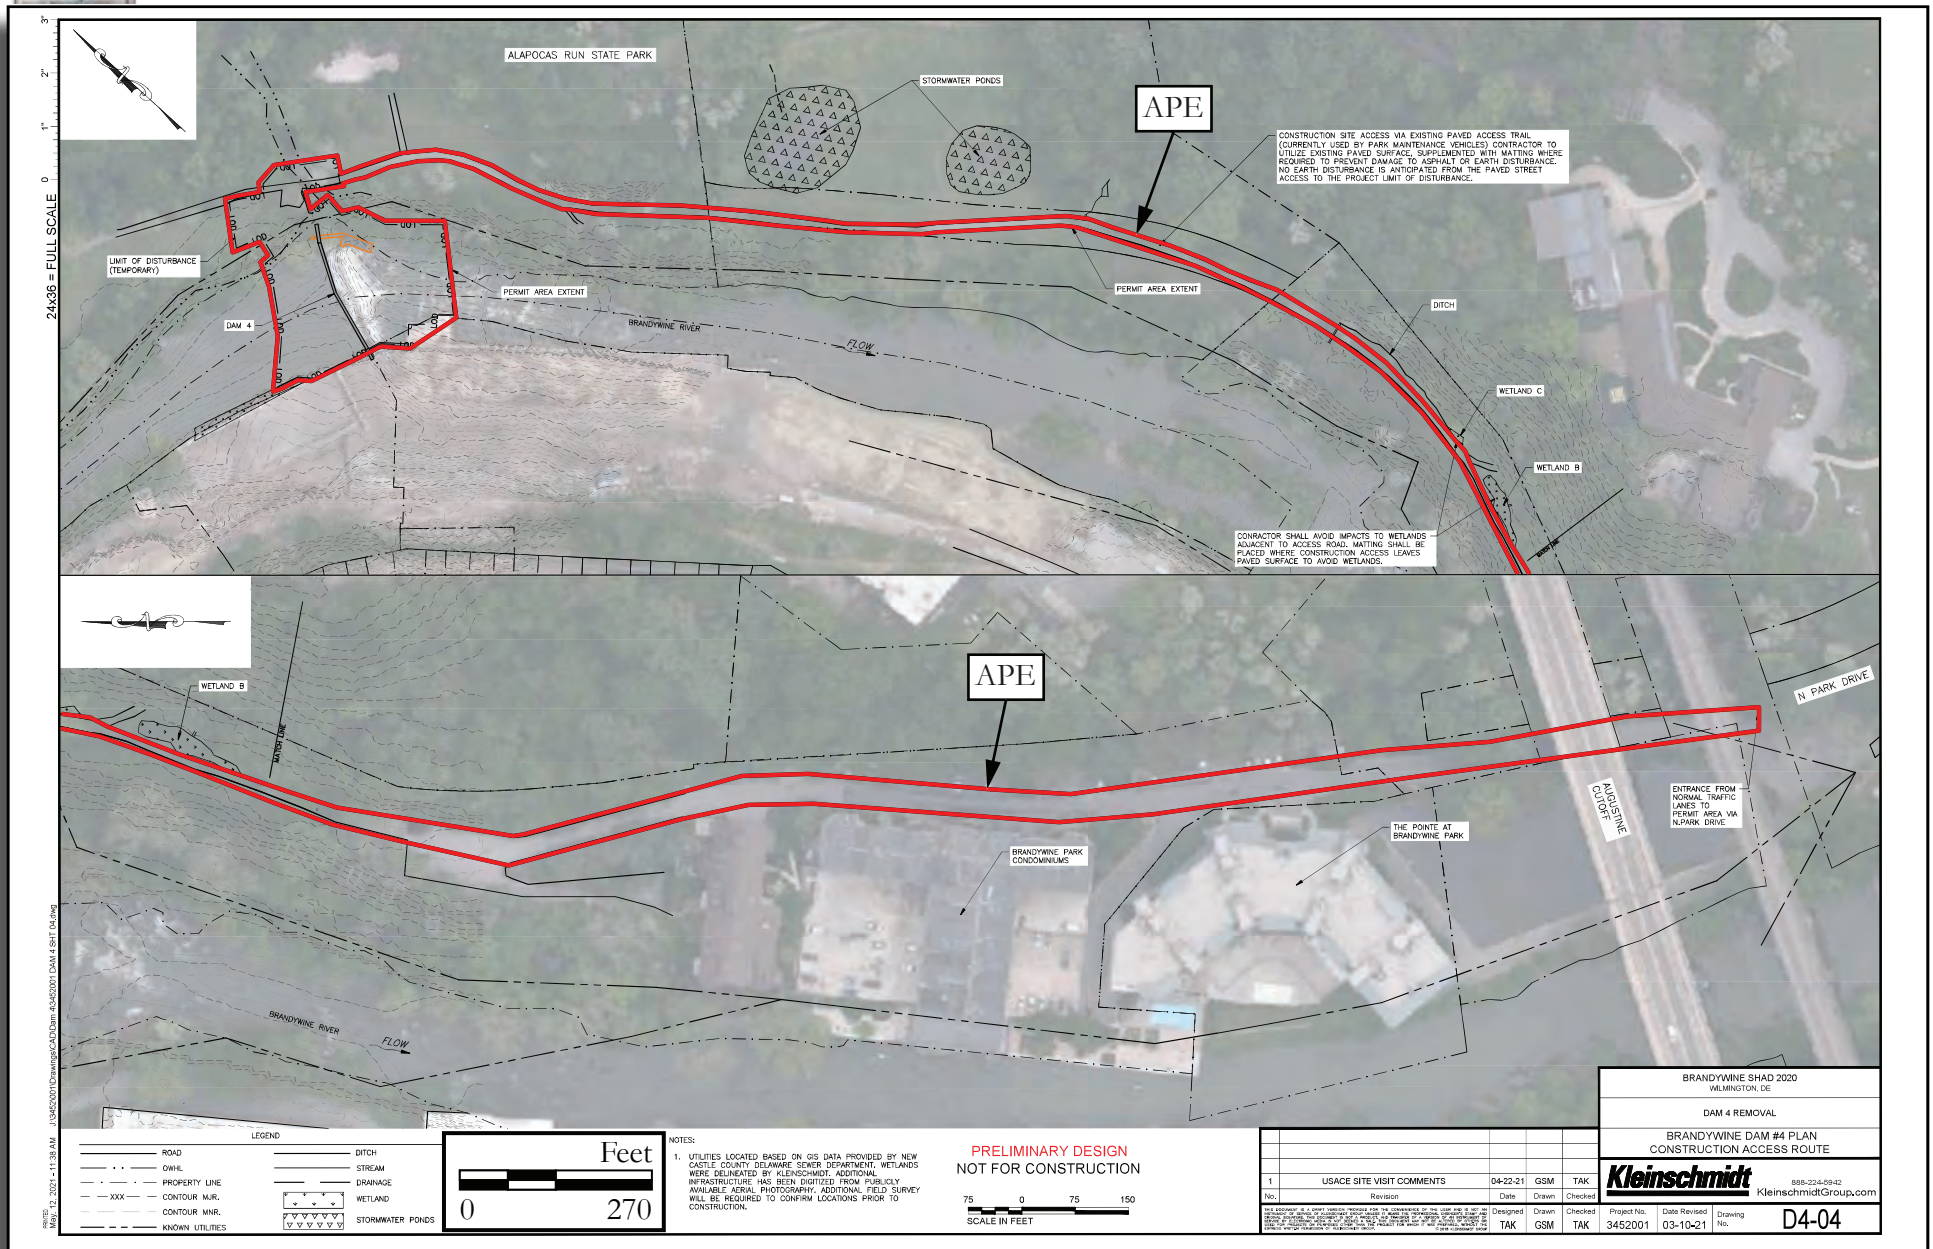
Figure 1.3b: Proposed project plans for Dam 4 removal
(from Kleinschmidt 2020b).

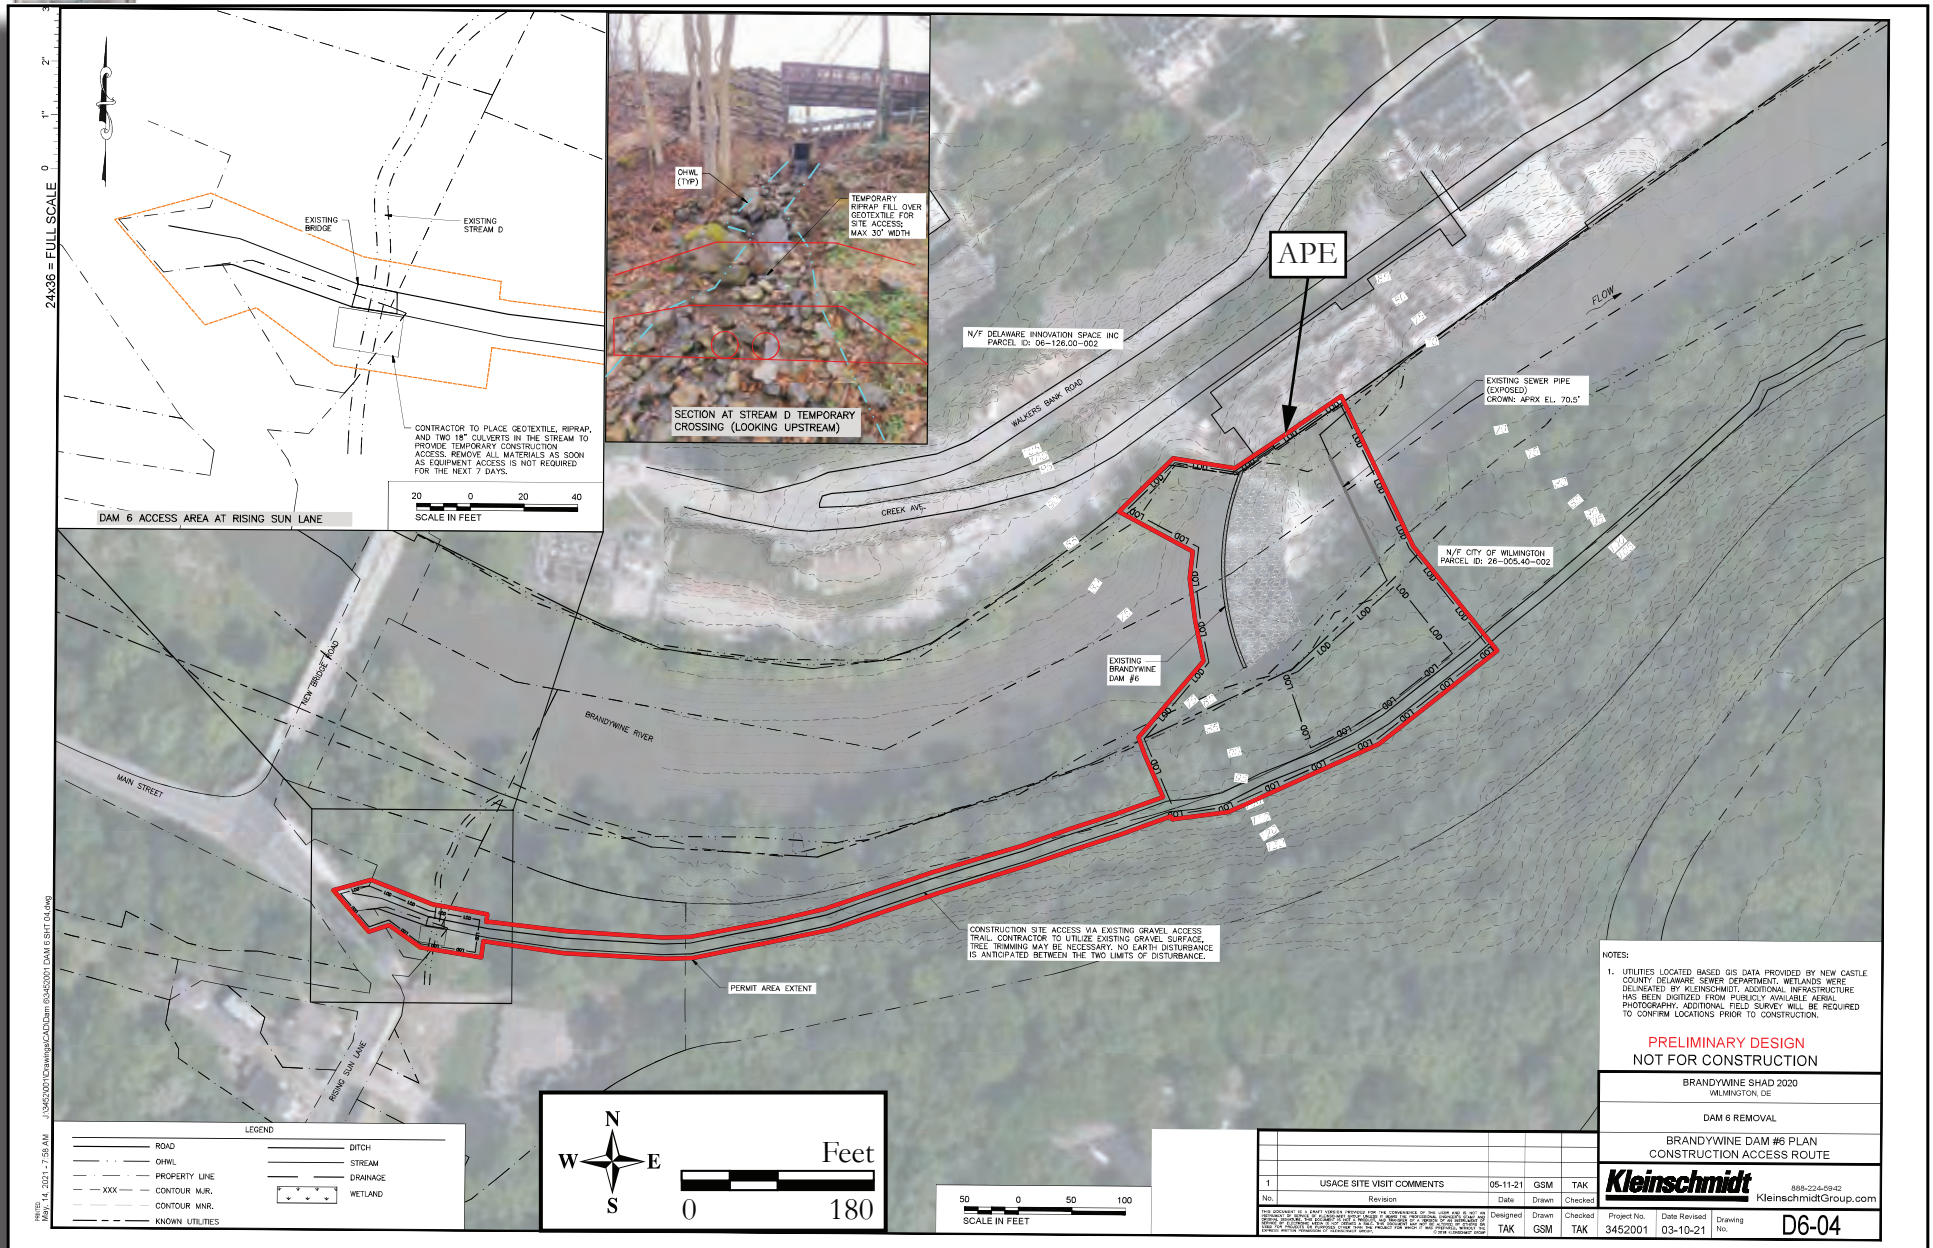
Figure 1.3d: Proposed project plans for Dam 6 removal
(from Kleinschmidt 2020c).

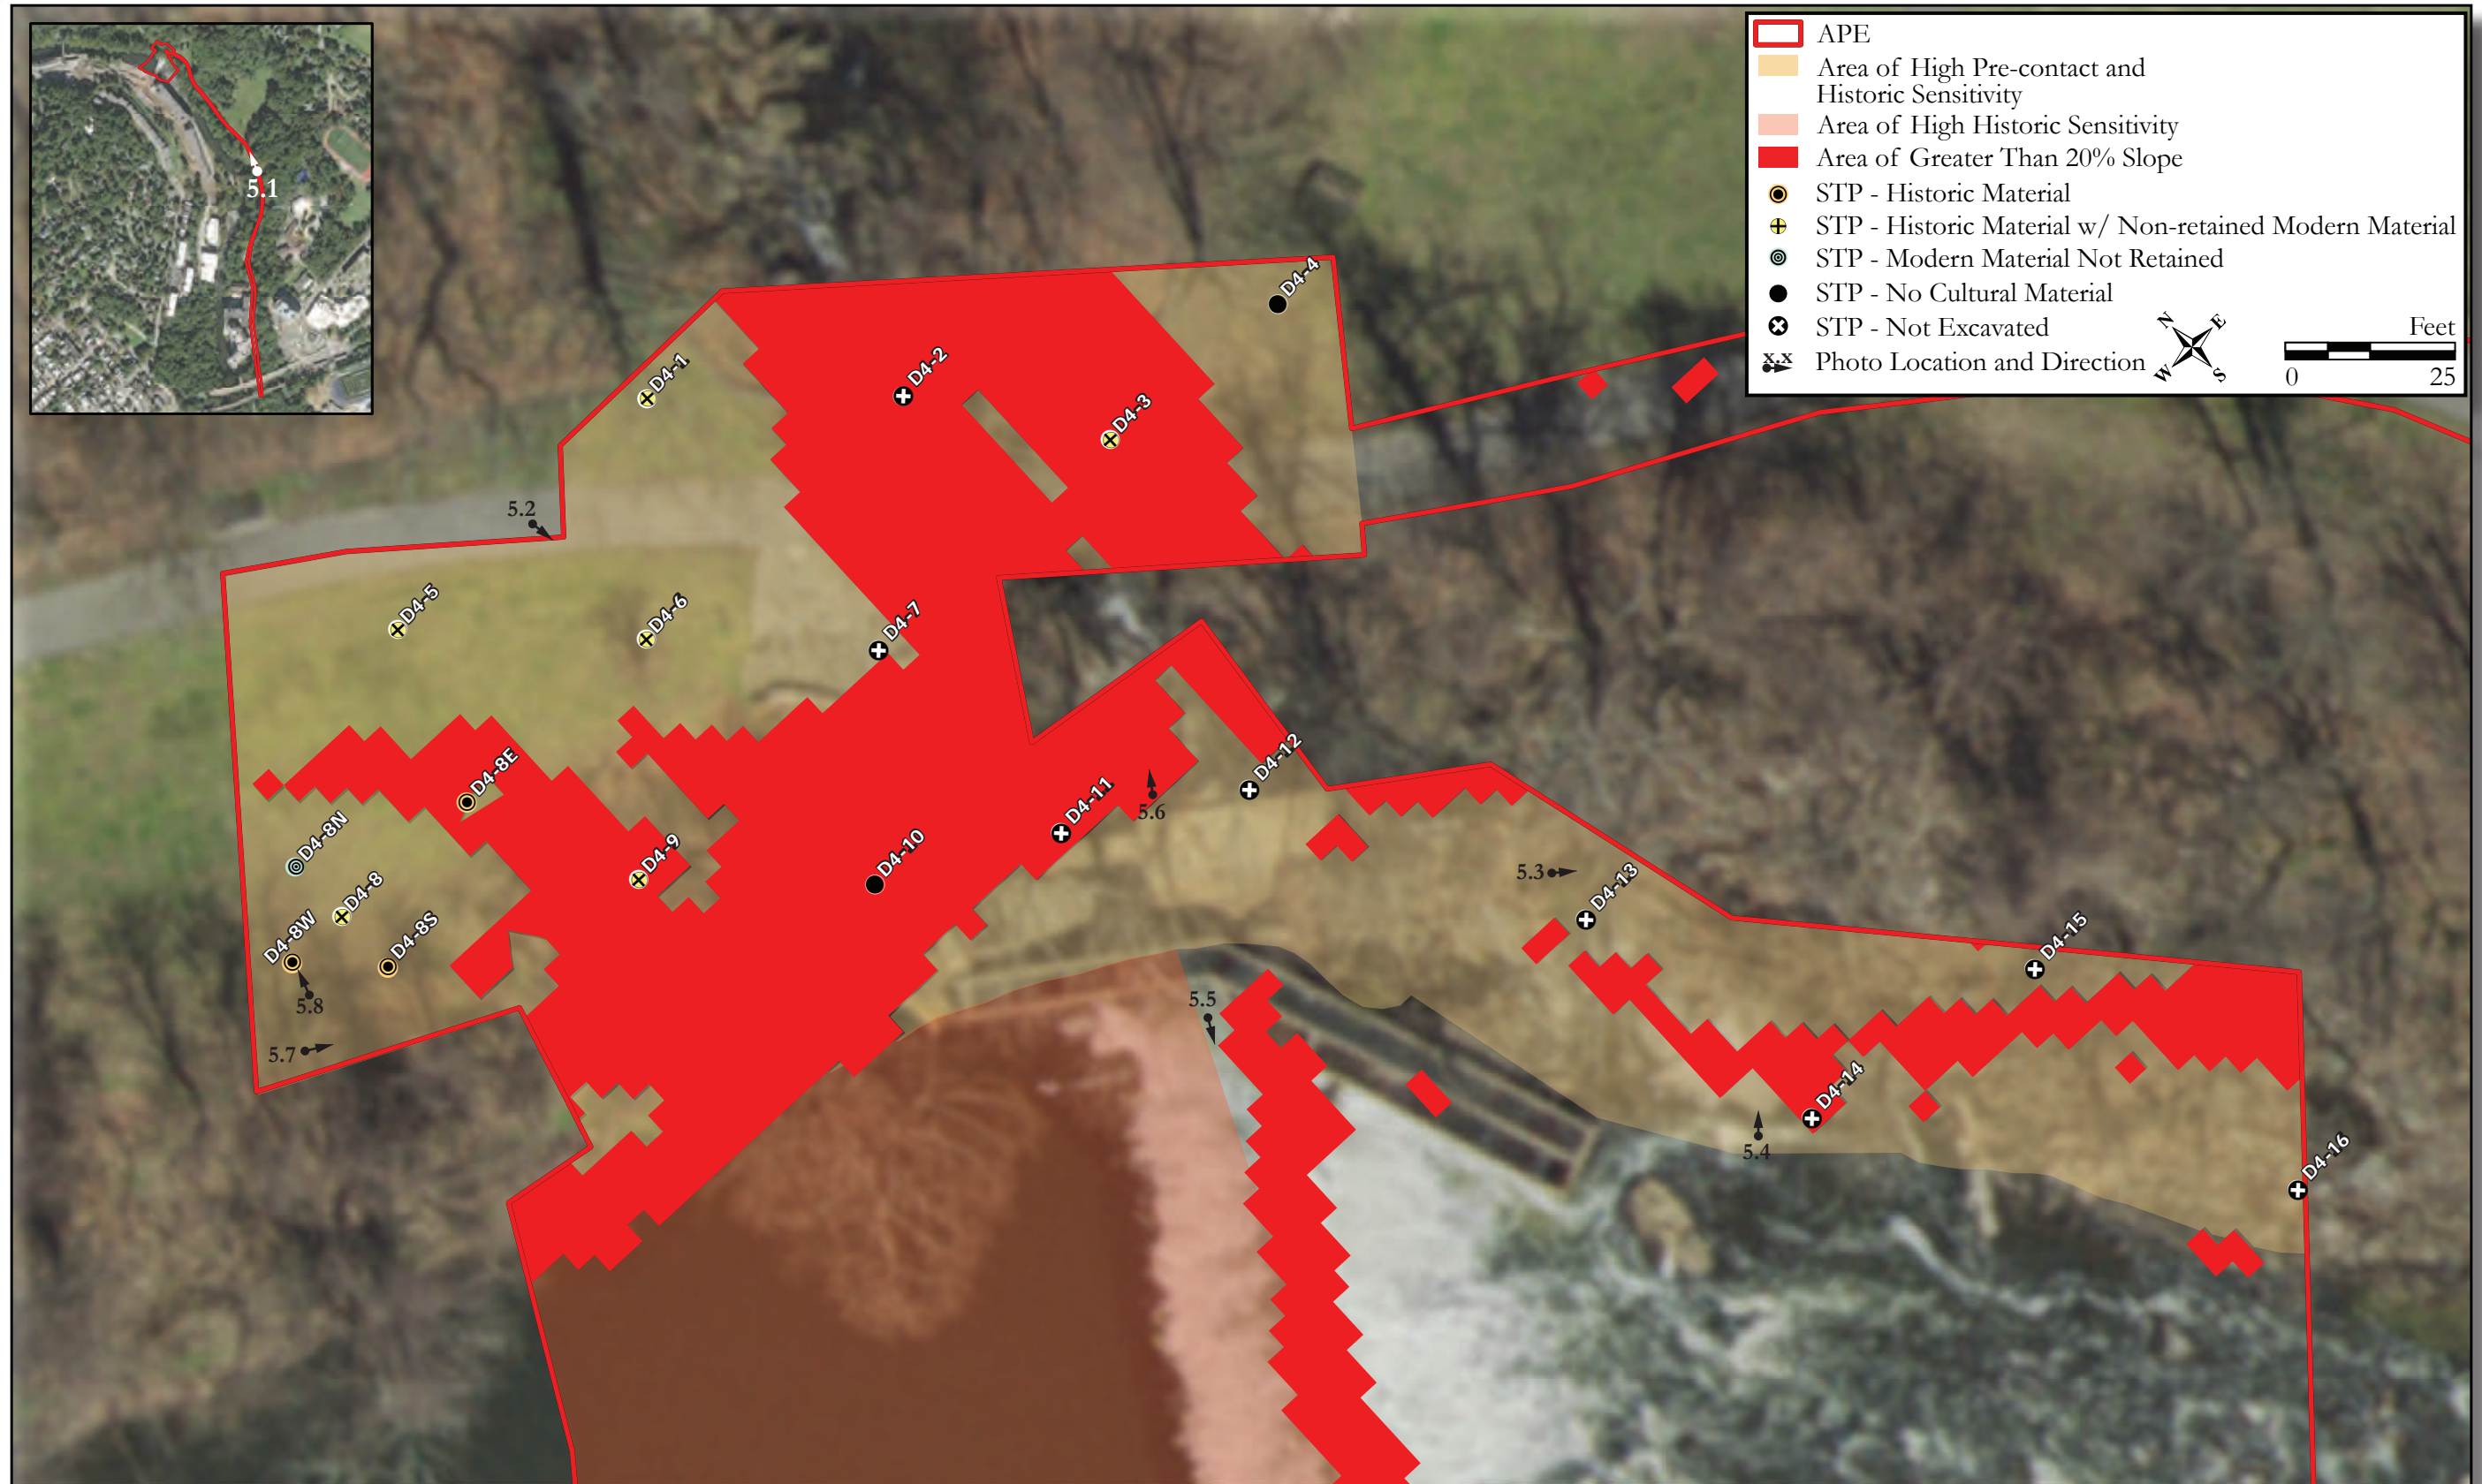
The stratigraphy identified in STPs primarily consisted of disturbed soils and imported fills. No STPs included a natural soil profile at grade, and one STP (D4-1) identified a potential buried A-horizon beneath 32.5 centimeters of secondary contexts. The possible buried A-horizon yielded no artifacts. Two STPs demonstrated a truncated subsoil and no buried topsoil (STPs D4-8N and D4-8S). No artifacts were found in the truncated subsoil. All other STPs had modern fill deposits to the base of the STP that appears to be associated with twentieth-century landscaping, infilling, and re-deposited soils associated with a circa-1901-to-1987 railroad line (see Plate 5.8). A total of 65 artifacts was retained (see Appendix E). The fill layers encountered primarily yielded coal and coal ash, likely the result of re-deposition of railroad-related fill soils (see Appendices D and E). Other railroad-related hardware found consists of three railroad spikes. Whiteware, yellowware, redware, stoneware drain pipe, vessel and window glass, rubber, wire nails, early to late twentieth-century bottle glass, and miscellaneous metal were also recovered (see Appendix E). No intact rail bedding, sleepers, or gauges were identified during testing. The re-deposited soils and artifacts are not indicative of an intact archaeological site. No pre-Contact Native American or early historic artifacts were recovered, and no intact cultural features were identified in the upland portion of the APE.

Figure 5.12: Aerial photograph of the Dam 4 APE showing photograph locations, areas of archaeological sensitivity, and STP locations and results.

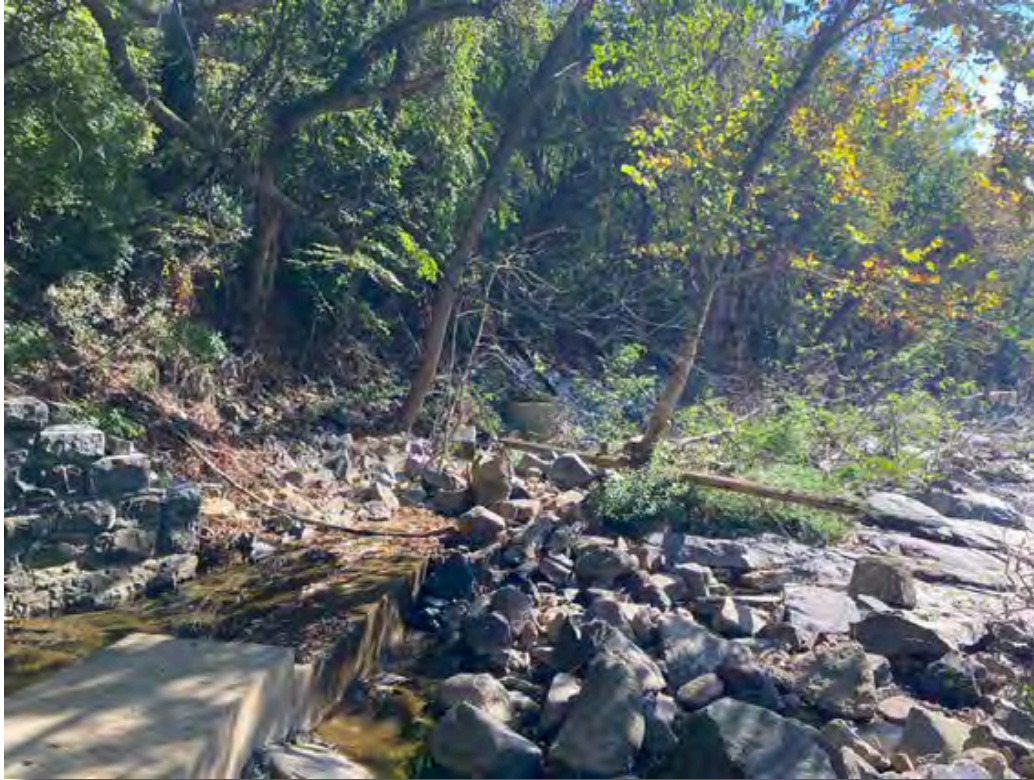
Plate 5.3: Overview of rocky slopes and the concrete-encased sewer line and manhole on the north bank of the creek.

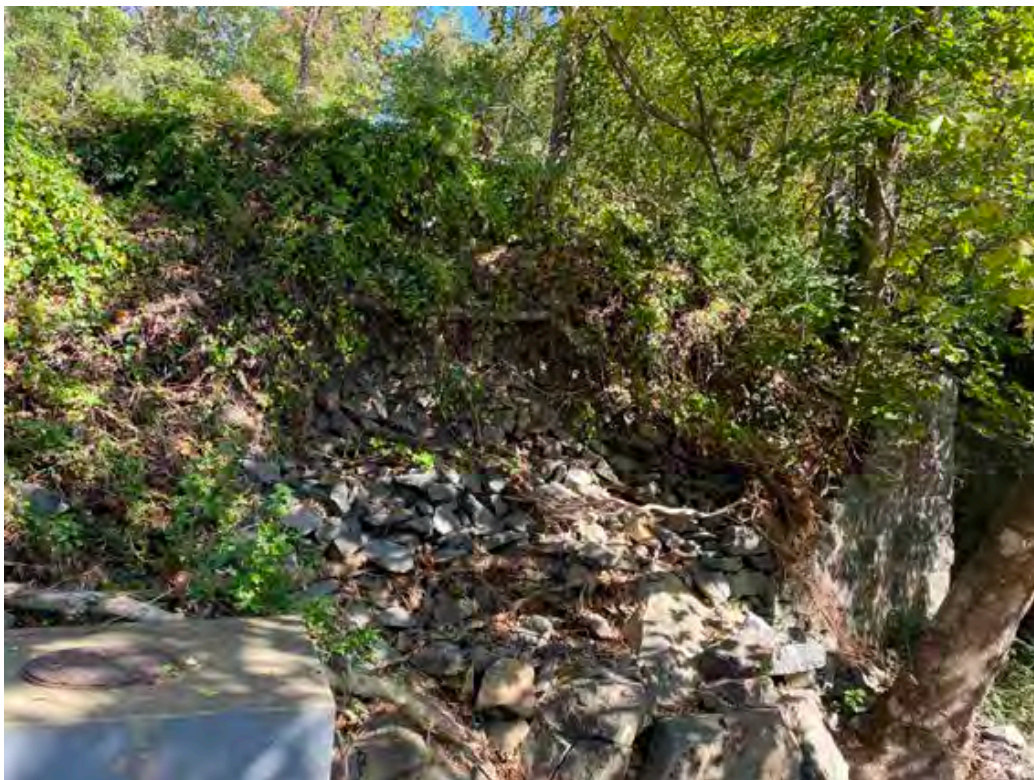
Plate 5.4: Overview of dense vegetation, concrete sewer line manhole, and a rocky slope on the north bank of the creek.

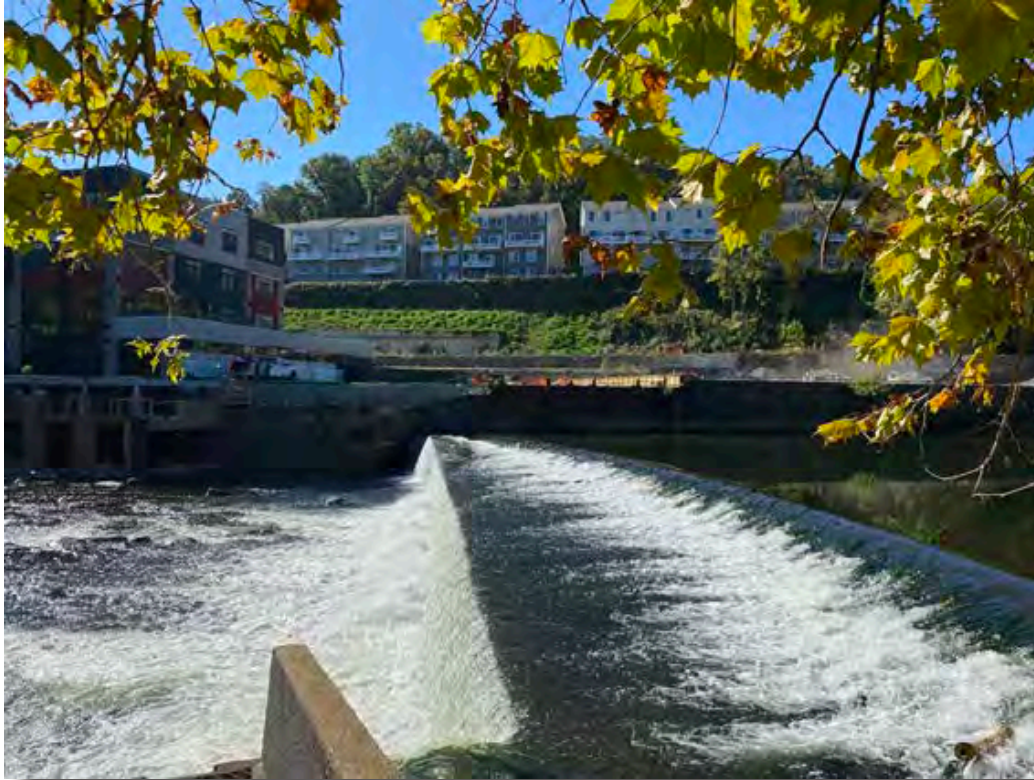
Plate 5.5: Overview of Dam 4.

The Dam 4 APE falls within the NRHP-listed Bancroft and Sons Cotton Mills Historic District (N03646) (NR: 12/20/1984). Dam 4 was constructed in 1896, is also known as the Kentmere/Bancroft II Dam, and has been determined individually eligible for the NRHP under Criteria A and C (SHPO Opinion: 5/5/2022). By 1901, a railroad was built within the footprint of the present-day asphalt-paved access path/drive in the APE that will be used for temporary construction access. The railroad was abandoned and removed between 1987 and 1997. Phase IB archaeological testing in areas of assessed moderate to high archaeological sensitivity resulted in the recovery of late nineteenth-through twentieth-century artifacts from secondary contexts of disturbed, possible alluvial, and/or imported soils. Two shovel test pits (STPs) contained coal/slag deposits that may be related to railroad use or re-deposition of regraded railroad-related soils. Shovel Test Pits D4-3, D4-5, and D4-8 contained coal, ash, and/or slag deposits with other artifacts, some of which date to the twentieth century. Coal was found in many of the STPs excavated, likely the result of disposal or colluvial soil movement during twentieth-century railroad use. No intact rail bedding, sleepers, or rails were identified. No intact structural evidence of a mill race was found. The artifacts recovered are not indicative of an intact archaeological resource. No further archaeological survey is recommended in the upland section of the APE. Archaeological monitoring during the dam's removal is recommended.

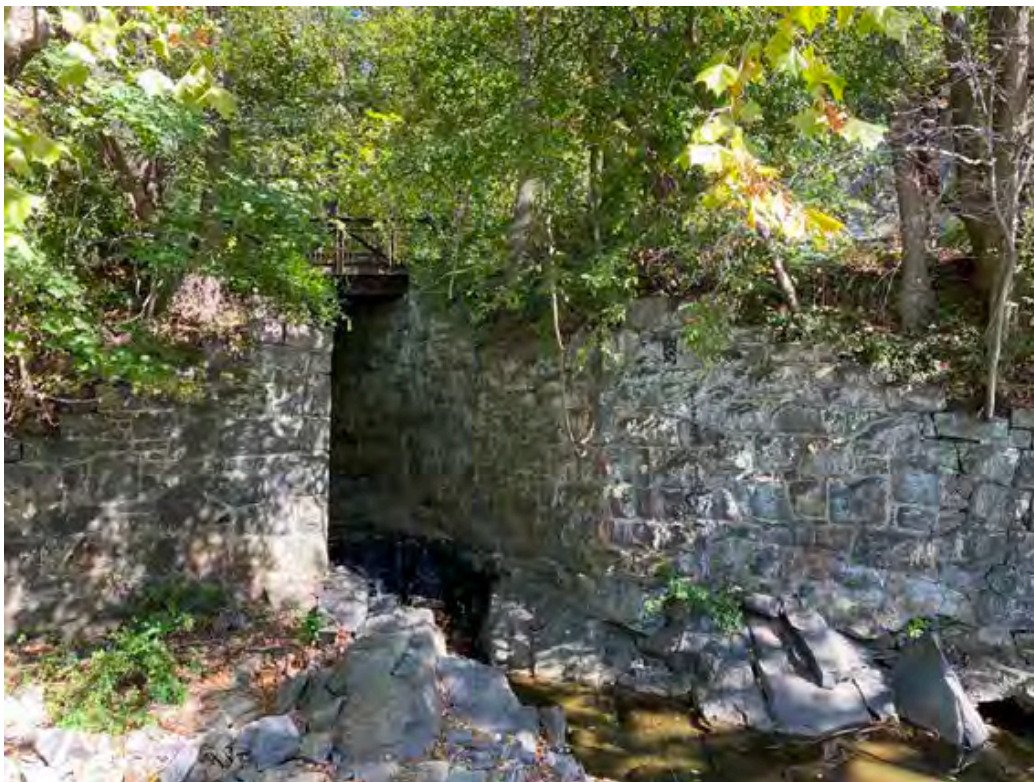
Plate 5.6: Overview of stone structure at the mouth of Alapocas Run.

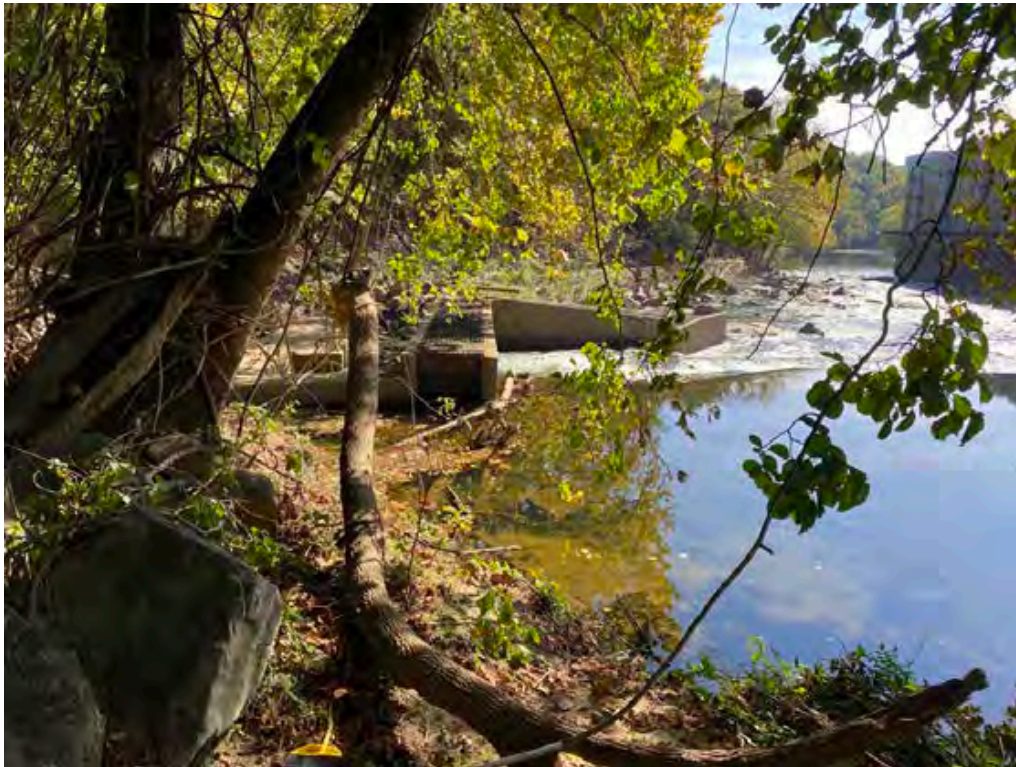
Plate 5.7: Overview of an abandoned concrete technical fishway and a concrete encased sewer line on the north side of Dam 4.

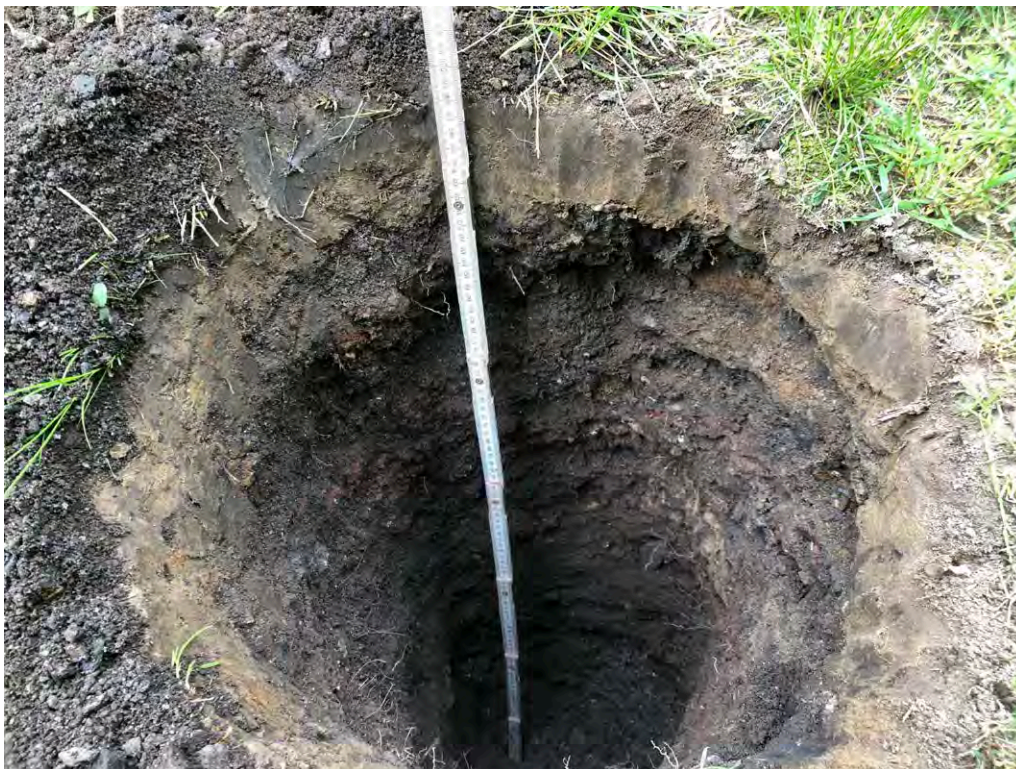
Plate 5.8: View of STP D4-8W soil profile.

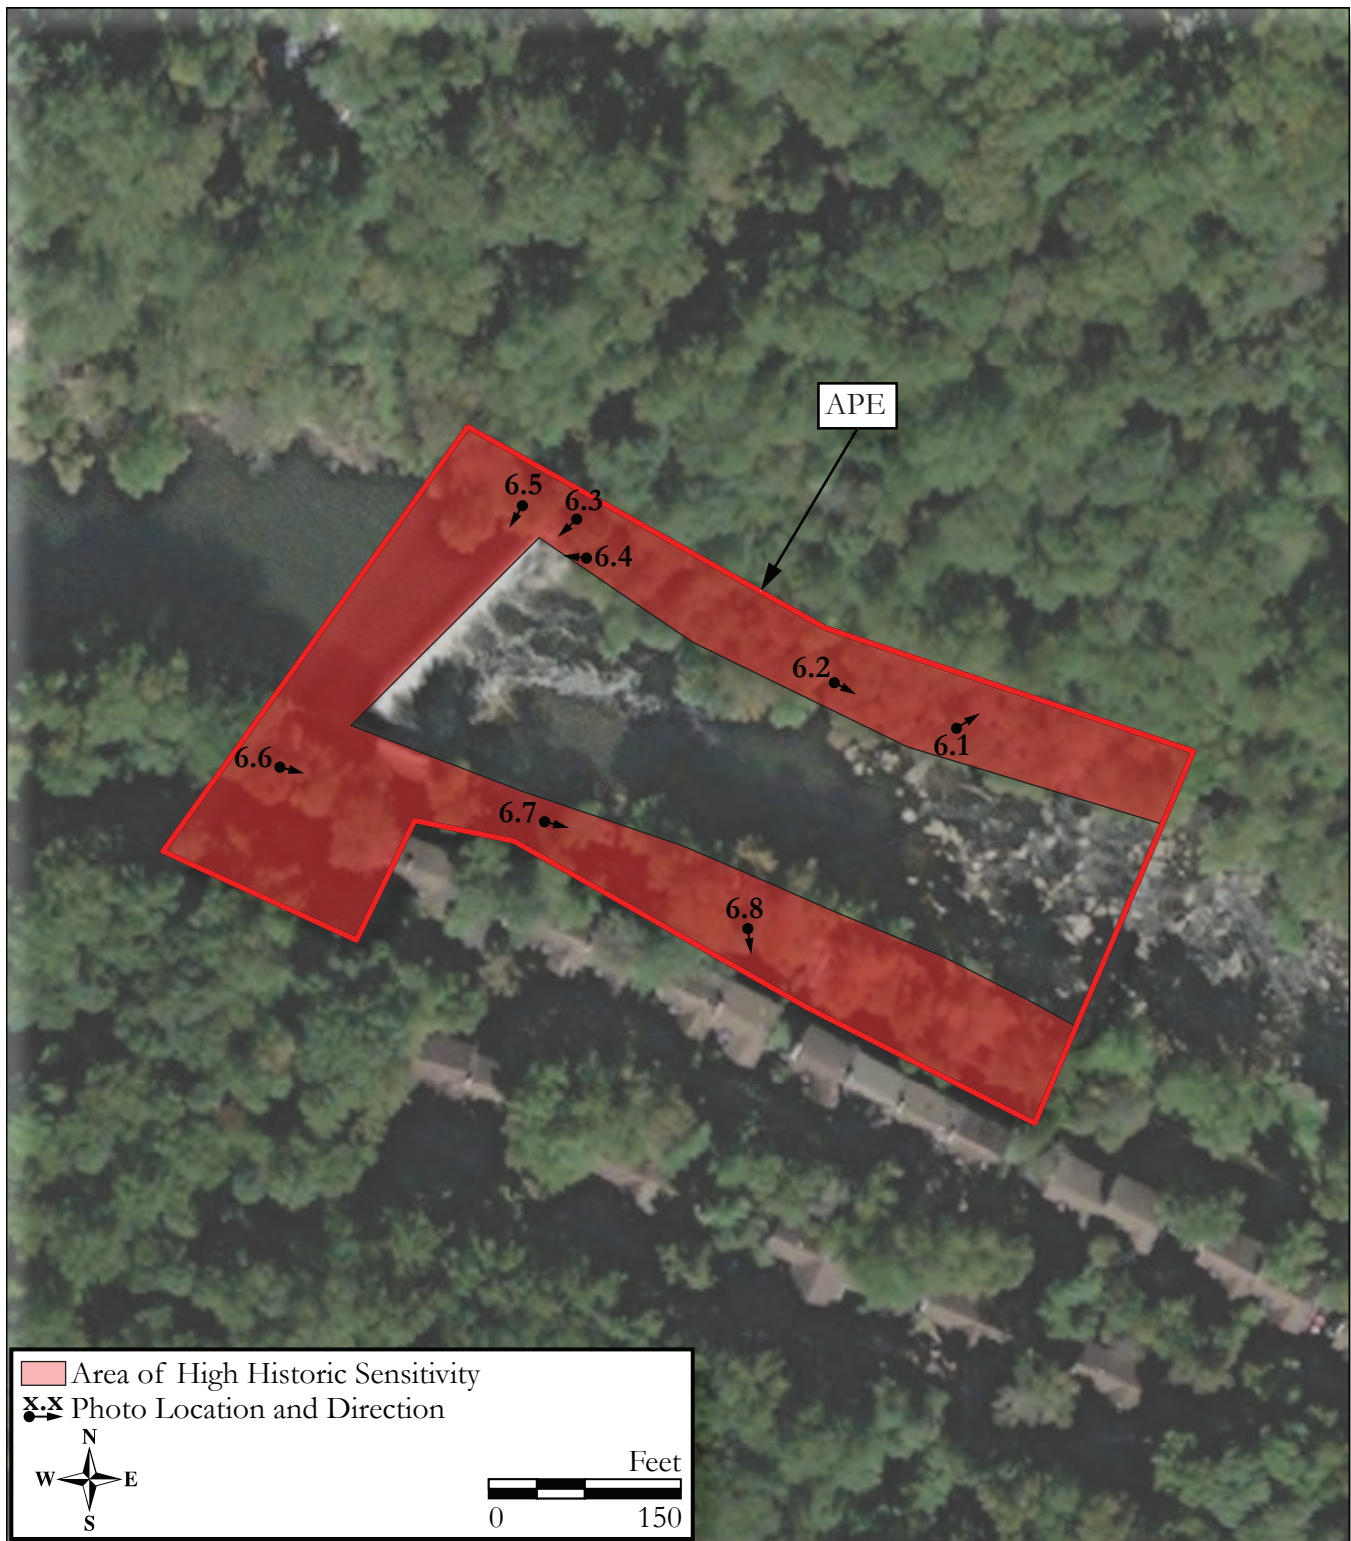
Senior Archaeologist, Sean McHugh conducted the archaeological reconnaissance survey on October 22, 2021 (Plates 6.1-6.9; Figure 6.8). The northern portion of APE for the Dam 5 removal is generally very sloped and rocky, and the area is covered in young deciduous trees (see Plates 6.1 and 6.2). It is unclear if the rock debris represents flood-destroyed mills that formerly stood along the north bank in the early to mid-nineteenth century (see Figure 6.2 and 6.5a). No evidence of intact foundations was observed along the north bank of the creek. The dam itself is accompanied by a sluice gate and adjacent stone retaining wall situated just upstream from the dam, which draws water into a raceway that runs along the creek's southern bank (see Plates 6.3 through 6.7). The datestone on the sluice reads "1878." The raceway directs water to the Bancroft and Sons Cotton Mills complex. A smaller sluice is situated along the raceway, near the buildings associated with the adjacent mill complex (see Plate 6.8)

Figure 6.8: Aerial photograph of the Dam 5 APE showing photograph locations and areas of archaeological sensitivity.

Although the northern bank of the Brandywine Creek within the APE is relatively sloped and rocky, this area is also the approximate mapped location of four former mill wheels on an 1816 map (see Figure 6.2). Another mill wheel is depicted on the southern bank near the APE. The southern portion of the APE is also adjacent to the Bancroft Mills complex and an extant mill race passes through this area. Due to the presence of mapped and extant historic resources and the APE's location within and adjacent to the Bancroft and Sons Cotton Mills Historic District, the northern and southern portions of the APE are assessed with a high sensitivity for historic archaeological resources (see Figure 6.8). In addition, the location of Dam 5 and the upstream area of Dam 5 also have an assessed high sensitivity for archaeological remains associated with the current dam and any former dams that existed since the early nineteenth century within the APE. Phase IB archaeological survey at Dam 5 will be conducted once the design for proposed undertaking at the dam has progressed and the limits of disturbance have been refined.

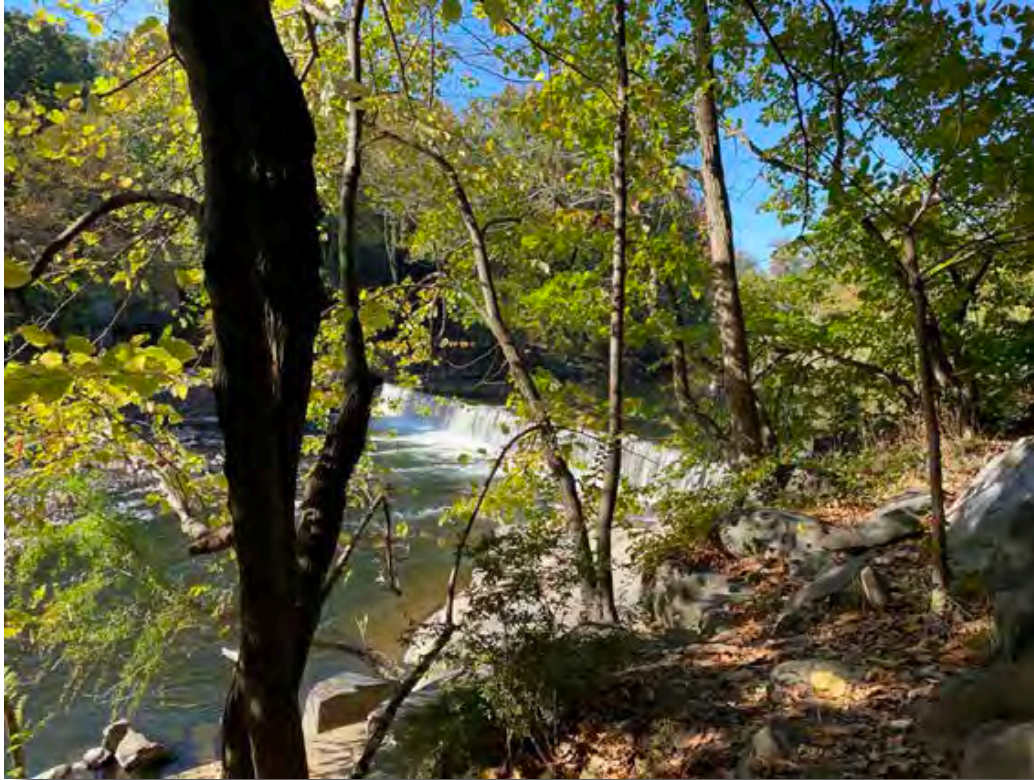
Plate 6.3: Overview of Dam 5 and the northern bank of the creek showing a possible concrete-encased sewer line at the edge of the creek in the lower left corner of the image.

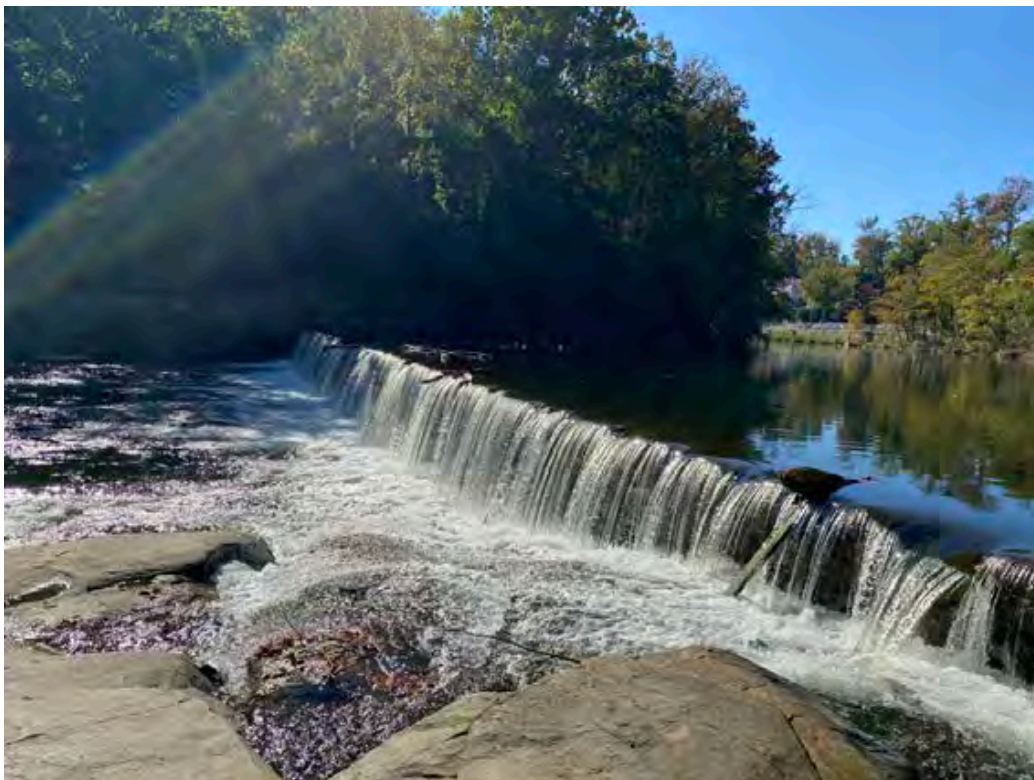
Plate 6.4: Overview of Dam 5.

The Dam 5 APE is partially encompassed within the northwestern boundary of the NRHP-listed Bancroft and Sons Cotton Mills Historic District (N03646) (NR: 12/20/1984). Dam 5 represents the 1878 Rockford Dam (N03646.048), which is considered a contributing element to the historic district. This dam, also known as the Rockford/Bancroft I Dam, has been determined individually eligible for the NRHP under Criteria A and C (SHPO Opinion: 5/5/2022). Dam 5 is situated at the location of an earlier, early nineteenth-century dam. The proposed project is not defined at this time but is anticipated to include either just the notching of the dam or the dam's complete removal. Archaeological monitoring of notching or removal of the dam is recommended. Phase IB archaeological testing is also recommended in areas of assessed moderate to high archaeological

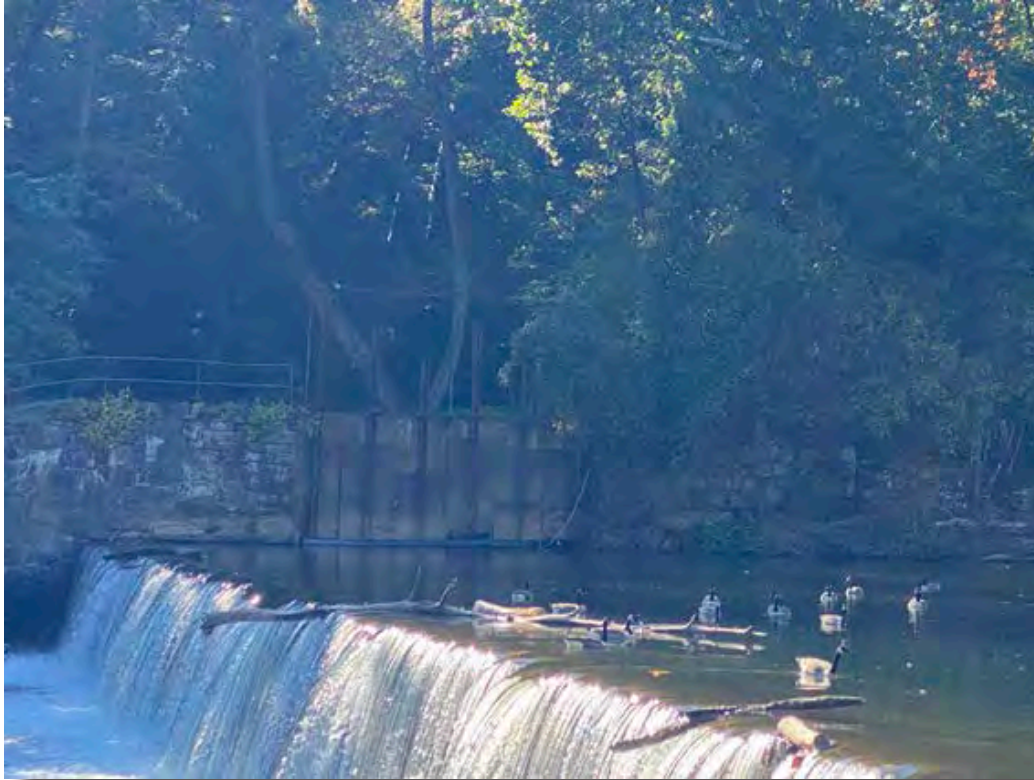
Plate 6.5: Overview of the sluice gate situated along the southern bank of the Brandywine Creek, just upstream from Dam 5.

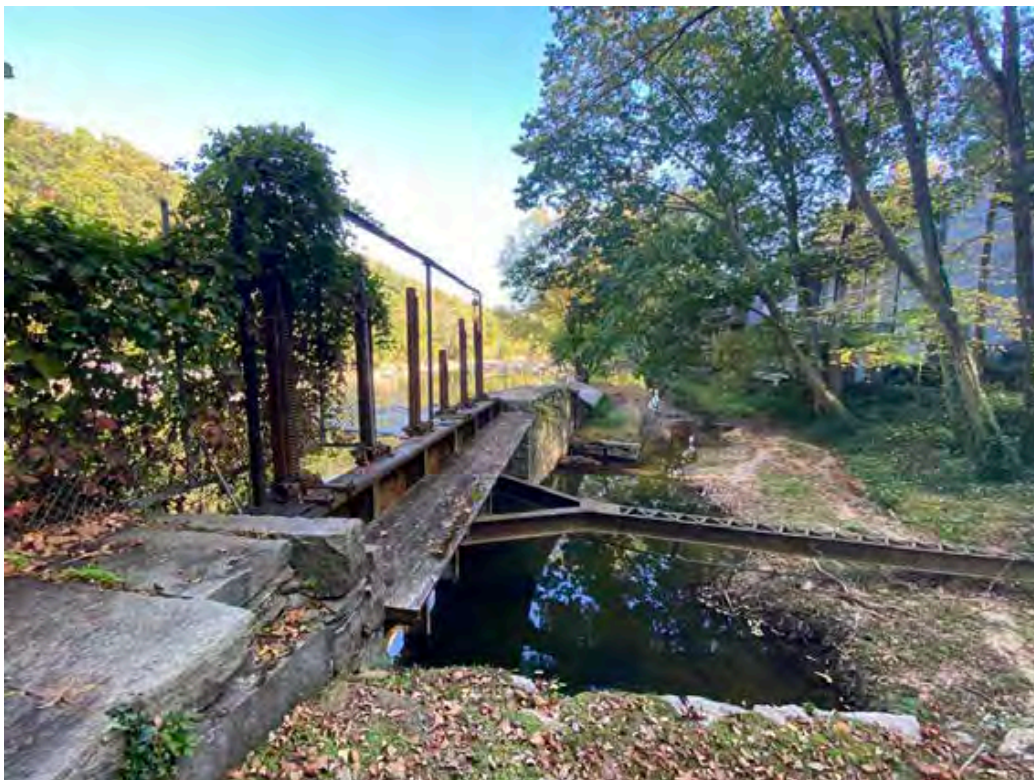
Plate 6.6: Overview of the sluice gate mechanism on the southern bank of the creek.

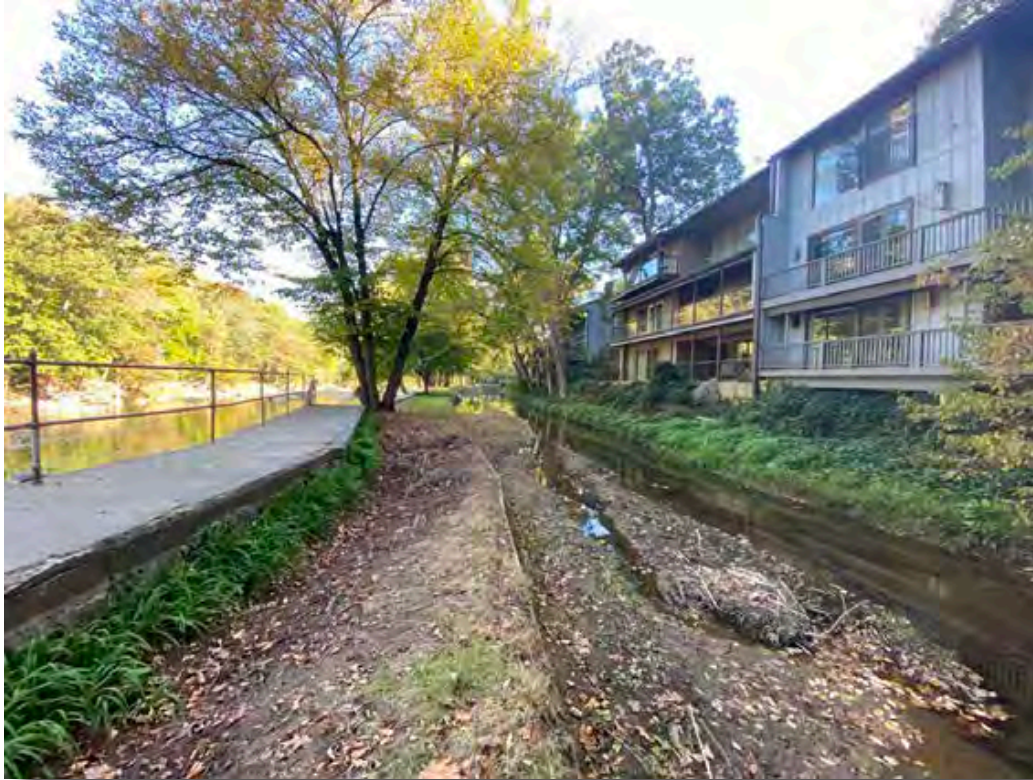
Plate 6.7: Overview of the millrace fed by the Brandywine Creek with a flow controlled by the sluice gate upstream from Dam 5.

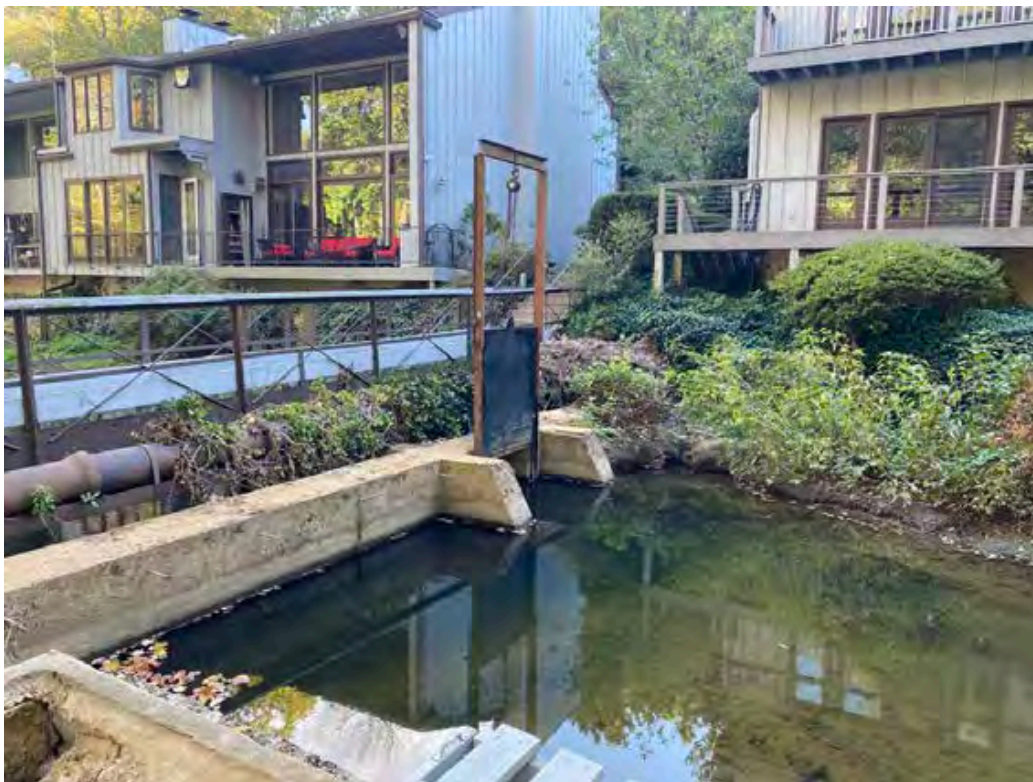
Plate 6.8: Overview of a smaller sluice gate along the millrace, further controlling the water flow to the former Bancroft and Sons Cotton Mills complex.
