FISH PASSAGE AT BRANDYWINE CREEK DAMS 4, 5 AND 6

City of Wilmington, Brandywine and Christiana
Hundreds, New Castle County, Delaware

DHCA Project Review No. 2020.06.22.06

ARCHAEOLOGICAL SURVEYS

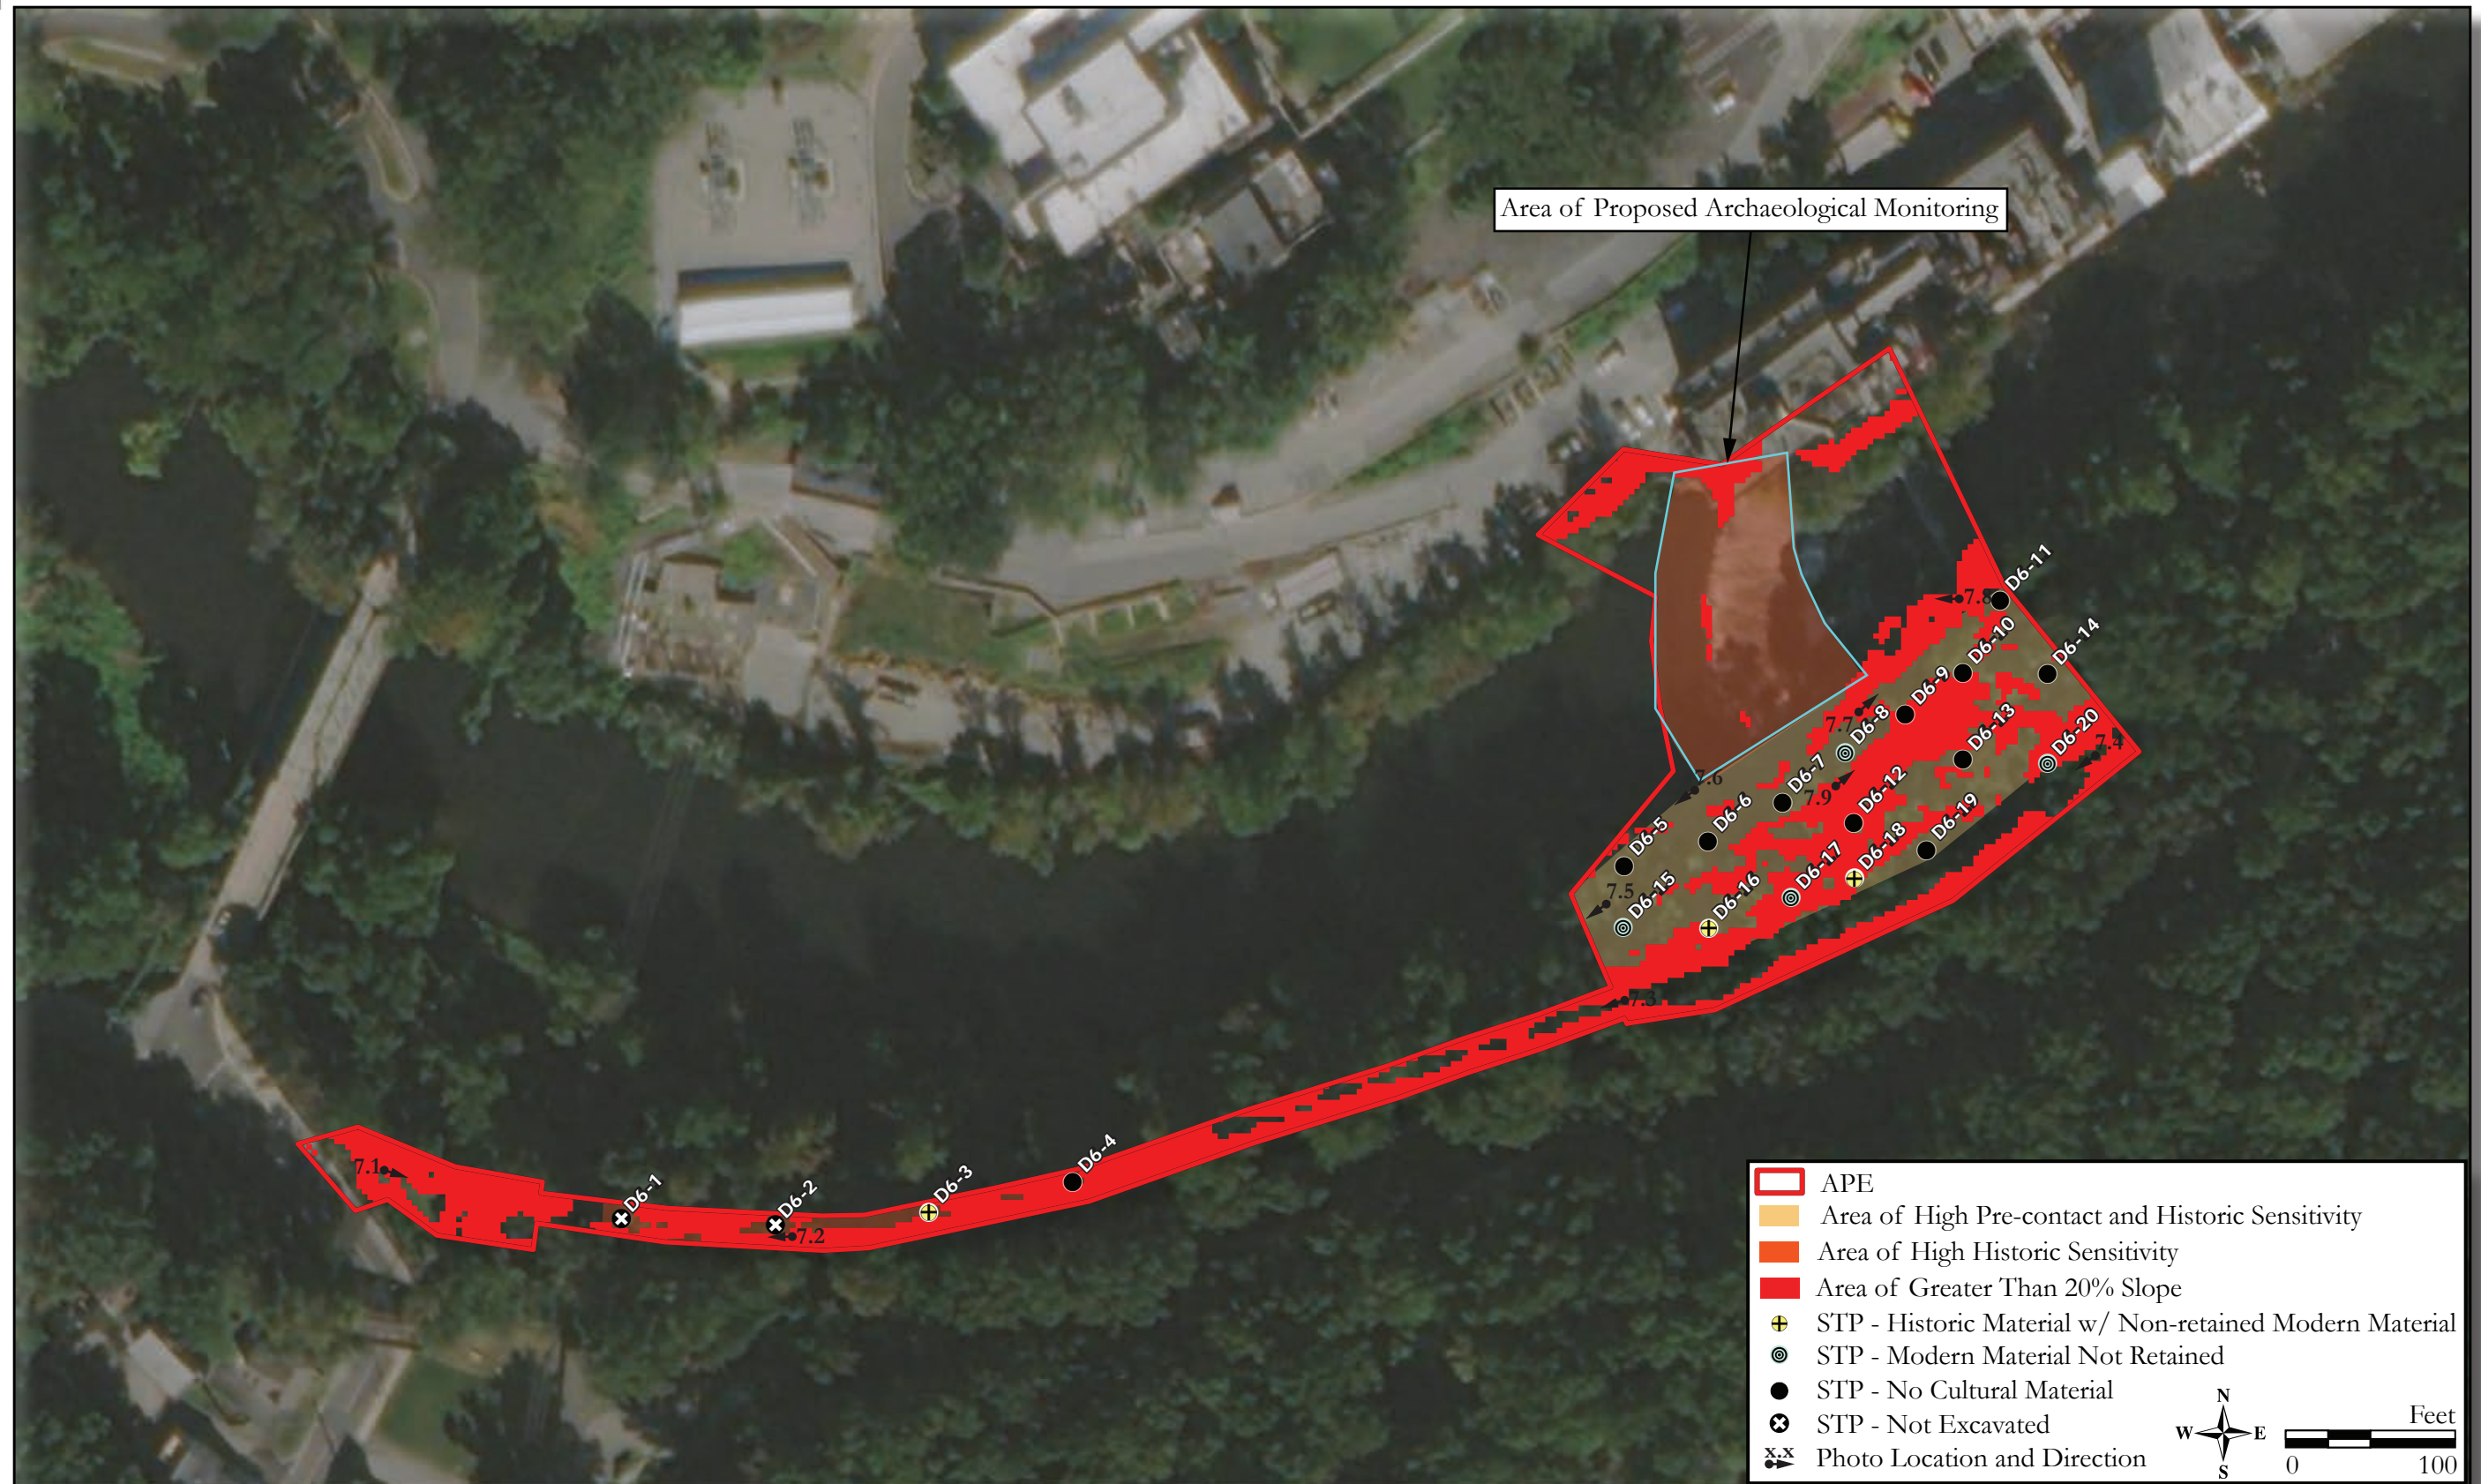
Seven STPs contained a natural soil profile at grade (STPs D6-3, D6-5, D6-7, D6-10, D6-11, D6-13, and D6-14; see Figure 7.11), none of which yielded any artifacts. Two STPs consisted of a shallow topsoil, overlying boulders (STPs D6-8 and D6-9). Six STPs demonstrated a truncated subsoil and no buried topsoil (STPs D6-4, D6-12, D6-17, D6-18, D6-19, and D6-20). No artifacts were found in the truncated subsoil. Three STPs had modern fill to the base of the STP (STPs D6-6, D6-15, and D6-16). Fill layers in the Dam 6 APE appear to be associated with twentieth-century landscape modification, gravel road and parking area construction, and utility installation. A total of six artifacts was recovered from the STPs, consisting of twentieth-century beverage bottle glass, window glass, and metal fasteners (see Appendix E). Items that were noted and not retained include plastic, Styrofoam, concrete, small brick fragments, and slag.

Figure 7.11: Aerial photograph of the Dam 6 APE showing photograph locations, areas of archaeological sensitivity, and STP locations and results.

In sum, no pre-Contact Native American or early historic artifacts were recovered, and no cultural features were identified in the upland portion of the APE. The low quantity of modern artifacts recovered from possibly intact, natural soils is not considered representative of an archaeological site.

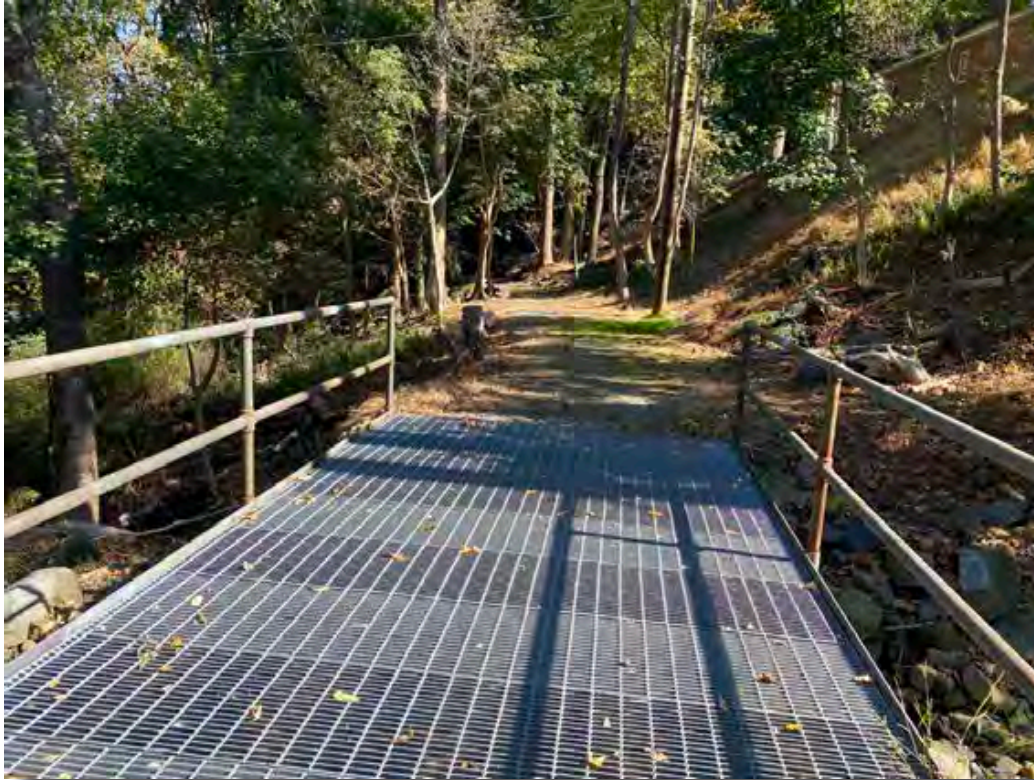
Plate 7.1: Overview of a metal grate bridge leading to gravel access road for the Dam 6 APE.

For Dam 6, the bridge and culvert on the access road must be included in the evaluation. The CHAD report states that these structures will not be “altered as a result of this project.” However, project plans are not yet complete, and we recall from the field meeting earlier this year that some form of reinforcement may be needed to allow equipment to pass over the bridge in particular. Additionally, the Section 106 review process requires consideration of resources that *may* be affected, which would include inadvertent damage that may occur during the course of the project. Similarly, we are concerned about the proximity of buildings/structures to the north side of the dam, which are not described in the report. Although the U.S. Army Corps of Engineers’ permit area abuts but does not include them, it would be prudent to at least identify the age and nature of these buildings/structures for consideration as planning and consultation for the project continues.

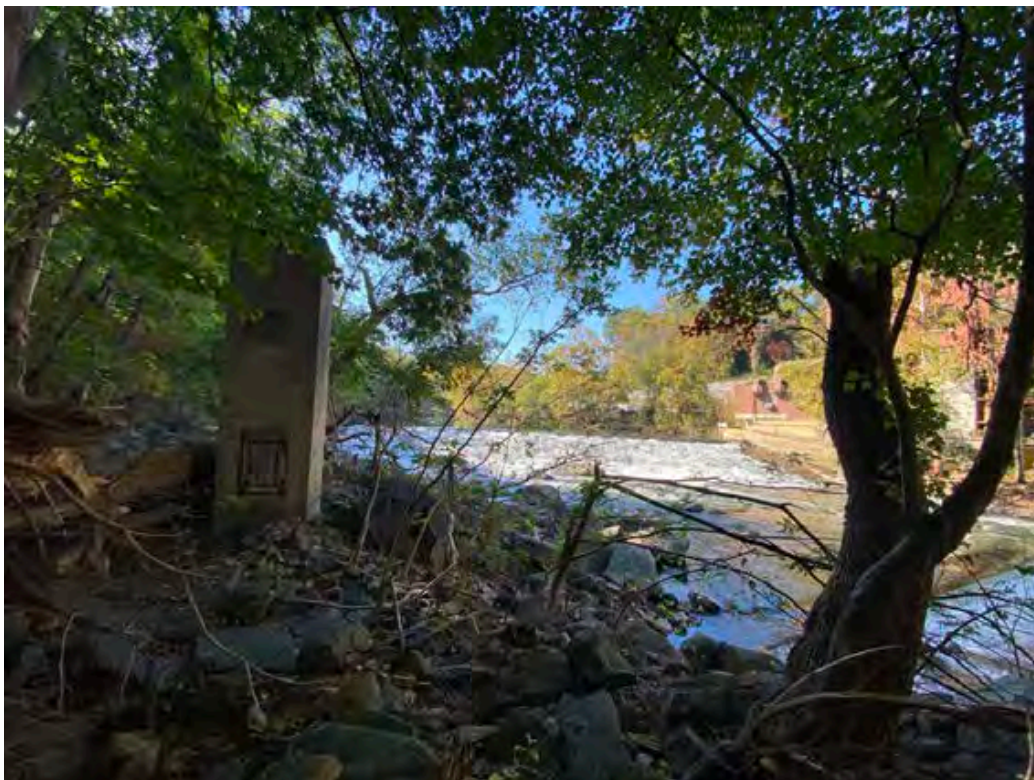
Plate 7.8: Overview of a U.S.G.S. gauging station abandoned in 2006 on the southern bank of the creek.

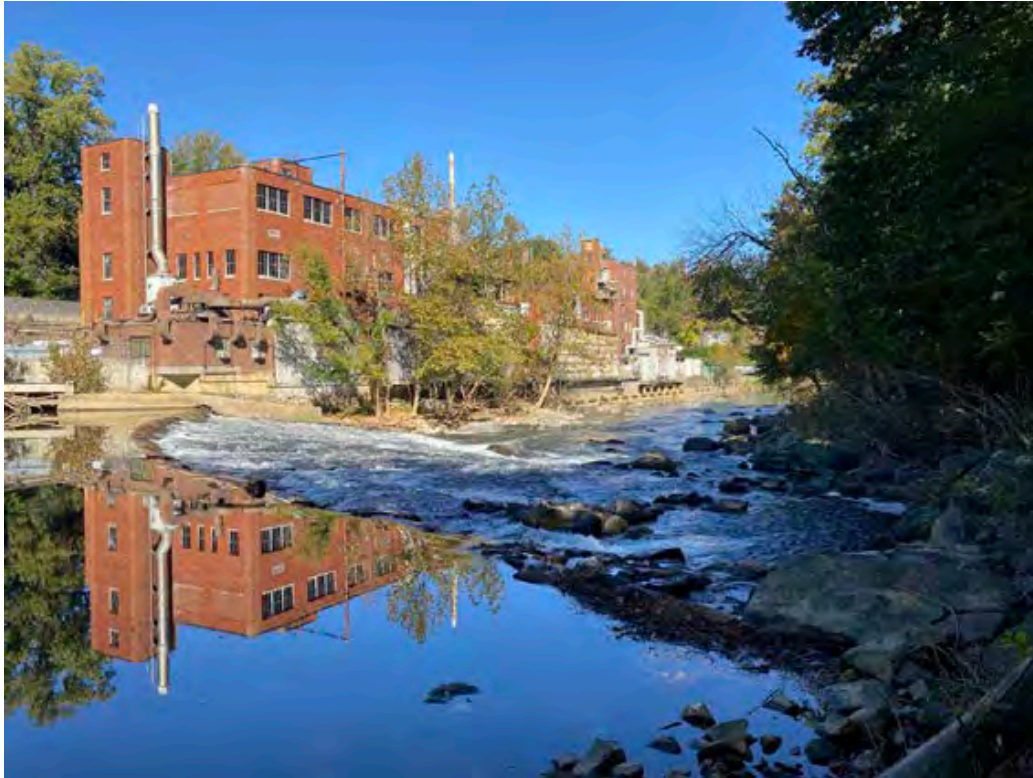
Plate 7.9: Overview of Dam 6 and brick industrial buildings in the background.

The Dam 6 APE includes the Lower Hagley Yard Dam associated with the nineteenth through early twentieth-century DuPont Company of black powder manufacturers. The 2022 report by CHAD concluded that Dam 6, the Lower Hagley Yard Dam, meets the criteria for historical significance at the local level and retains sufficient integrity to be listed in the NRHP (Morrissey, Emmons, and Showell 2022). The southern bank of the Brandywine Creek within the APE was assessed with a high sensitivity for pre-Contact archaeological resources due to its environmental setting and a moderate sensitivity for historic archaeological resources due to its proximity to the DuPont complex and its location adjacent to the historic dam. A stone retaining wall is present in the western portion of the APE, and the area of the retaining wall has an assessed high sensitivity for historic archaeological resources. Phase IB archaeological testing was conducted in the upland area assessed with moderate to high archaeological sensitivity to determine if archaeological resources exist that could be affected by the proposed undertaking. Archaeological fieldwork resulted in the recovery of a low number of late nineteenth- through twentieth-century artifacts with no clear spatial patterning. These artifacts are likely the result of secondary deposition and not considered to represent an intact archaeological site. No further archaeological survey is recommended in the upland portion of the APE. Due to the map-documented presence of a dam at the location of Dam 6 in the early nineteenth century, archaeological monitoring of the removal of Dam 6 is recommended to record dam construction techniques.

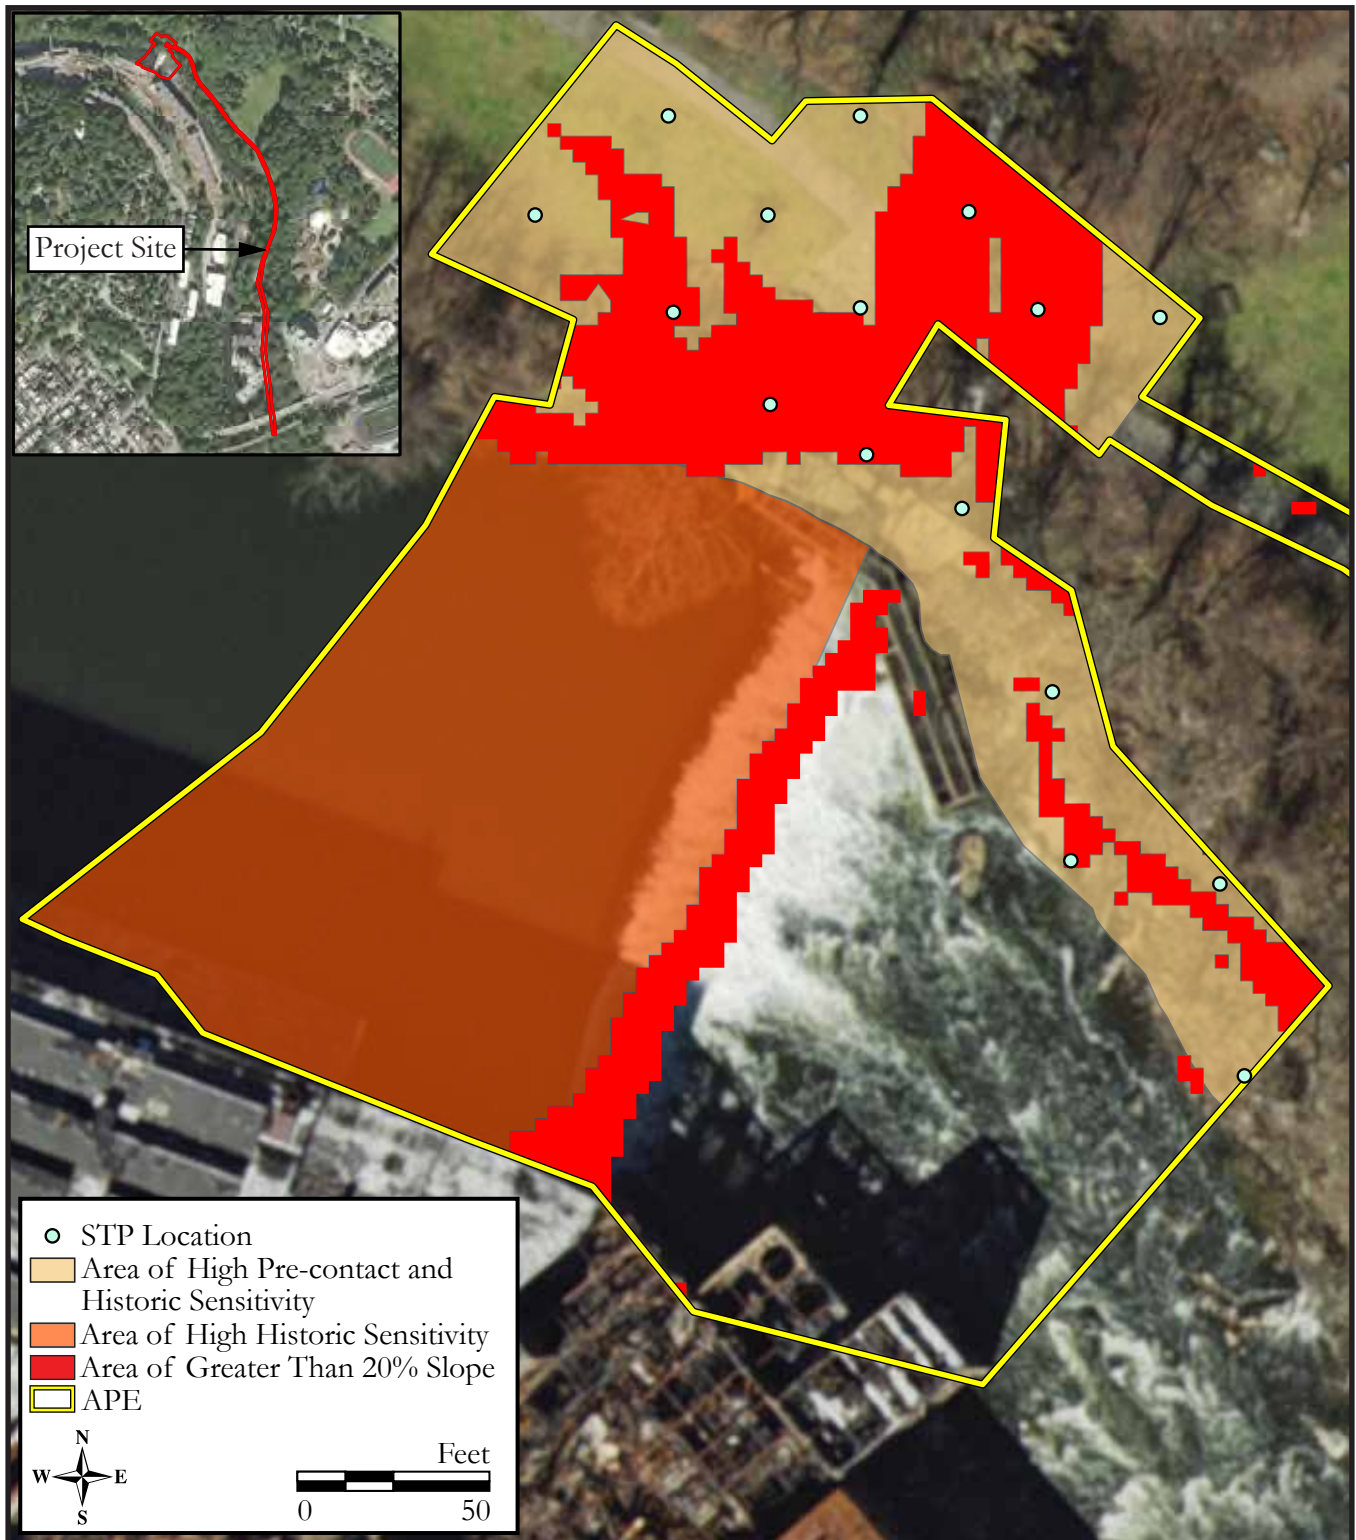
Figure 1: Aerial showing the APE for Dam 4, areas of 20 percent or greater slope, areas of assessed archaeological sensitivity, and proposed shovel test pit locations.

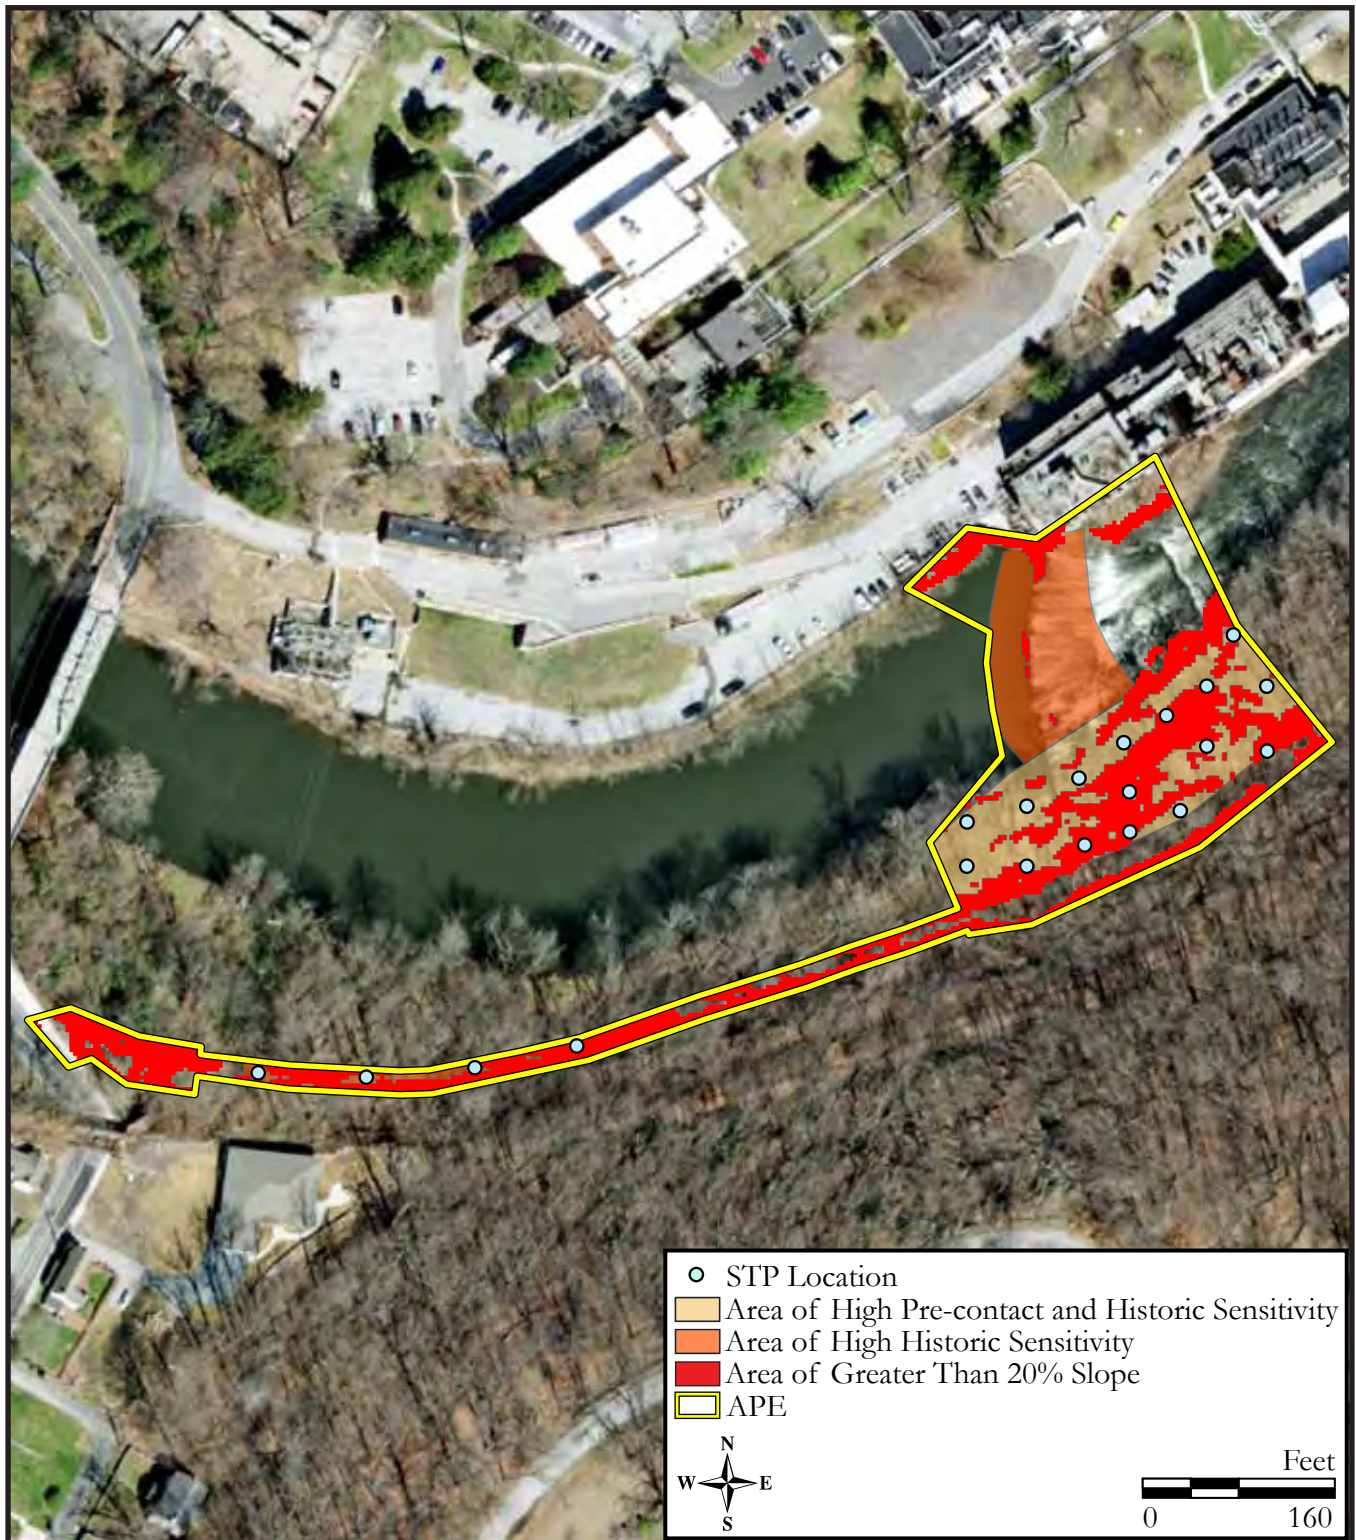
Figure 2: Aerial showing the APE for Dam 6, areas of 20 percent or greater slope, areas of assessed archaeological sensitivity, and proposed shovel test pit locations.
