Brandywine River Restoration Trust

Brandywine Dam 4 & 6: Dam Removal Section 106 Consultation

January 19,
2023

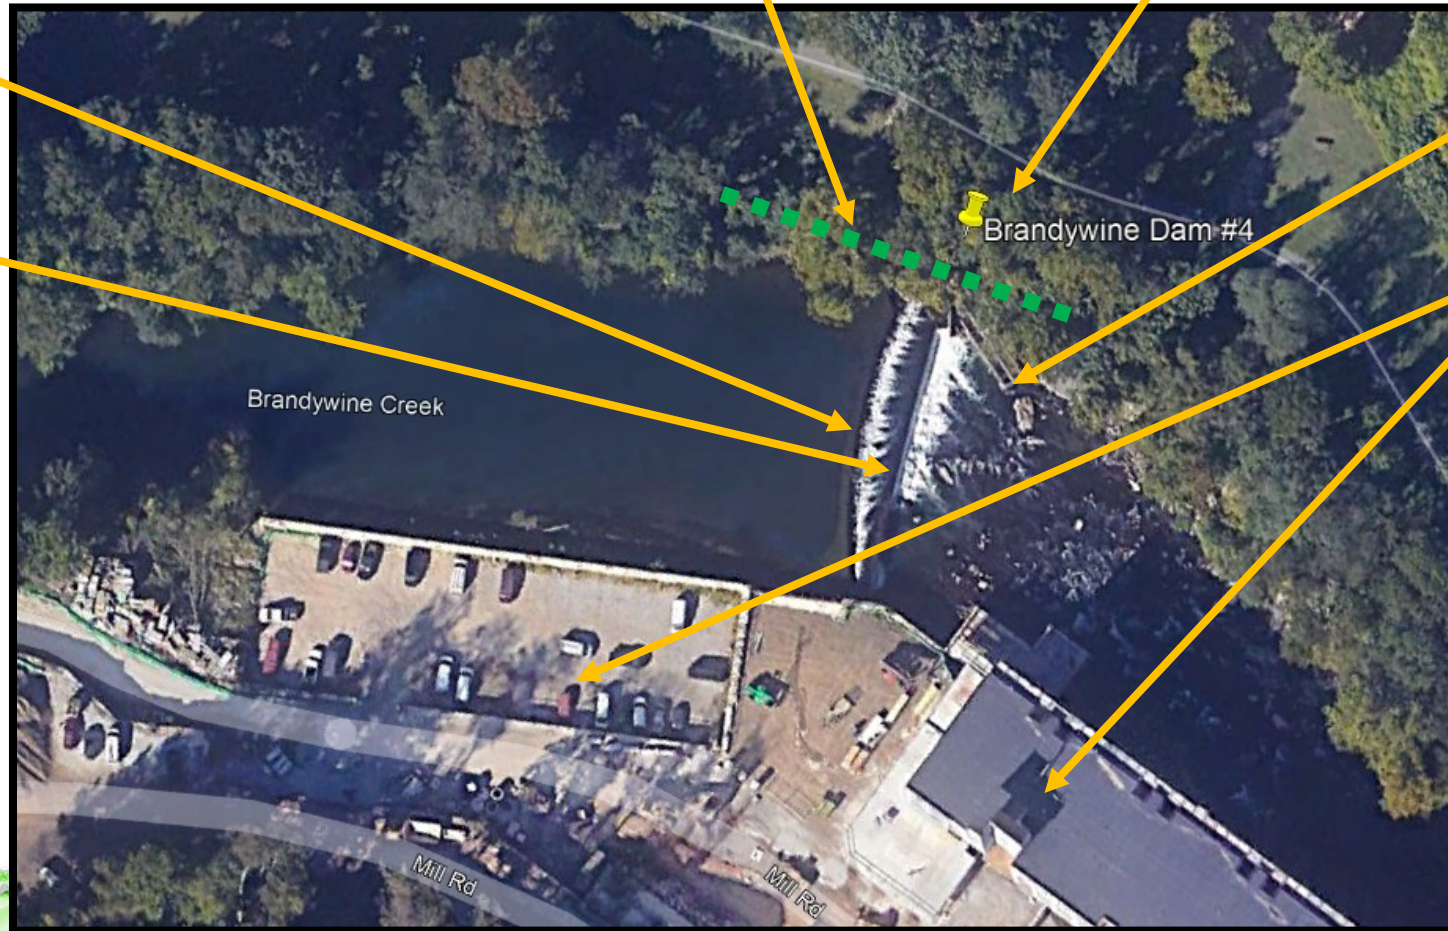
Dam 4
(Earlier Dam)

Dam 4
(Current Dam)

Utility

Alapocas Run
culvert walls

Non-functional
Technical Fishway

Former Bancroft
Mill Buildings:
new buildings
constructed/
under
construction

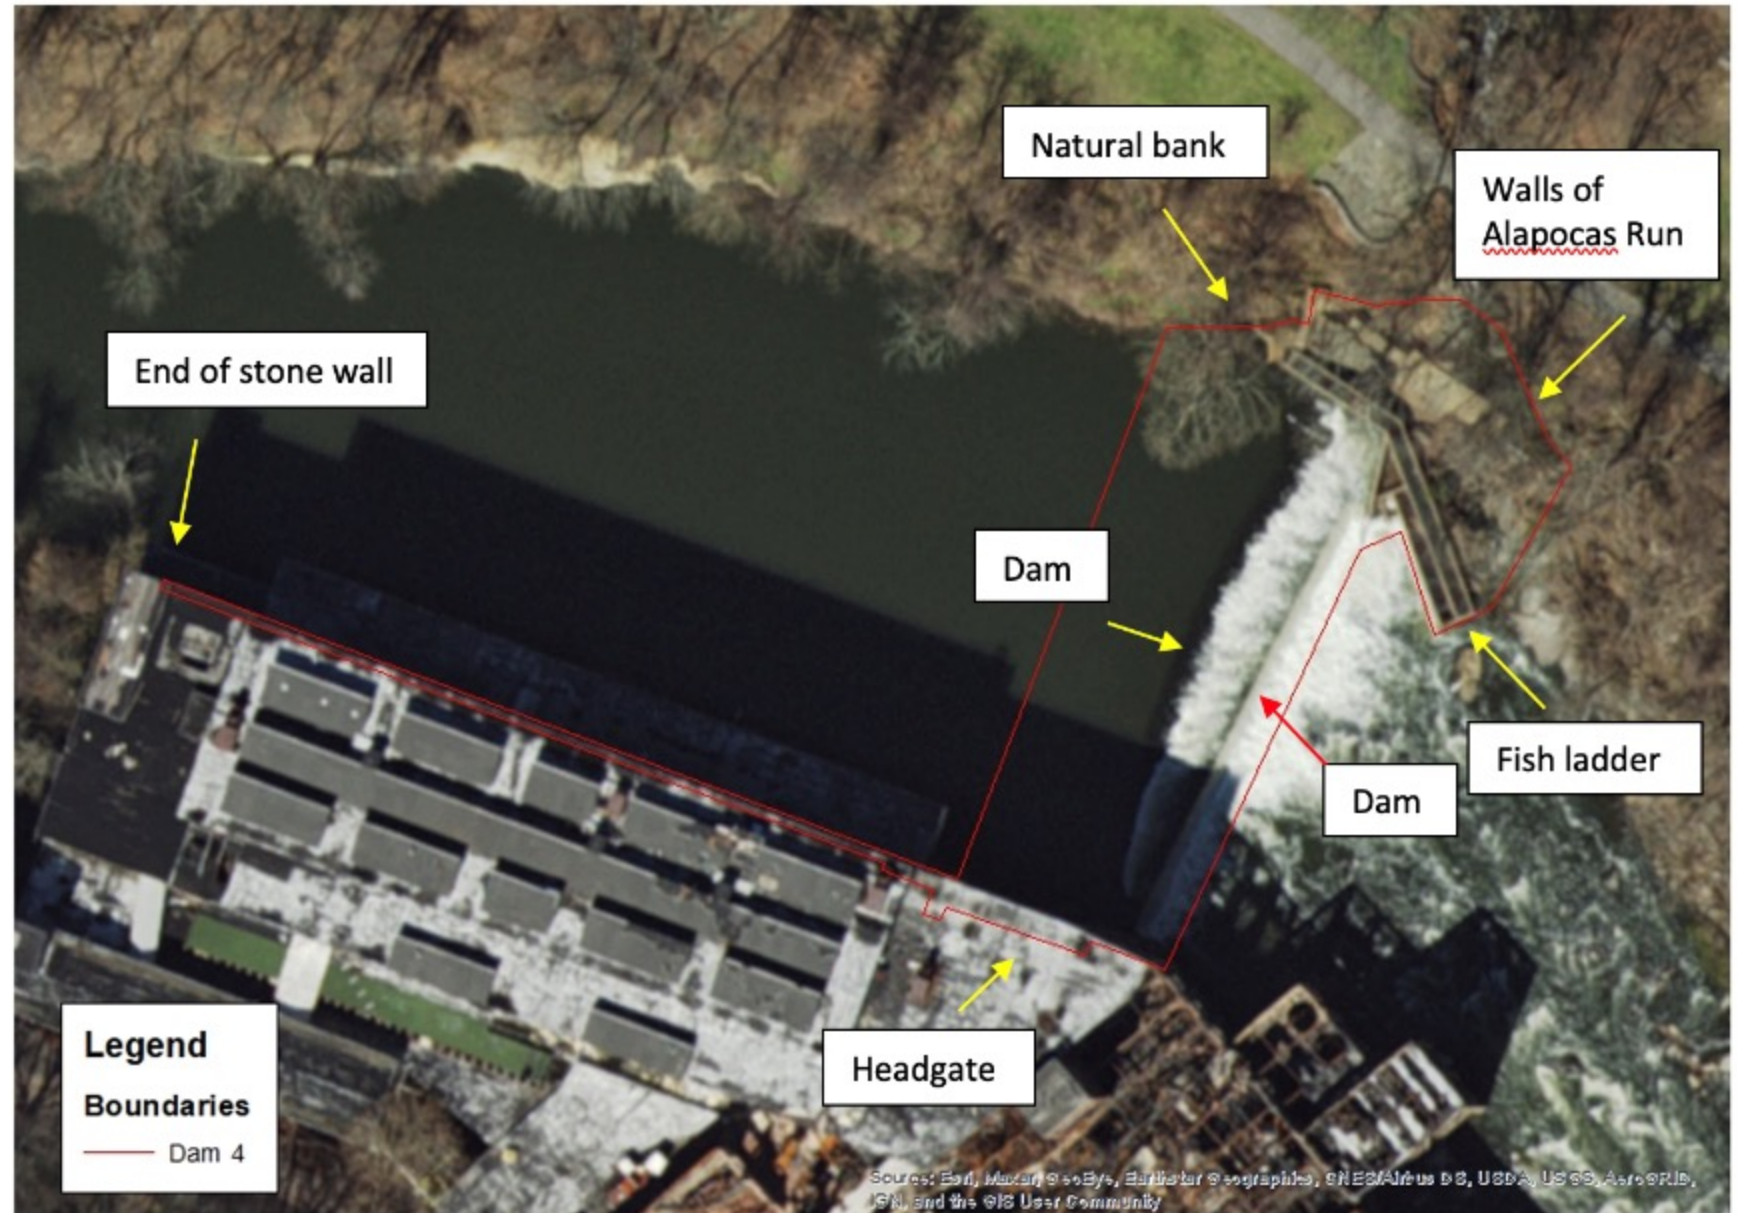
Boundaries of Dam 4

Kentmere Dam Complex

Determined Eligible

- Under Criterion A and C

Components:

- Upper dam, 1896
- Current dam, c. 1940
- Fish ladder, c. 1970

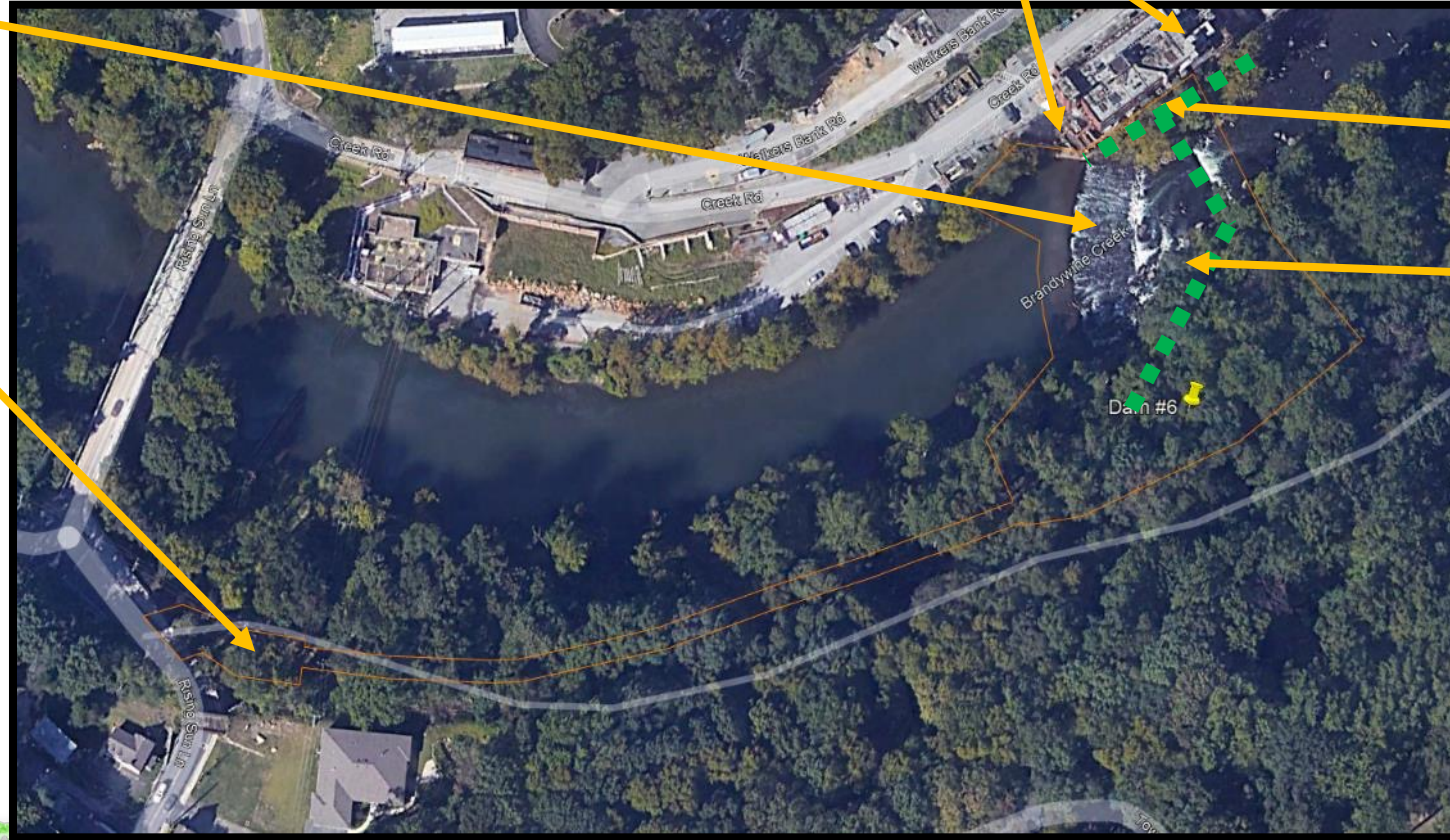
Dupont Experimental
Station Buildings

Dam 6

Culvert
& Bridge

Utilities

USGS Water
Monitoring
Station

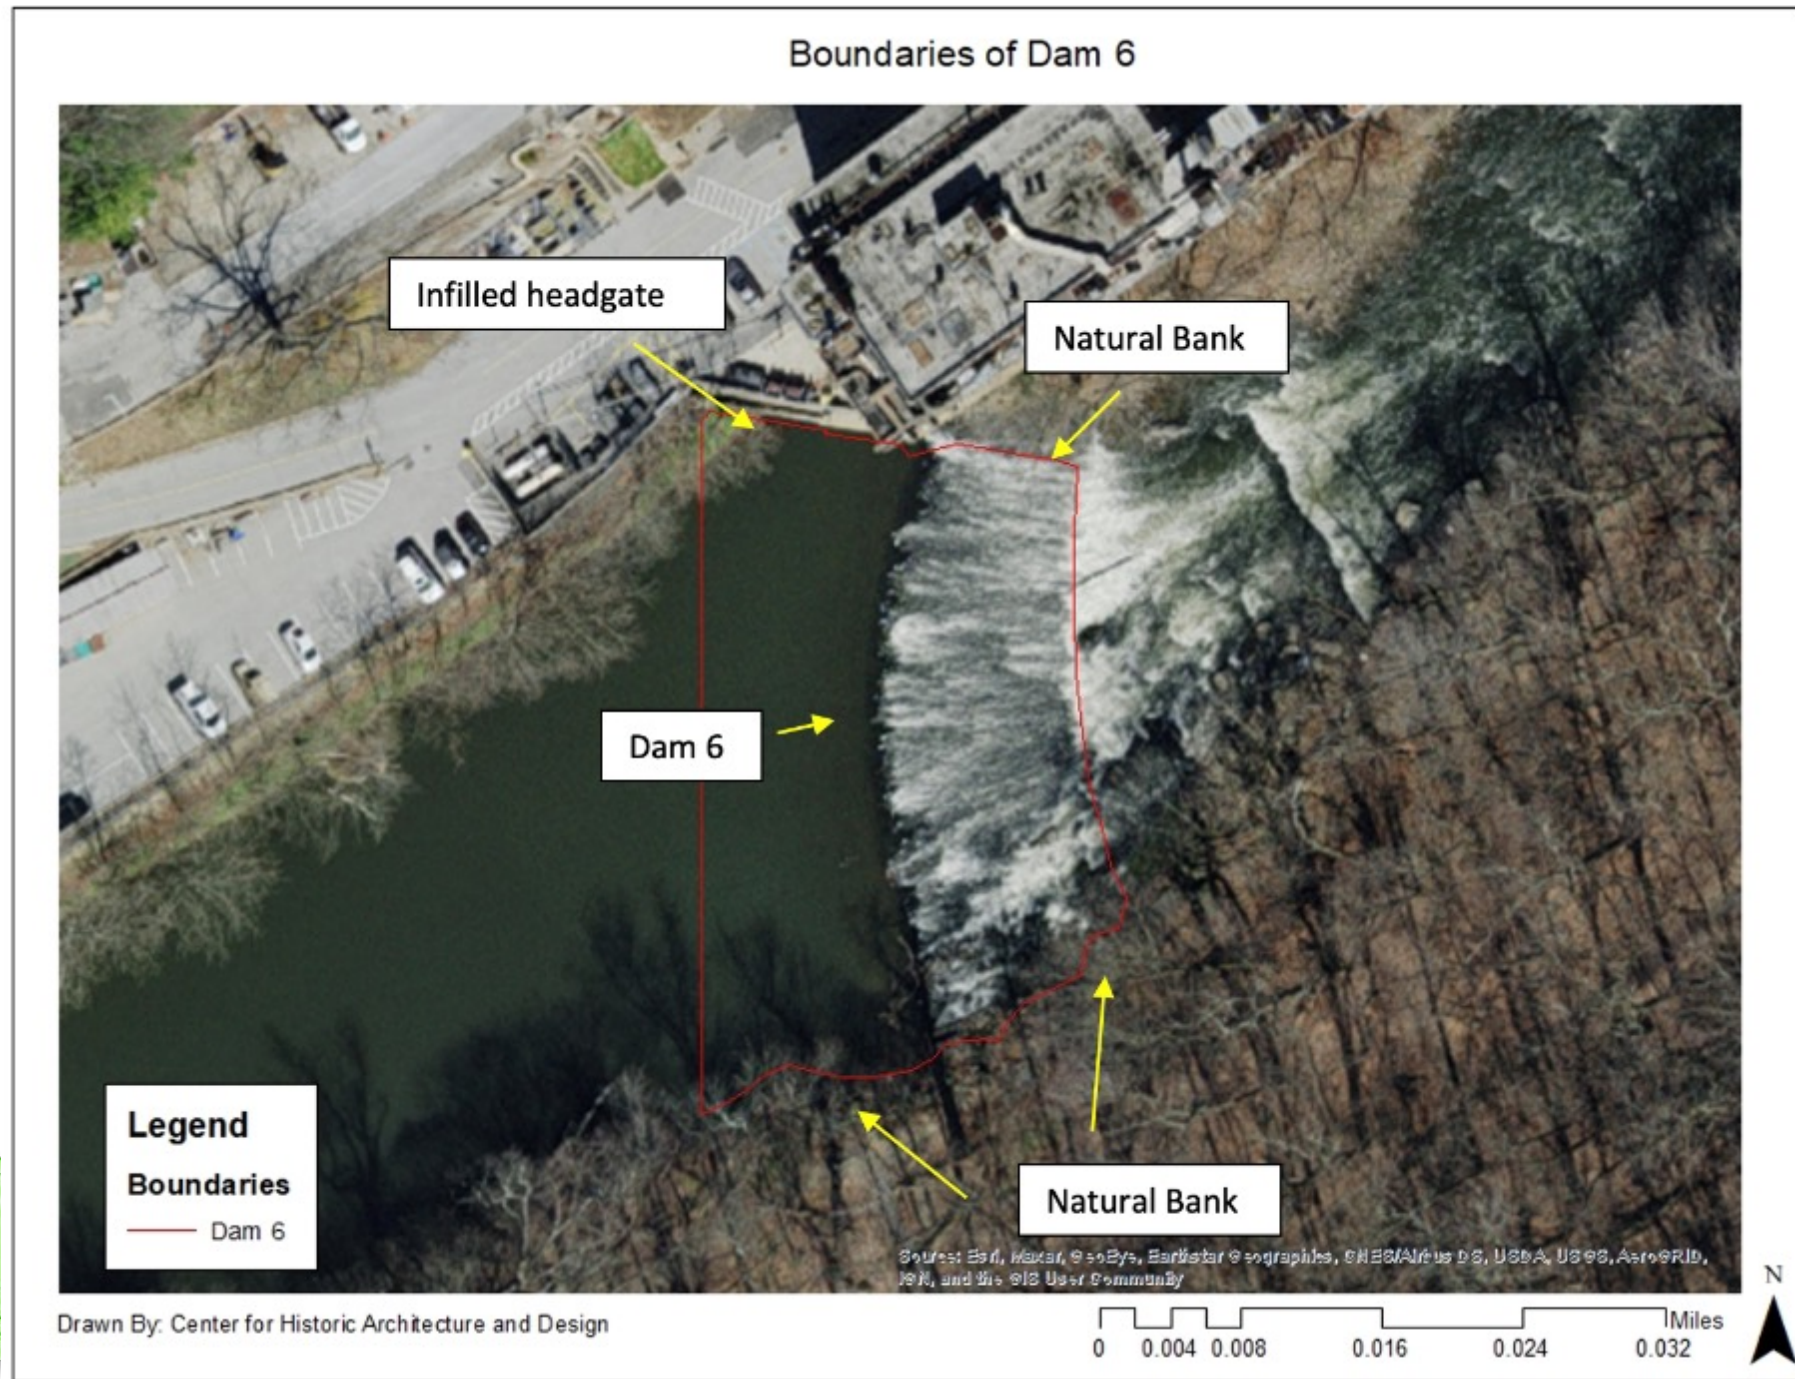
Other Resources in APE

All determined ineligible

Stone culvert, late 19th cen.

Platform bridge, c. 1946

USGS Water Monitoring Station, 1946

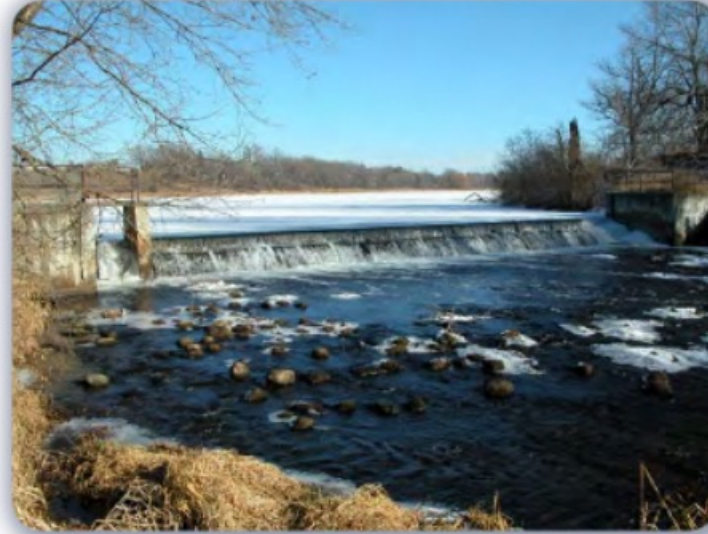
Before

Upstream view of dam during low flow

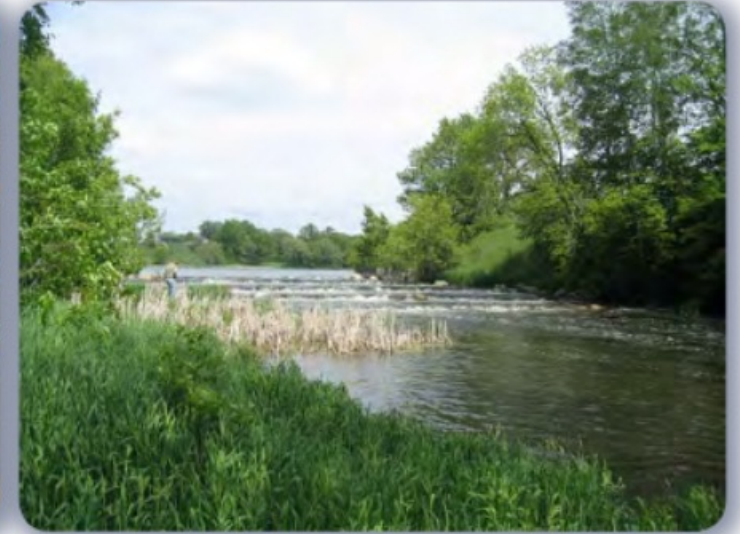
After

Upstream view of completed ramp

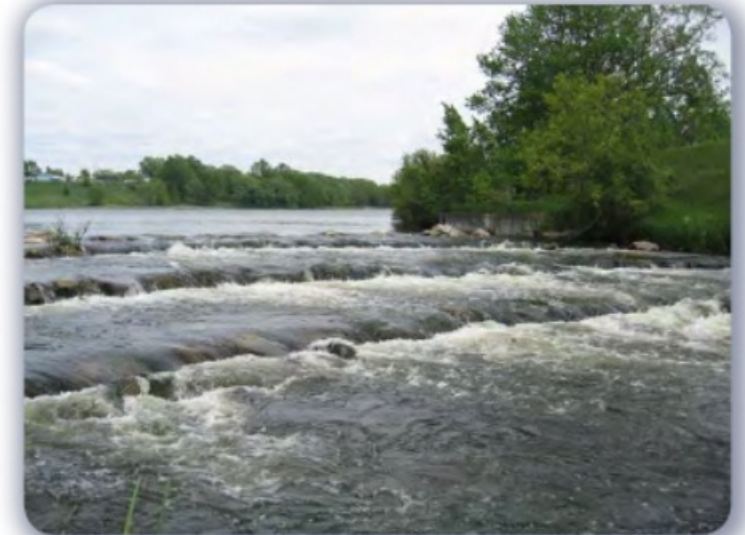
Closer view of rapids showing boulder weirs

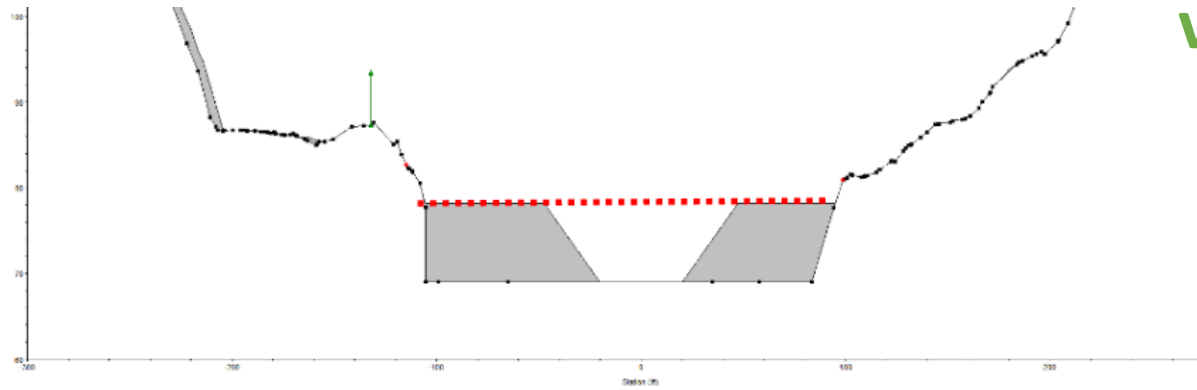
Partial Dam Removal

Figure 12. Partial-width Removal Geometry Visualization for Dam 6 in HEC-RAS Modeling Software (red line is dam crest, grey is dam/banks to remain)

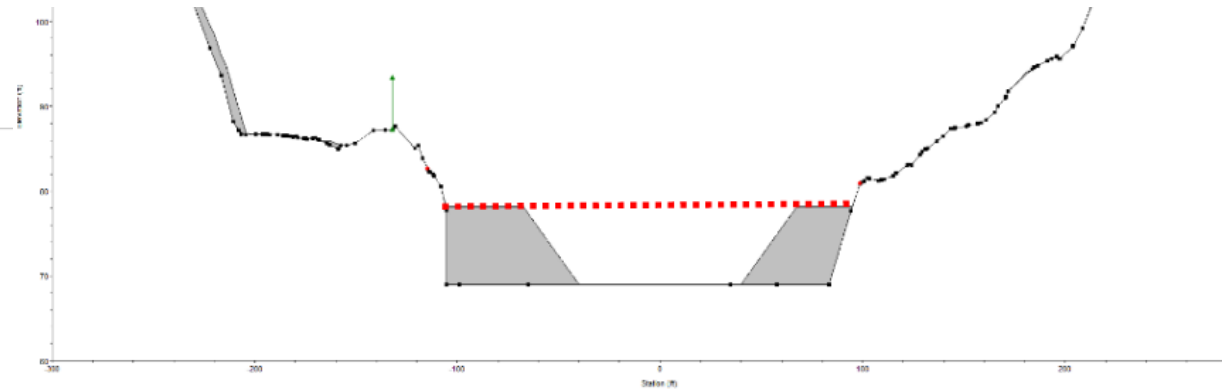
Full-width Dam Removal

Figure 11. Full Removal Geometry Visualization for Dam 6 in HEC-RAS Modeling Software (red line is existing dam crest, grey is dam/banks to remain)

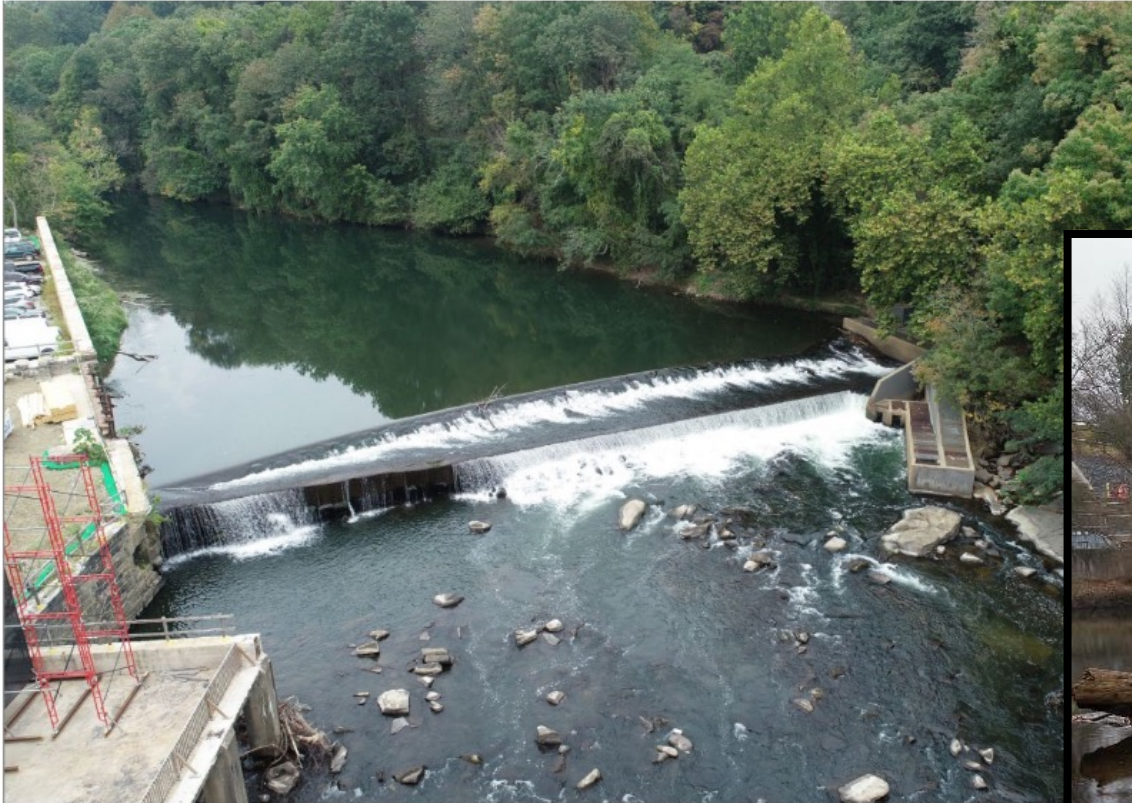
Photo 1. Aerial View of Dam 4 from Drone Showing Void on Left Side, Dated 9/2
